**Scope of Work and Specifications**

**CRSF Building Demolition**

**OAK RIDGE NATIONAL LABORATORY**

**March 2021**

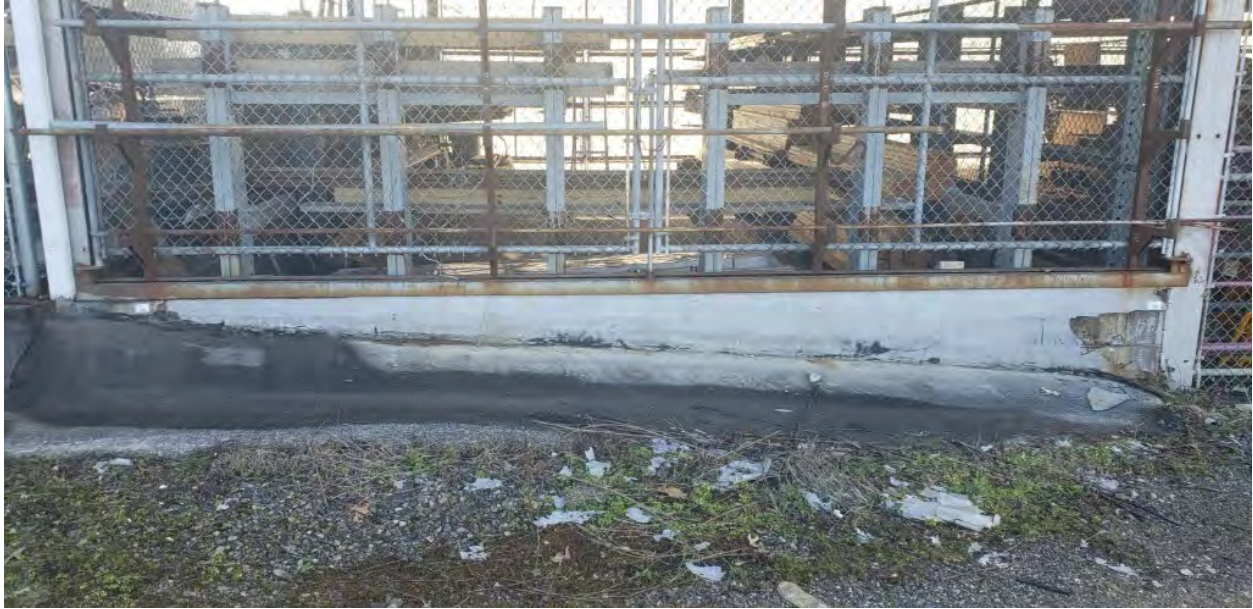
Bldg. 7070, SID13979; roof flashing material at base of bldg.

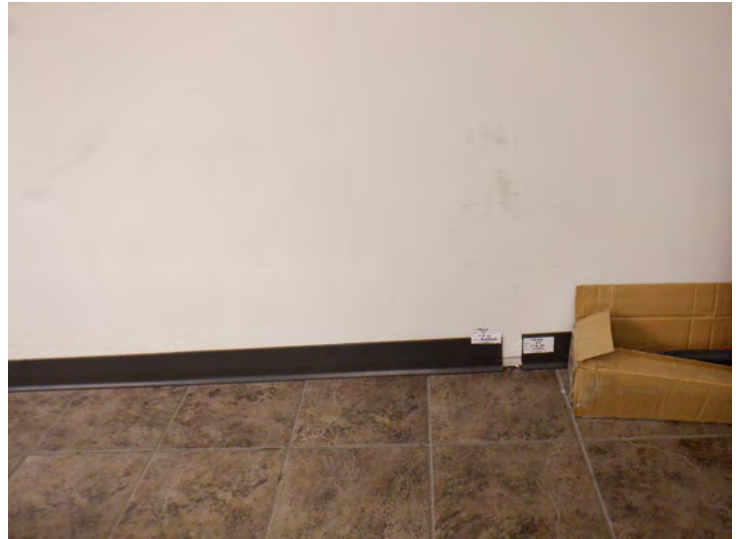
<b>HA Description</b>	Dark Gray Baseboard White mastic associated with sample 01.
	<b>Sample #</b>	<b>SID14064-01</b> <b>SID14064-02</b>
	<b>Sample Location / Orientation</b>	SID14064-01 – Rm 03 (Kitchen)Center of South Wall SID14064-02 – Rm 03 (Kitchen)Center of South Wall
	<b>Sample/Inspection Results</b>	<b>SID14064-01 – None Detected</b> <b>SID14064-02 – None Detected</b>
	<b>Recommendation</b>	None

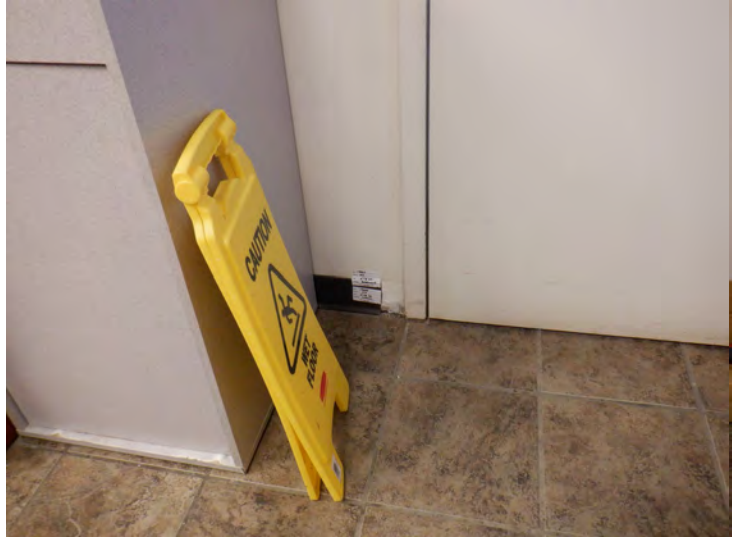
<b>HA Description</b>	Dark Gray Baseboard White mastic - associated with sample 03.
	<b>Sample #</b>	<b>SID14064-03</b> <b>SID14064-04</b>
	<b>Sample Location / Orientation</b>	SID14064-03 – Rm 03 East wall beside exterior door SID14064-04 – Rm 03 East wall beside door associated with sample 03.
	<b>Sample/Inspection Results</b>	<b>SID14064-03 – None Detected</b> <b>SID14064-04 – None Detected</b>
	<b>Recommendation</b>	None

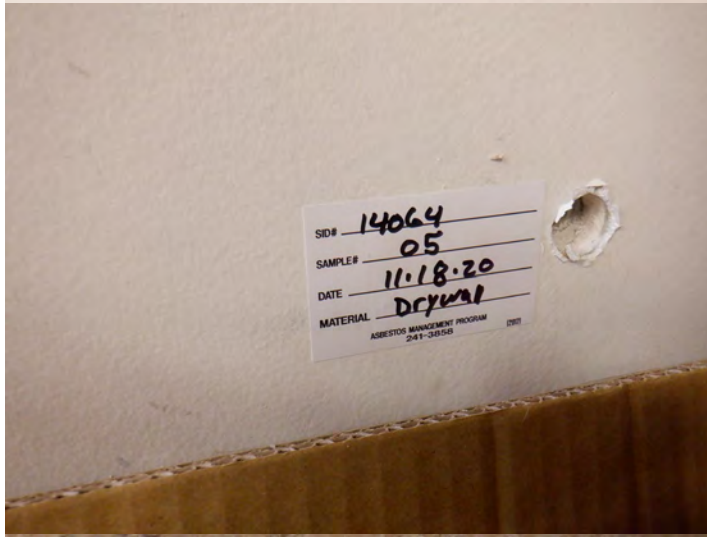
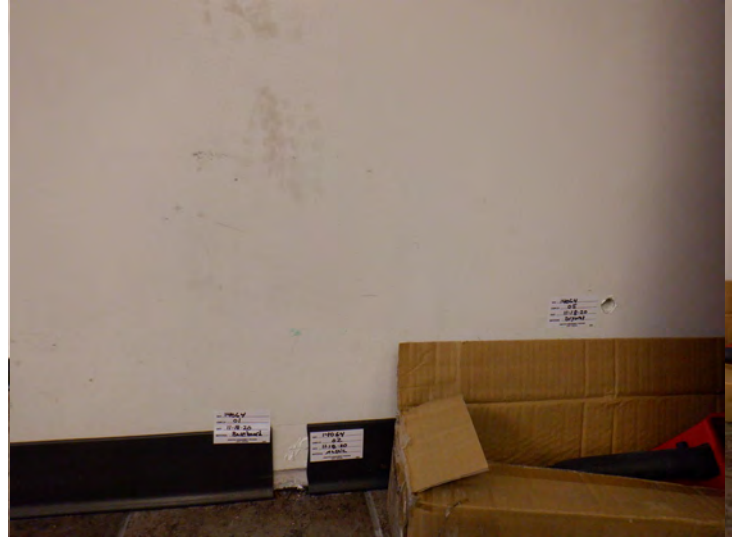
<b>HA Description</b>	Drywall
	<b>Sample #</b>	SID14064-05
	<b>Sample Location / Orientation</b>	SID14064-05 – Rm 03 Center of south wall
	<b>Sample/Inspection Results</b>	SID14064-05 – None Detected
	<b>Recommendation</b>	None

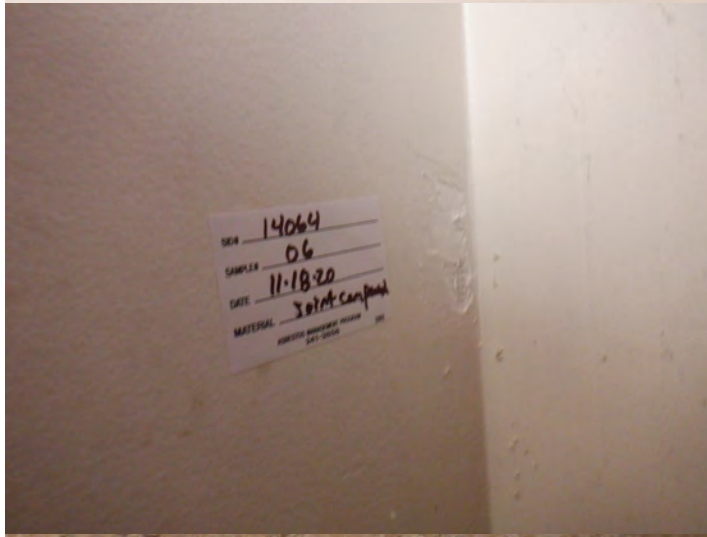
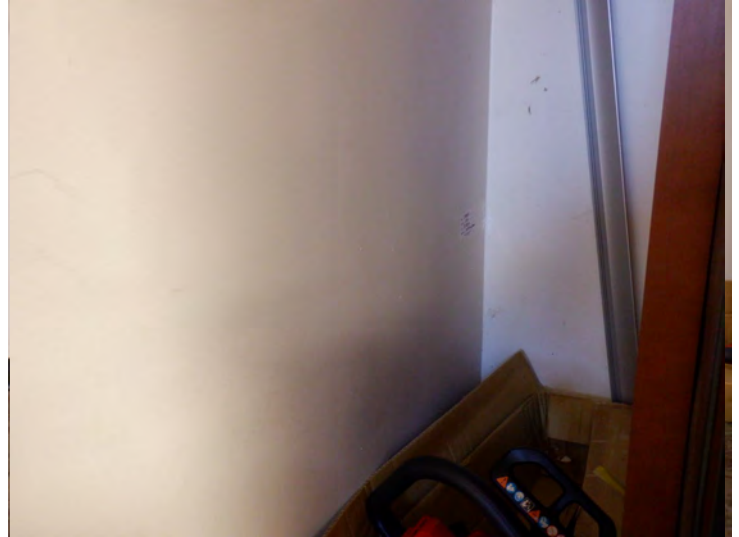
<b>HA Description</b>	Joint Compound
	<b>Sample #</b>	<b>SID14064-06</b>
	<b>Sample Location / Orientation</b>	SID14064-06 – Rm 03 South wall. SW Corner
	<b>Sample/Inspection Results</b>	<b>SID14064-06 – None Detected</b>
	<b>Recommendation</b>	None

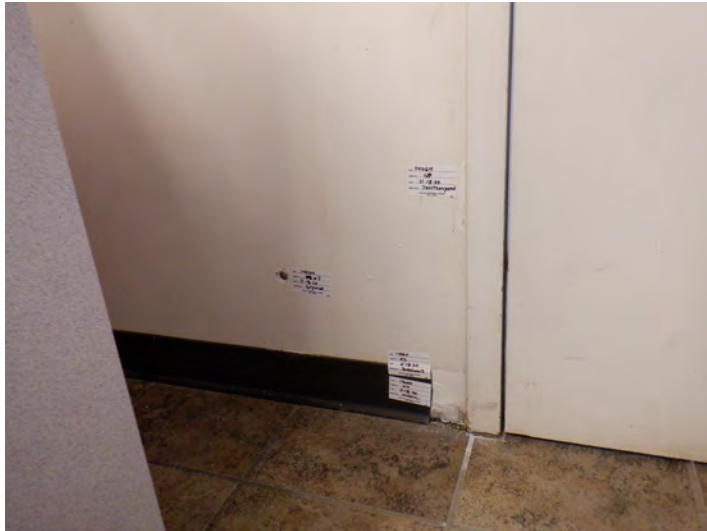
<b>HA Description</b>	Drywall Joint Compound
	<b>Sample #</b>	<b>SID14064-07</b> <b>SID14064-08</b>
	<b>Sample Location / Orientation</b>	SID14064-07 – Rm 03 East Wall, beside east exterior door SID14064-08 – Rm 03 East wall beside ext door
	<b>Sample/Inspection Results</b>	<b>SID14064-07 – None Detected</b> <b>SID14064-08 – None Detected</b>
	<b>Recommendation</b>	None

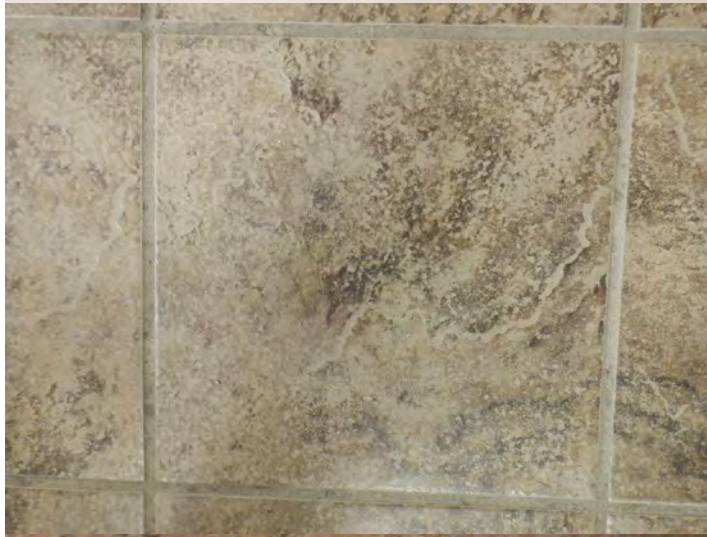
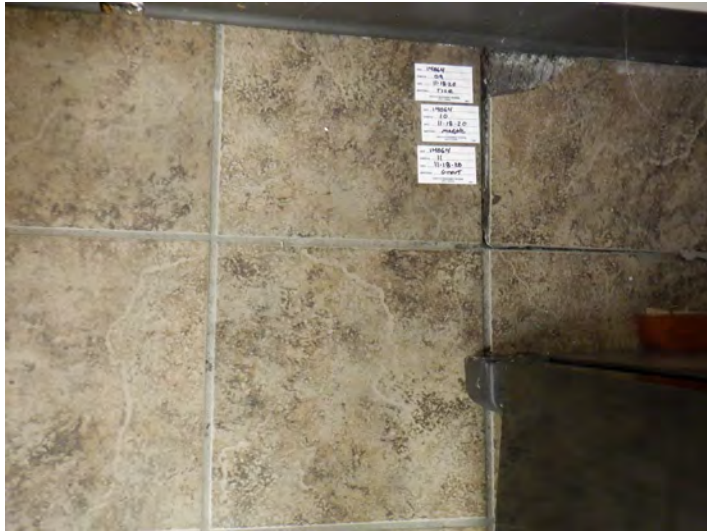
<b>HA Description</b>	12x12 Tan, Black, Brown Tile Gray mastic Gray Grout
	<b>Sample #</b>	<b>SID14064-09</b> <b>SID14064-10</b> <b>SID14064-11</b>
	<b>Sample Location / Orientation</b>	09-Rm 03 Floor near center of south wall 10-Rm 03 Floor near center of south wall assoc/sample 09 11-Rm 03 Floor near center of south wall assoc/sample 09
	<b>Sample/Inspection Results</b>	<b>SID14064-09 – None Detected</b> <b>SID14064-10 - None Detected</b> <b>SID14064-11 – None Detected</b>

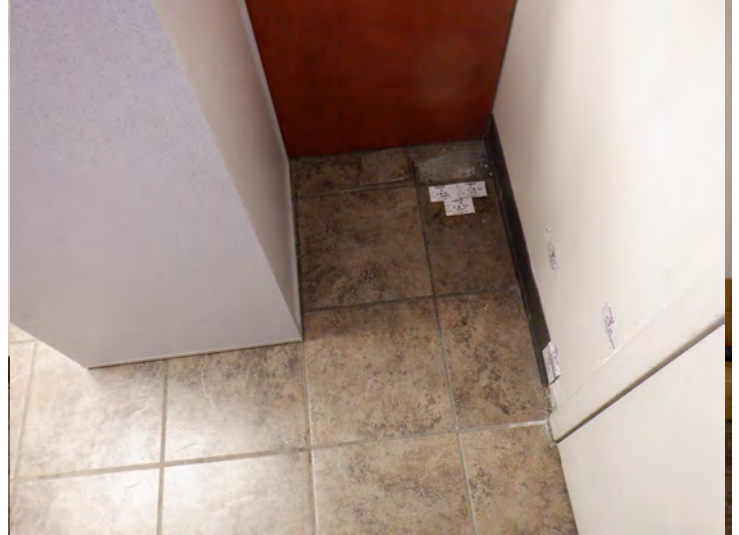
<b>HA Description</b>	12x12 Tan, Black, Brown Tile Gray mastic Gray Grout
	<b>Sample #</b>	<b>SID14064-12</b> <b>SID14064-13</b> <b>SID14064-14</b>
	<b>Sample Location / Orientation</b>	12-Rm 03 Floor beside east exterior door 13-Rm 03 Floor beside east exterior door assoc/sample 12 14 -Rm 03 Floor beside east exterior door assoc/sample 12
	<b>Sample/Inspection Results</b>	<b>SID14064-12 – None Detected</b> <b>SID14064-13 – None Detected</b> <b>SID14064-14 – None Detected</b>

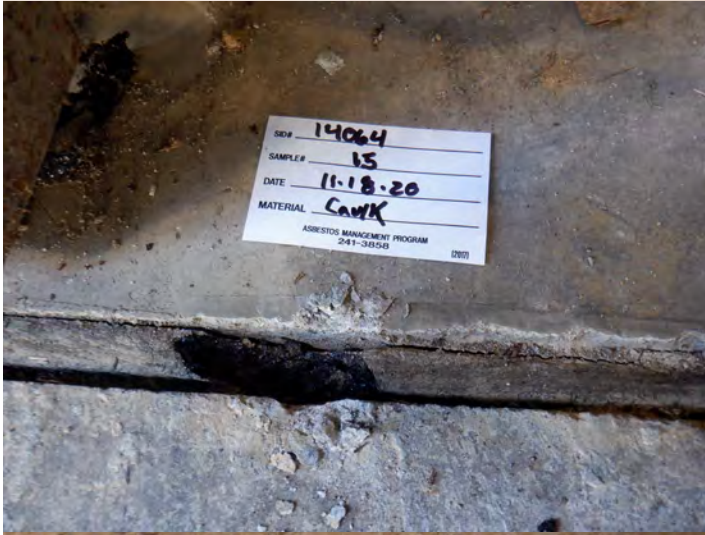
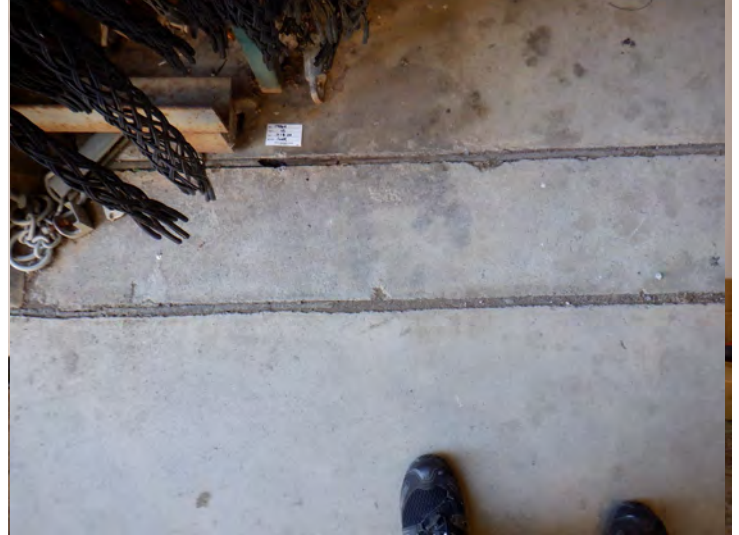
<b>HA Description</b>	Black expansion joint
	<b>Sample #</b>	<b>SID14064-15</b>
	<b>Sample Location / Orientation</b>	Rm 01 Between staging area and bucket truck covered area; south side of expansion joint
	<b>Sample/Inspection Results</b>	<b>SID14064-15 – None Detected</b>
	<b>Recommendation</b>	None

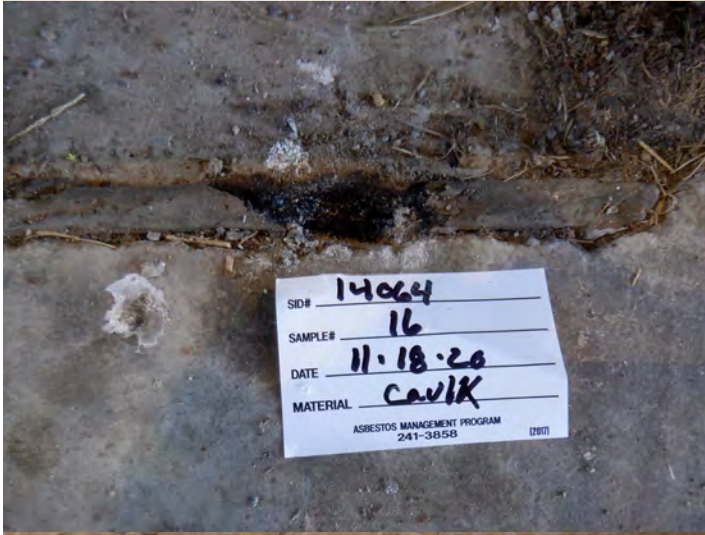
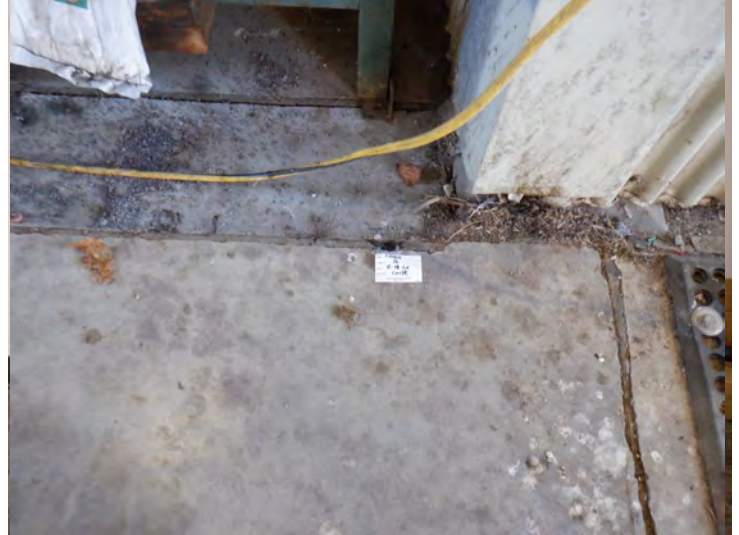
<b>HA Description</b>	Black expansion joint
	<b>Sample #</b>	<b>SID14064-16</b>
	<b>Sample Location / Orientation</b>	Rm 01 Between staging area and bucket truck covered area; North side of expansion joint
	<b>Sample/Inspection Results</b>	<b>SID14064-16 – None Detected</b>
	<b>Recommendation</b>	None

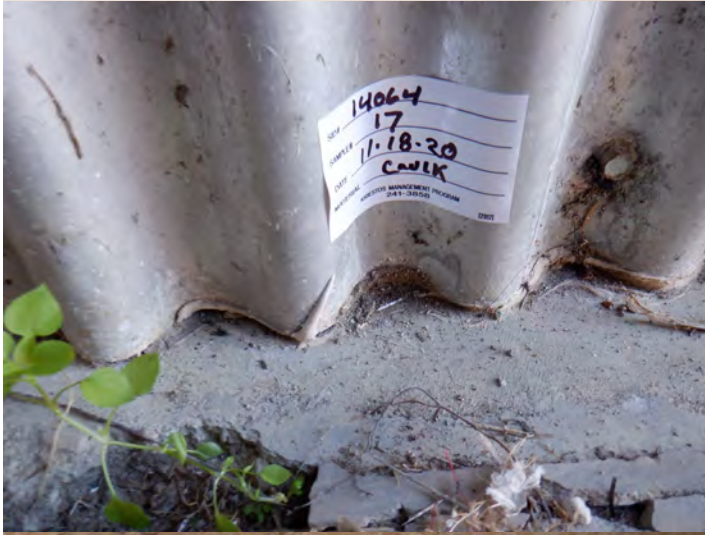
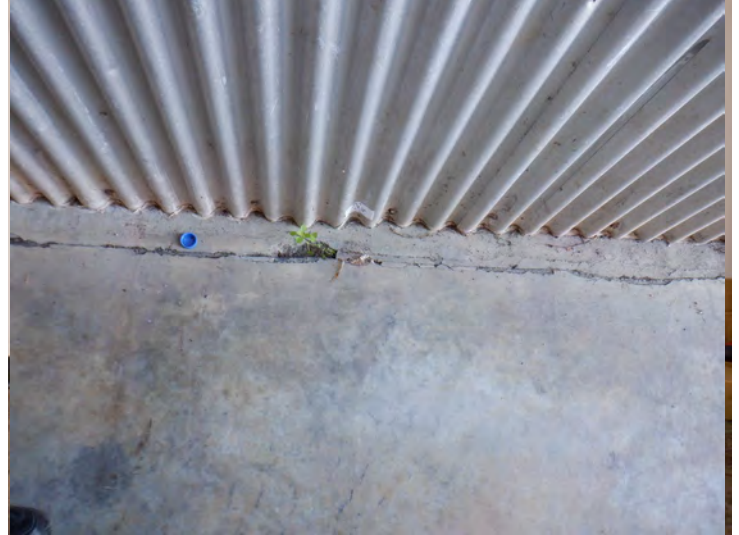
<b>HA Description</b>	White Caulk
	<b>Sample #</b>	<b>SID14064-17</b>
	<b>Sample Location / Orientation</b>	Rm 01 West wall, north of door into rm 02; between slab and corrugated wall. Bucket truck area
	<b>Sample/Inspection Results</b>	<b>SID14064-17 – None Detected</b>
	<b>Recommendation</b>	None

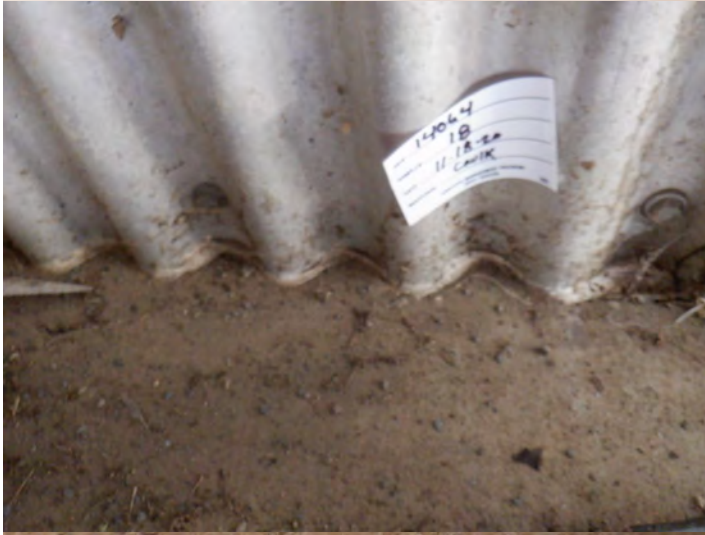
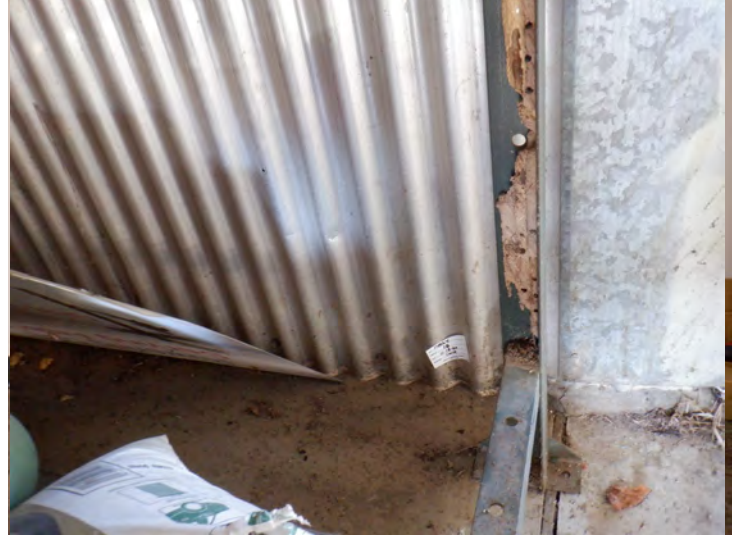
<b>HA Description</b>	White Caulk
	<b>Sample #</b>	<b>SID14064-18</b>
	<b>Sample Location / Orientation</b>	Rm 01, Outside SE corner of rm 02. Between corrugated wall and floor slab on NW corner between staging area and truck bay.
	<b>Sample/Inspection Results</b>	<b>SID14064-18 – None Detected</b>
	<b>Recommendation</b>	None

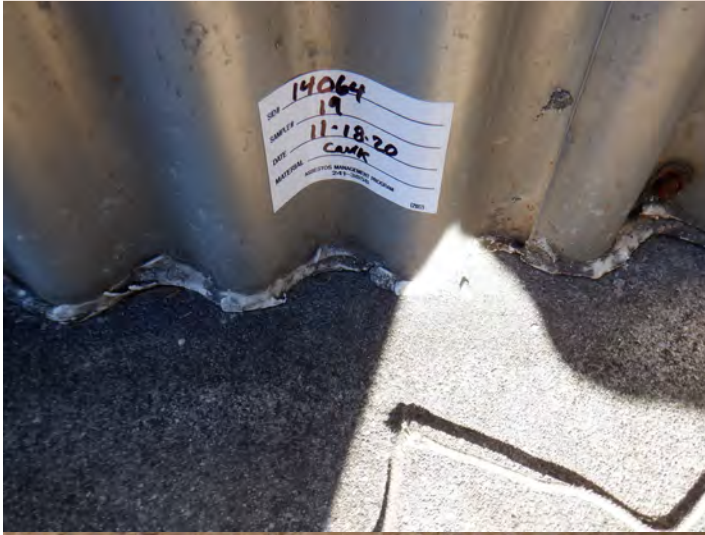
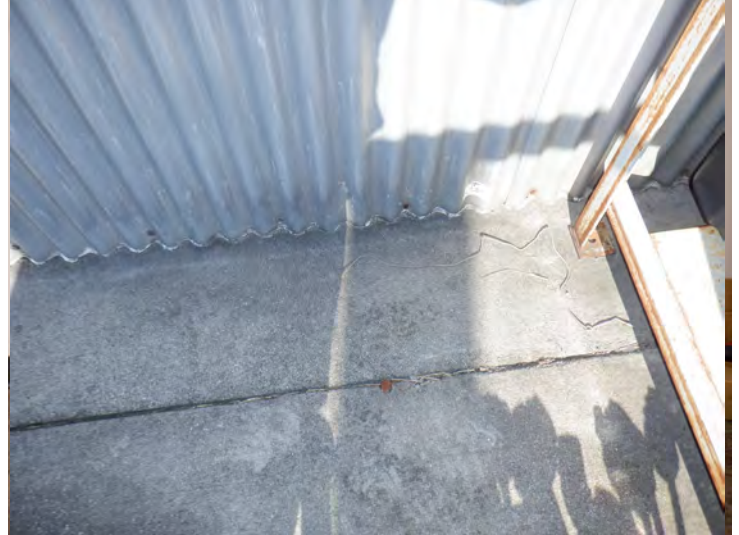
<b>HA Description</b>	White Caulk
	<b>Sample #</b>	<b>SID14064-19</b>
	<b>Sample Location / Orientation</b>	South outside wall between metal wall and concrete pad of rm 04 storage area
	<b>Sample/Inspection Results</b>	<b>SID14064-19 – None Detected</b>
	<b>Recommendation</b>	None

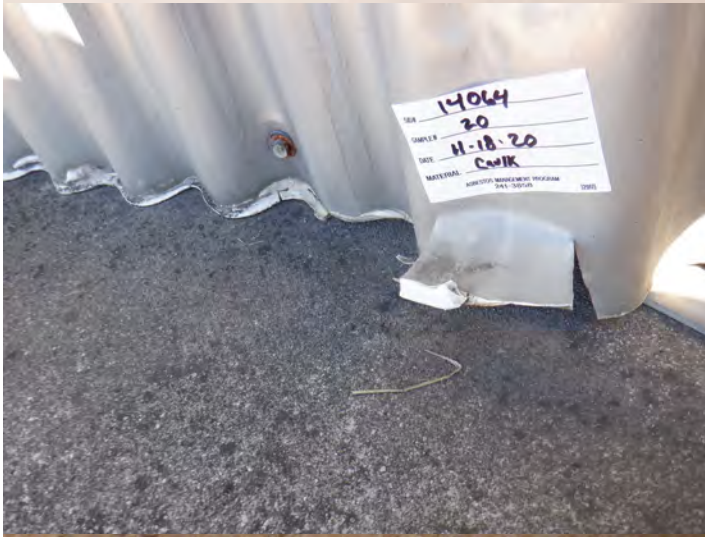
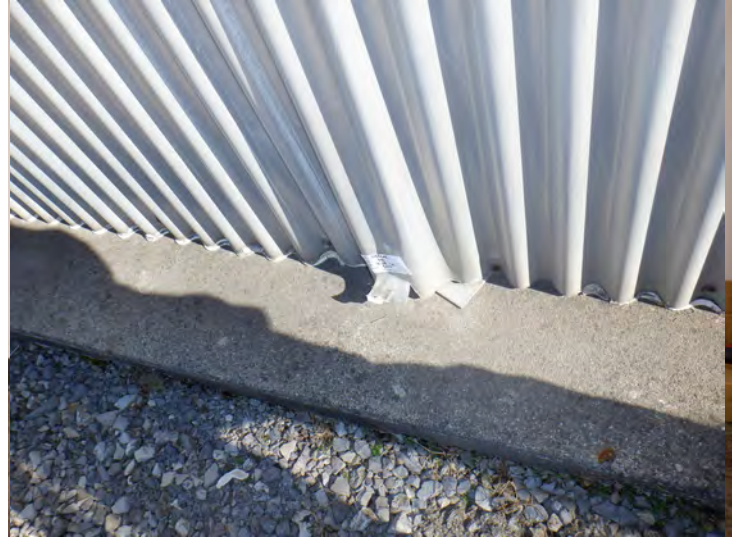
<b>HA Description</b>	White Caulk
	<b>Sample #</b>	SID14064-20
	<b>Sample Location / Orientation</b>	West outside wall between metal wall and concrete pad of rm 04 storage area
	<b>Sample/Inspection Results</b>	SID14064-20 – None Detected
	<b>Recommendation</b>	None

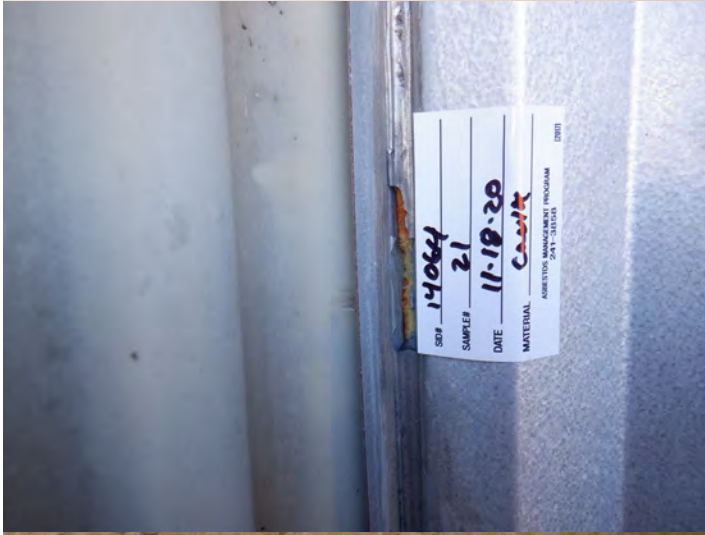
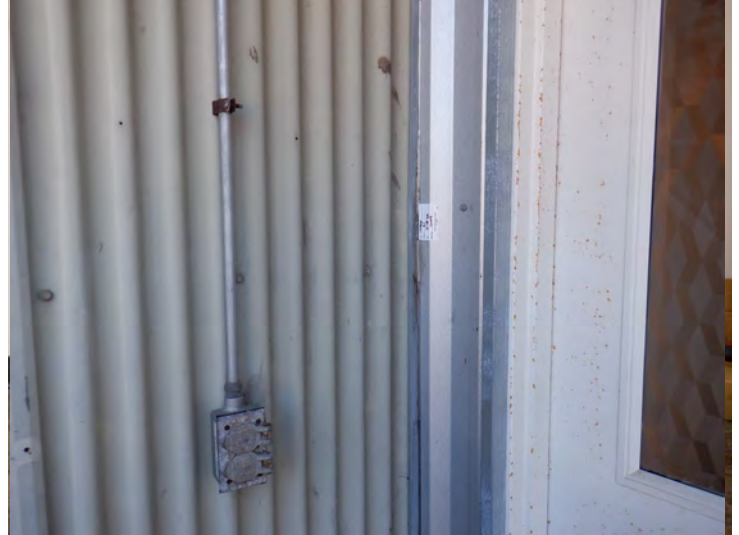
<b>HA Description</b>	Silver Caulk
	<b>Sample #</b>	<b>SID14064-21</b>
	<b>Sample Location / Orientation</b>	East side outside corner of room 02 and 03. Considered 03 HA area.
	<b>Sample/Inspection Results</b>	<b>SID14064-21 – None Detected</b>
	<b>Recommendation</b>	None

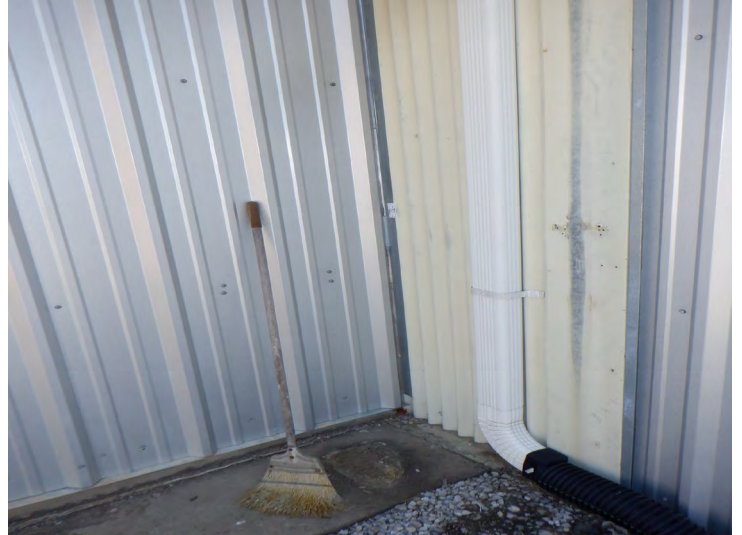
<b>HA Description</b>	Silver Caulk
	<b>Sample #</b>	<b>SID14064-22</b>
	<b>Sample Location / Orientation</b>	West side outside corner of room 03 and 05
	<b>Sample/Inspection Results</b>	<b>SID14064-22 – None Detected</b>
	<b>Recommendation</b>	None

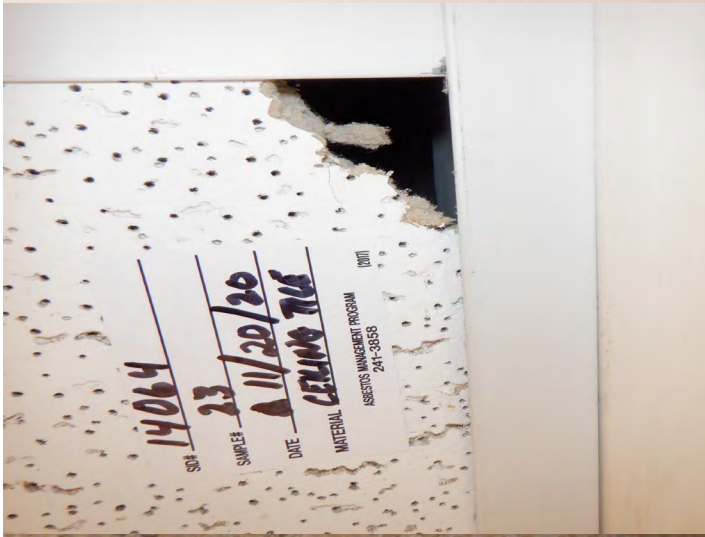
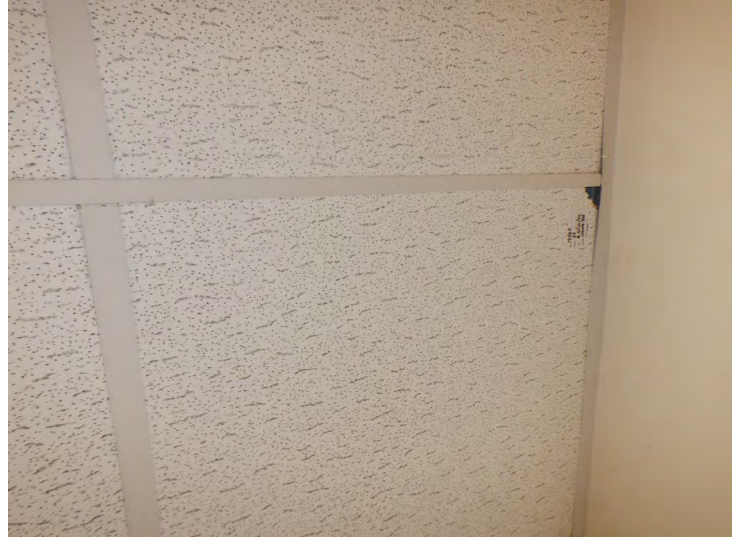
<b>HA Description</b>	2x4 Ceiling Tile, Cellulose
	<b>Sample #</b>	<b>SID14064-23</b>
	<b>Sample Location / Orientation</b>	Kitchen, SE Corner
	<b>Sample/Inspection Results</b>	<b>SID14064-23 – None Detected</b>
	<b>Recommendation</b>	None

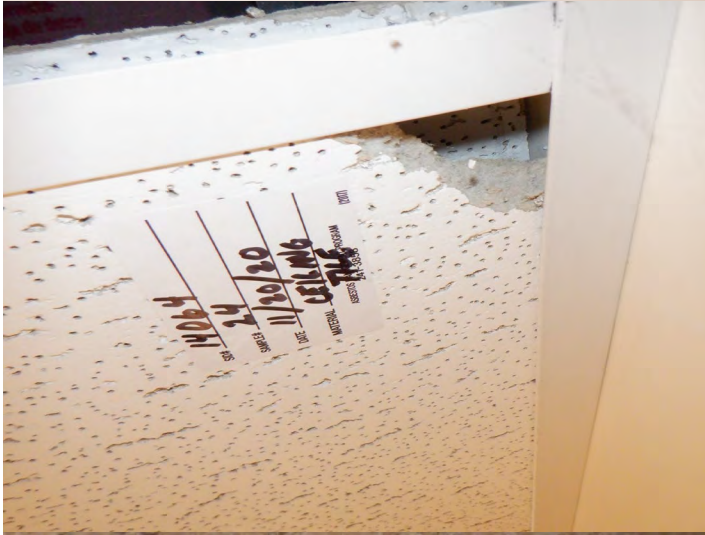
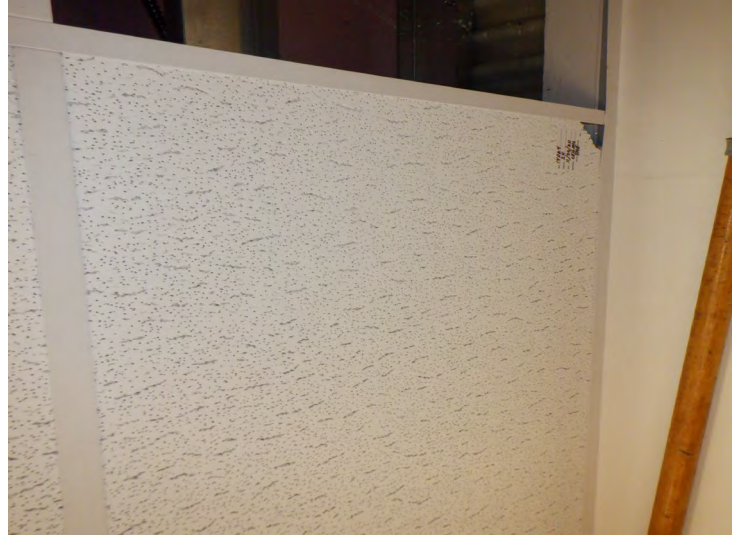
<b>HA Description</b>	2x4 Ceiling Tile, Cellulose
	<b>Sample #</b>	<b>SID14064-24</b>
	<b>Sample Location / Orientation</b>	Kitchen, SW Corner
	<b>Sample/Inspection Results</b>	<b>SID14064-24 – None Detected</b>
	<b>Recommendation</b>	None

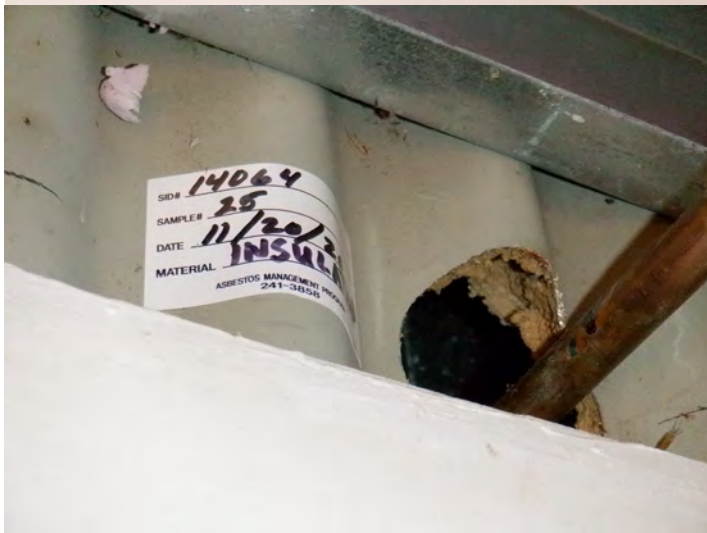
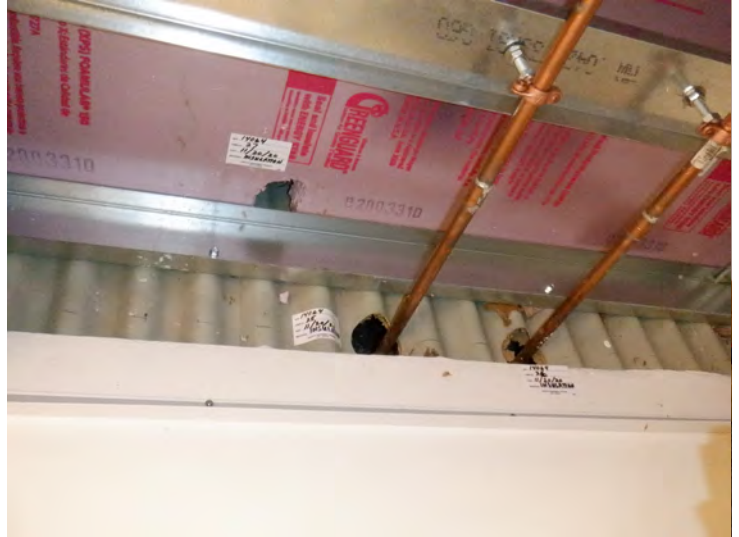
<b>HA Description</b>	Brown Batt Insulation
	<b>Sample #</b>	SID14064-25
	<b>Sample Location / Orientation</b>	Kitchen, Inside south wall above ceiling in SW corner
	<b>Sample/Inspection Results</b>	SID14064-25 – None Detected
	<b>Recommendation</b>	None

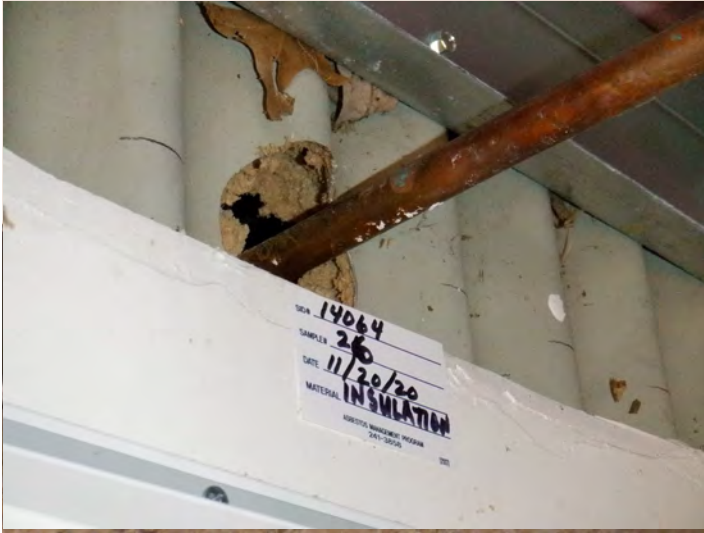
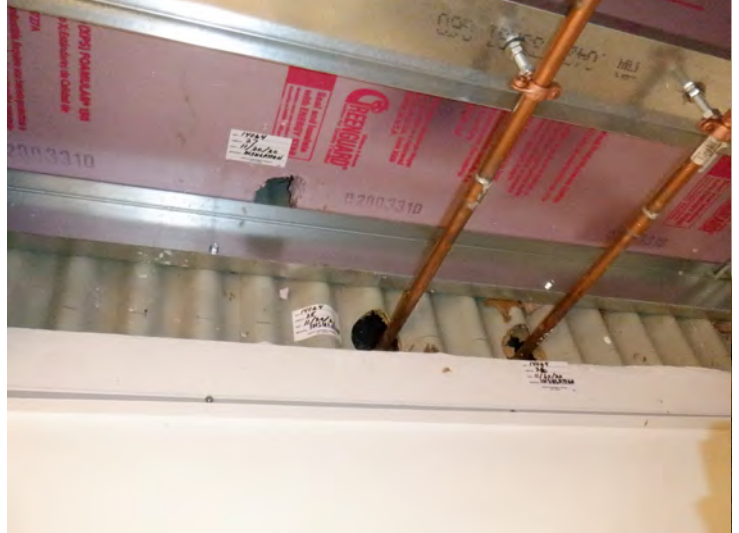
<b>HA Description</b>	Brown Batt Insulation
	<b>Sample #</b>	SID14064-26
	<b>Sample Location / Orientation</b>	Kitchen, Inside south wall above ceiling in SW corner
	<b>Sample/Inspection Results</b>	SID14064-26 – None Detected
	<b>Recommendation</b>	None

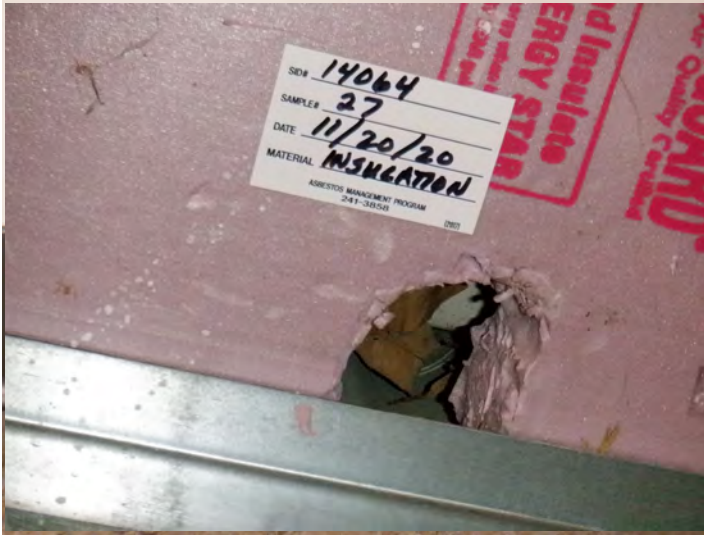
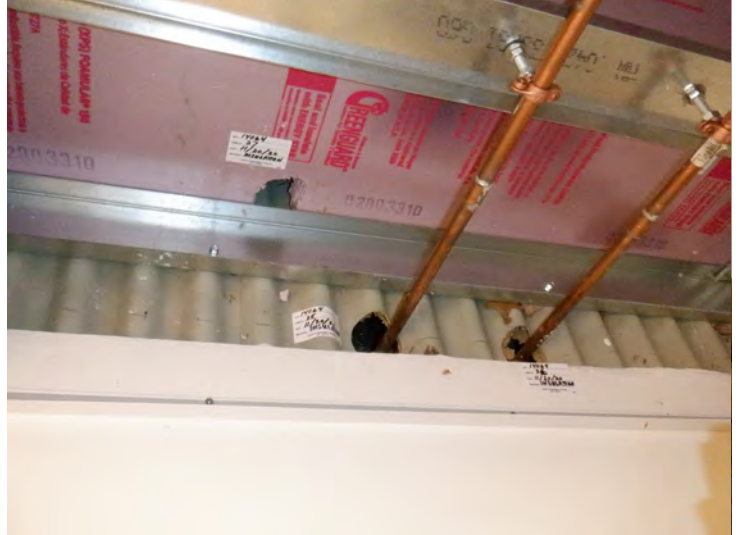
<b>HA Description</b>	Purple "Greenguard" insulation board
	<b>Sample #</b>	SID14064-27
	<b>Sample Location / Orientation</b>	Kitchen, Inside south wall above ceiling in SW corner
	<b>Sample/Inspection Results</b>	SID14064-27 – None Detected
	<b>Recommendation</b>	None

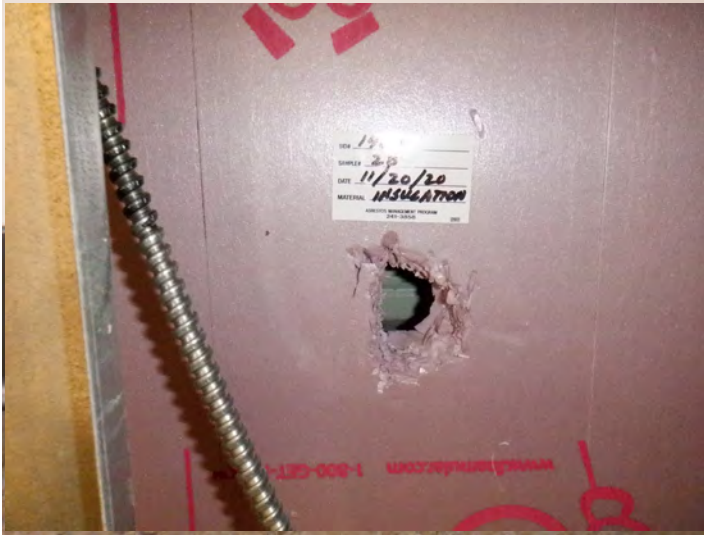
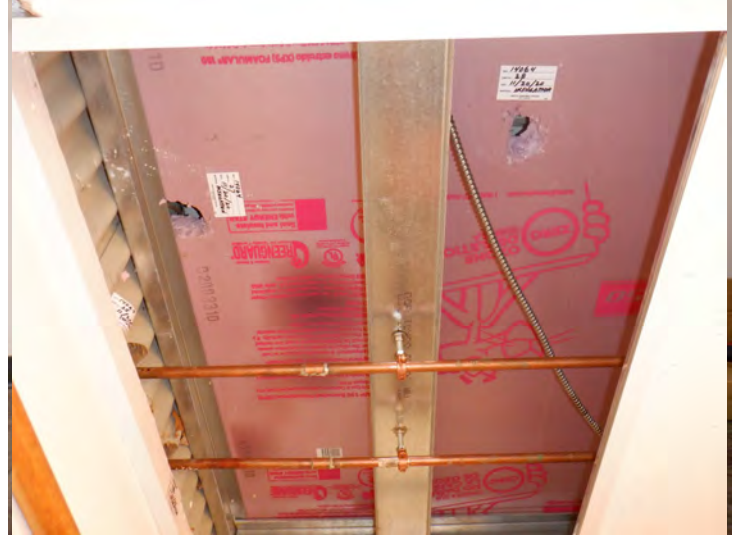
<b>HA Description</b>	Purple "Greenguard" insulation board
	<b>Sample #</b>	SID14064-28
	<b>Sample Location / Orientation</b>	Kitchen, Inside south wall above ceiling in SW corner
	<b>Sample/Inspection Results</b>	SID14064-28 – None Detected
	<b>Recommendation</b>	None

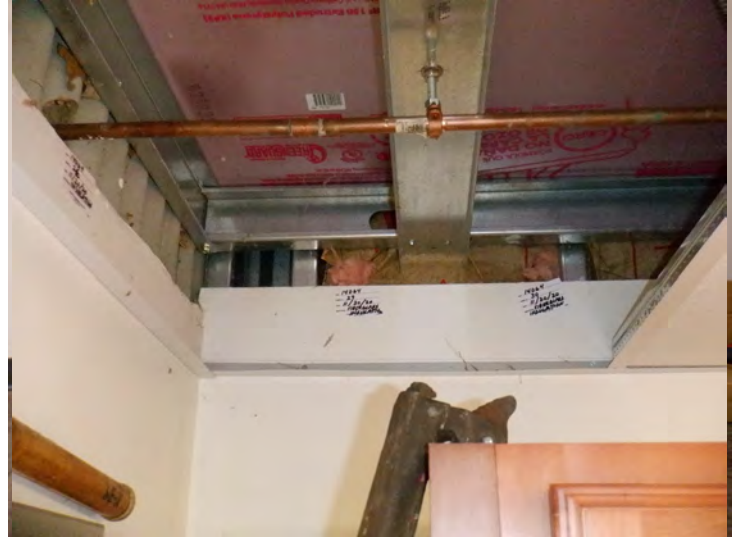
<b>HA Description</b>	Pink Fiberglass Batt Insulation
	<b>Sample #</b>	SID14064-29 SID14064-30
	<b>Sample Location / Orientation</b>	Kitchen, Inside south wall above ceiling in SW corner
	<b>Sample/Inspection Results</b>	<b>SID14064-29 – None Detected</b> <b>SID14064-30 – None Detected</b> Analysis revealed the pink fibrous layer as 97% mineral wool and the brown/black wrap layer as 80% cellulose in both samples.
	<b>Recommendation</b>	None

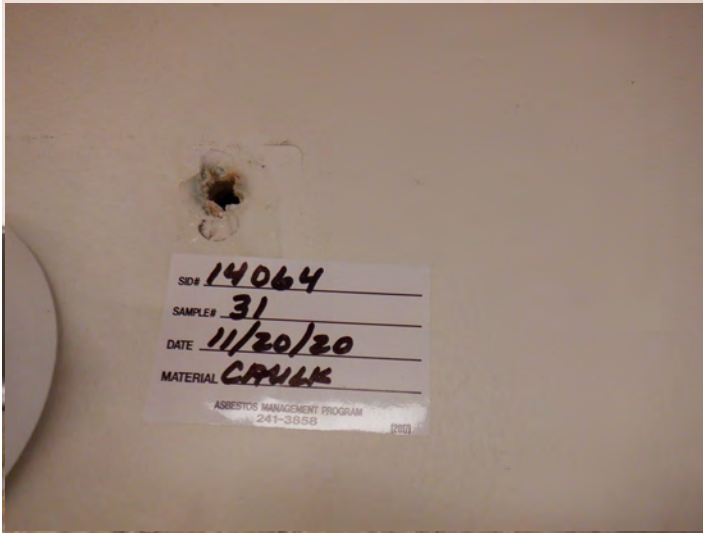
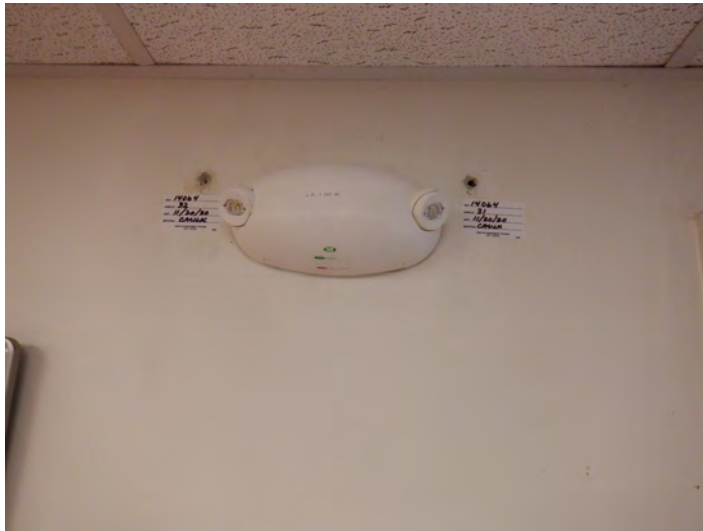
<b>HA Description</b>	Clear Caulk
	<b>Sample #</b>	SID14064-31 SID14064-32
	<b>Sample Location / Orientation</b>	Kitchen, East wall, north of door
	<b>Sample/Inspection Results</b>	SID14064-31 – None Detected SID14064-32 – None Detected
	<b>Recommendation</b>	None

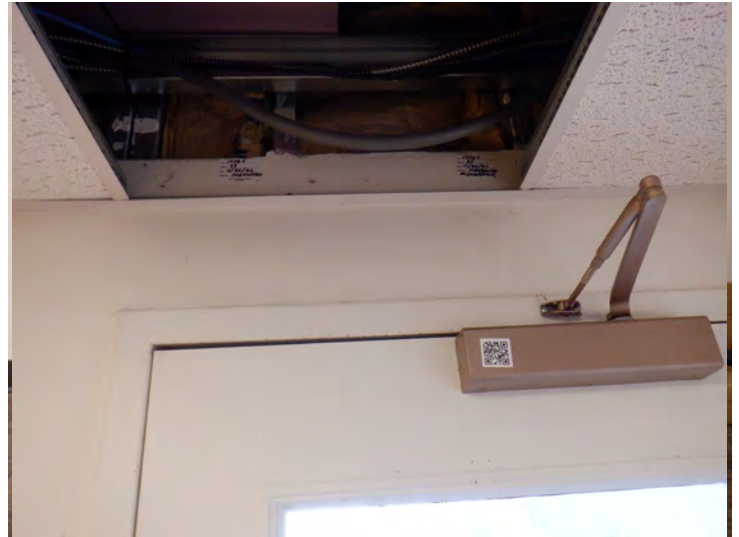
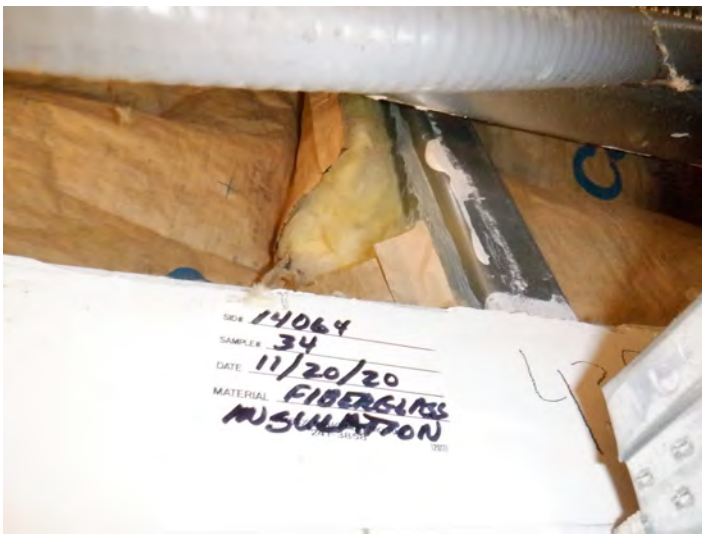
<b>HA Description</b>	SID14064-33 – Yellow Fiberglass Batt Insulation SID14064-34 – Yellow Fiberglass Batt Insulation
<b>Sample #</b>	SID14064-33 SID14064-34
<b>Sample Location / Orientation</b>	East Wall above ceiling and exterior door
<b>Sample/Inspection Results</b>	<p><b>SID14064-33 – None Detected</b></p> <p><b>SID14064-34 – None Detected</b></p> <p>Analysis revealed the yellow fibrous layer as 99% glass and the brown/black/blue wrap layer as 80% cellulose in both samples.</p>
<b>Recommendation</b>	None

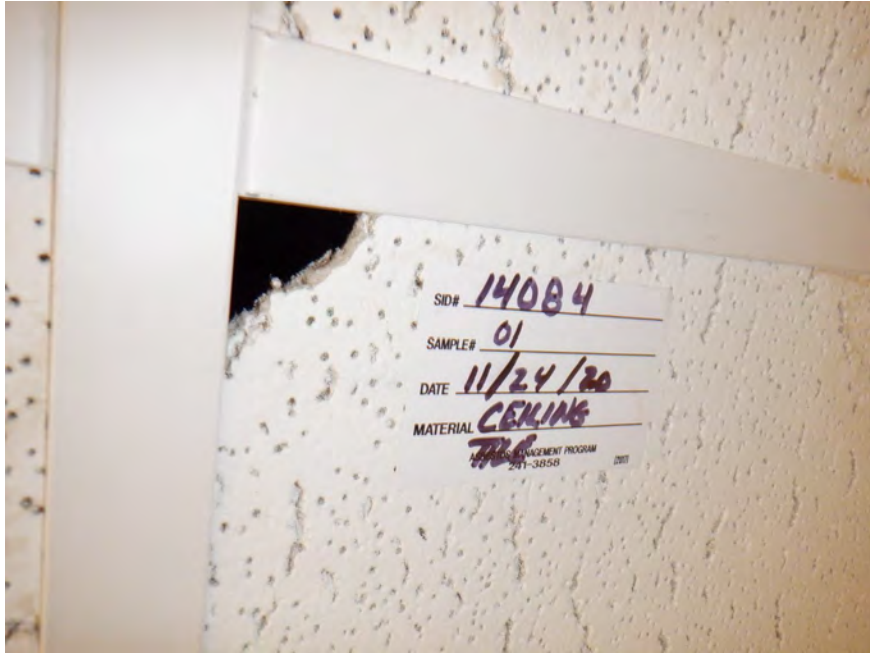
<b>HA Description</b>	<b>2 FT x 4 FT White Cellulose Tile, Fissured</b>
	<b>Sample #</b>	<b>SID14084-01</b>
	<b>Sample Location / Orientation</b>	<b>South Side Ceiling of Room 05 (Change Room)</b>
	<b>Sample/Inspection Results</b>	<b>SID14084-01 – None Detected</b>
	<b>Recommendation</b>	<b>None</b>

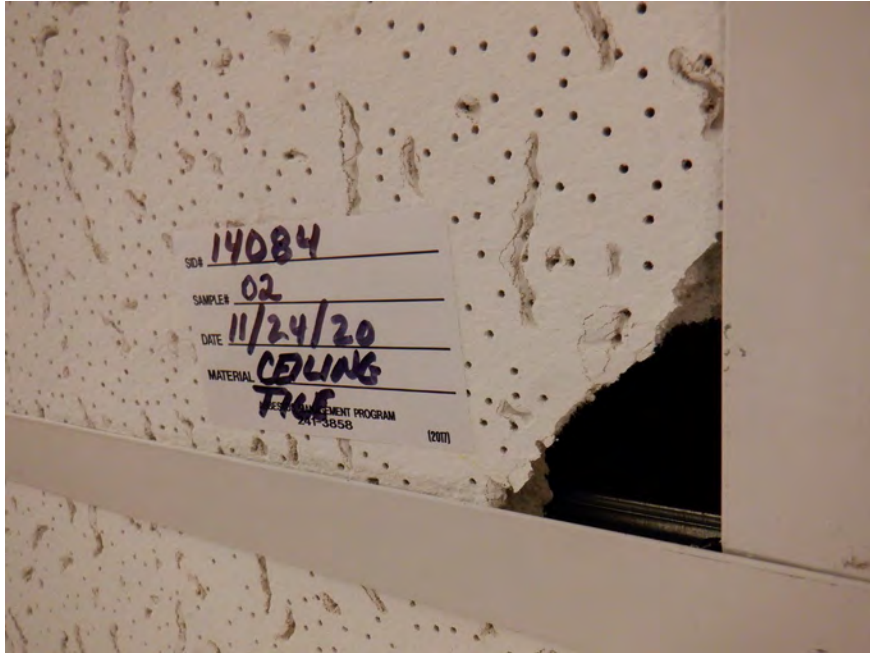
<b>HA Description</b>	<b>2 FT x 4 FT White Cellulose Tile, Fissured</b>
	<b>Sample #</b>	<b>SID14084-02</b>
	<b>Sample Location / Orientation</b>	<b>North Side Ceiling of Room 05 (Change Room)</b>
	<b>Sample/Inspection Results</b>	<b>SID14084-02 – None Detected</b>
	<b>Recommendation</b>	<b>None</b>

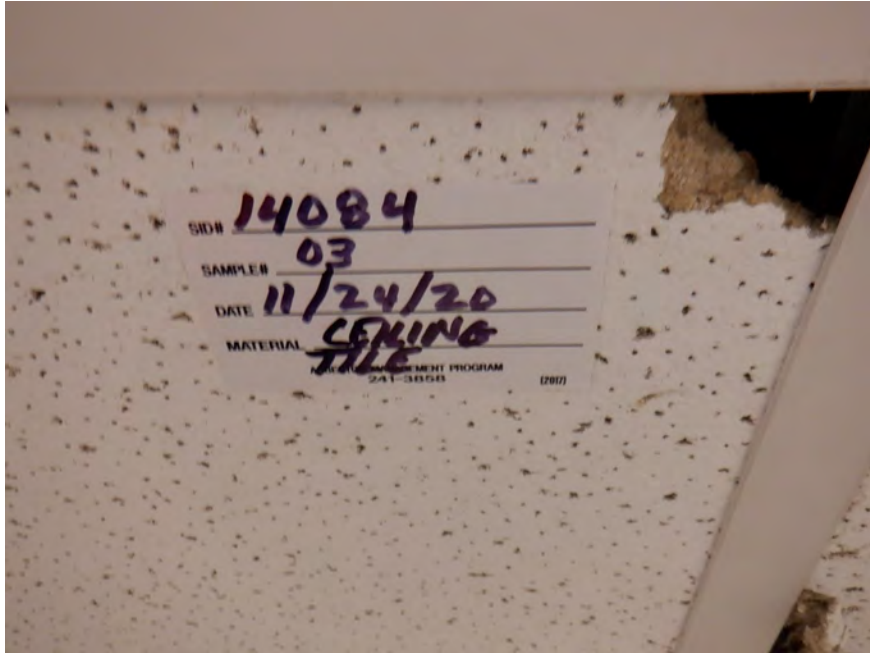
<b>HA Description</b>	<b>2 FT x 4 FT White Cellulose Tile, Fissured</b>
	<b>Sample #</b>	<b>SID14084-03</b>
	<b>Sample Location / Orientation</b>	<b>North Side Middle Ceiling of Room 02B (Hallway)</b>
	<b>Sample/Inspection Results</b>	<b>SID14084-03 – None Detected</b>
	<b>Recommendation</b>	<b>None</b>

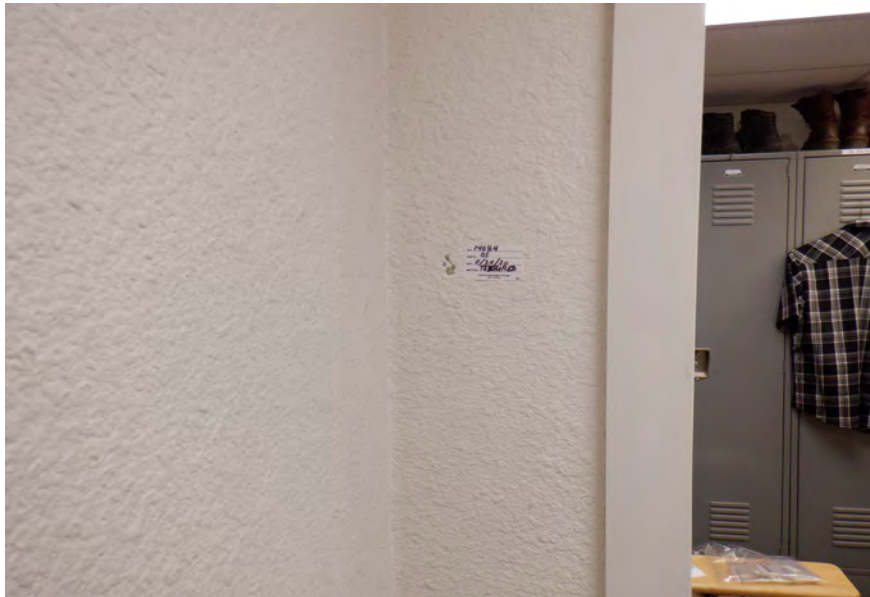
<b>HA Description</b>	<b>White Textured Wall Coating Spray Applied</b>
	<b>Sample #</b>	<b>SID14084-05</b>
	<b>Sample Location / Orientation</b>	<b>West Wall, South Side Beside Door of Room 02B (Hallway)</b>
	<b>Sample/Inspection Results</b>	<b>SID14084-05 – None Detected</b>
	<b>Recommendation</b>	<b>None</b>

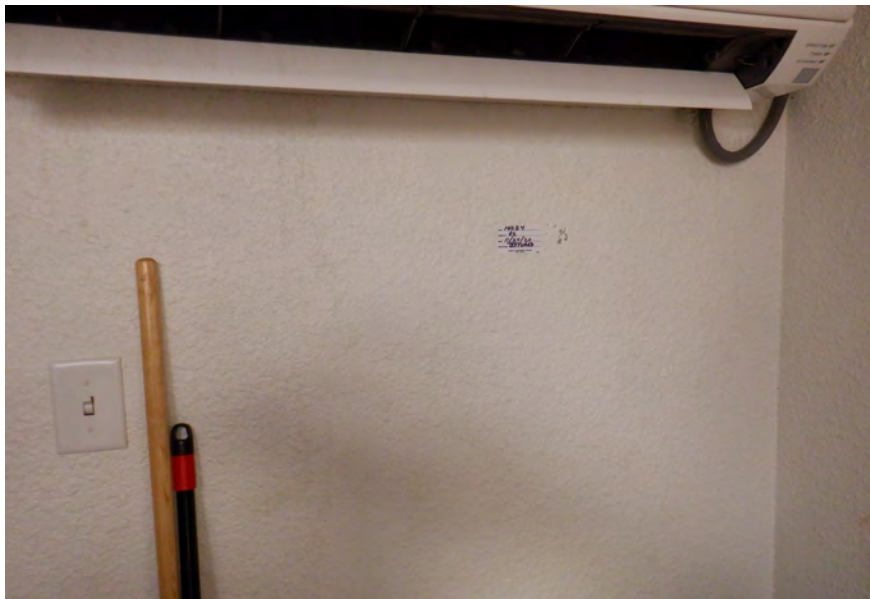
<b>HA Description</b>	<b>White Textured Wall Coating Spray Applied</b>
	<b>Sample #</b>	<b>SID14084-06</b>
	<b>Sample Location / Orientation</b>	<b>South Wall, West of Exterior Door of Room 05 (Change Room).</b>
	<b>Sample/Inspection Results</b>	<b>SID14084-06 – None Detected</b>
	<b>Recommendation</b>	<b>None</b>
