**Scope of Work and Specifications**

**CRSF Building Demolition**

**OAK RIDGE NATIONAL LABORATORY**

**March 2021**

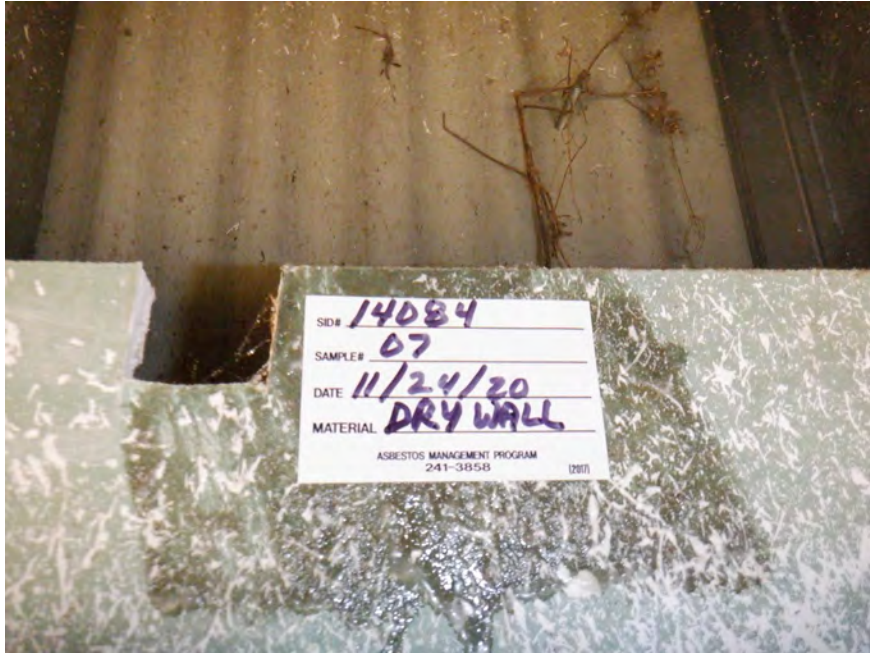
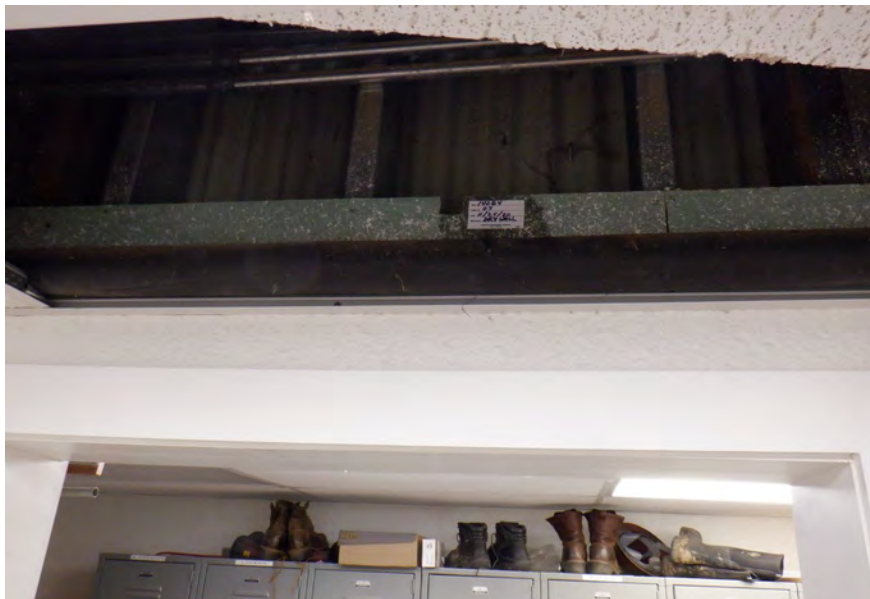
<b>HA Description</b>	<b>White Drywall with Green and White Top Layer</b>
	<b>Sample #</b>	<b>SID14084-07</b>
	<b>Sample Location / Orientation</b>	<b>West Wall Above Door and Ceiling in Room 02B (Hallway).</b>
	<b>Sample/Inspection Results</b>	<b>SID14084-07 – None Detected</b>
	<b>Recommendation</b>	<b>None</b>

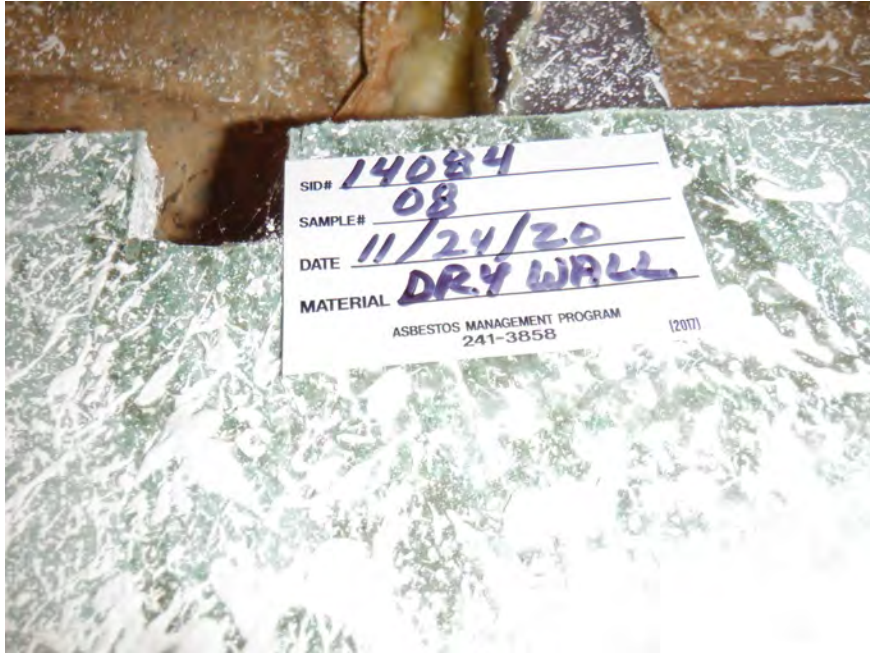
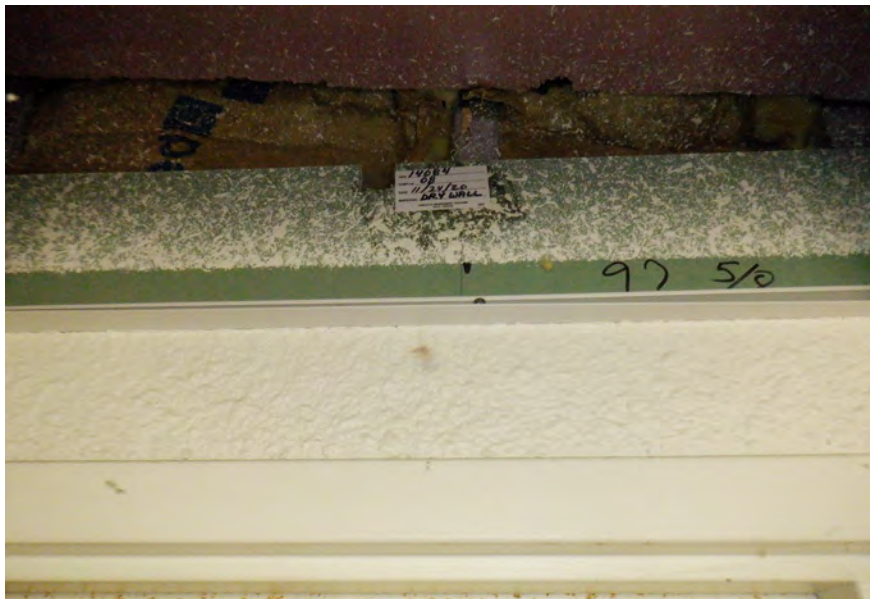
<b>HA Description</b>	<b>White Drywall with Green and White Top Layer</b>
	<b>Sample #</b>	<b>SID14084-08</b>
	<b>Sample Location / Orientation</b>	<b>South Wall Above Door and Ceiling in Room 05 (Changeroom).</b>
	<b>Sample/Inspection Results</b>	<b>SID14084-08 – None Detected</b>
	<b>Recommendation</b>	<b>None</b>

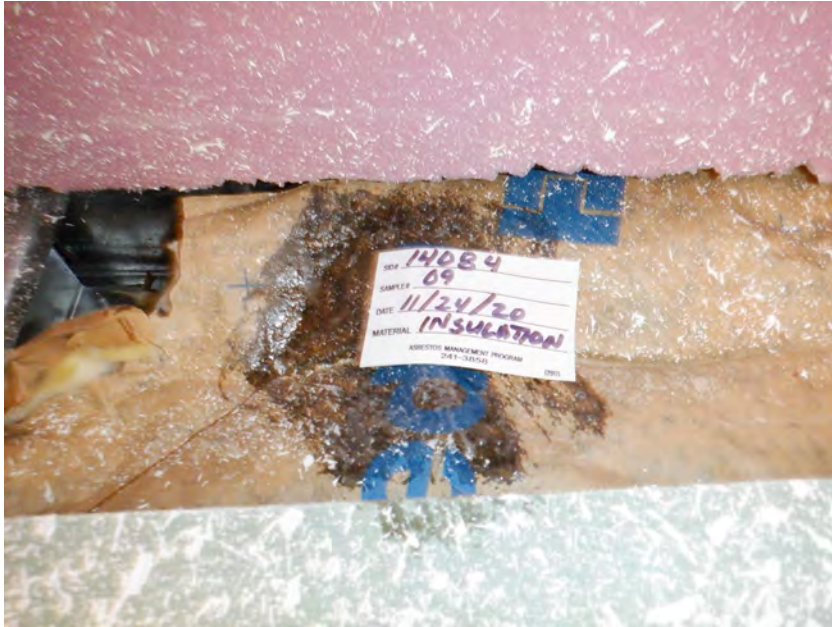
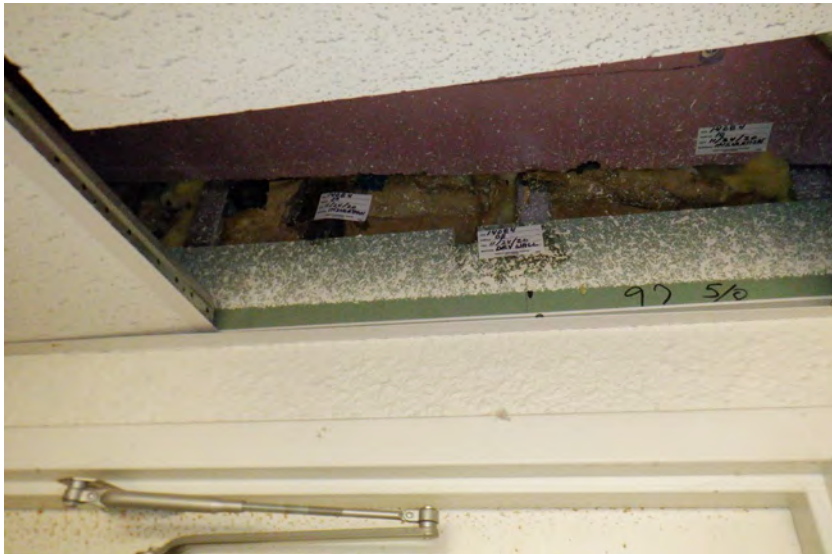
<b>HA Description</b>	<b>Yellow Fiber Glass Batt Insulation</b>
<b>Sample #</b>	<b>SID14084-09</b>
<b>Sample Location / Orientation</b>	<b>South Wall Above Door and Ceiling in Room 05 (Change Room).</b>
<b>Sample/Inspection Results</b>	<b>SID14084-09 – None Detected Analysis revealed the yellow/tan/black insulation with paper backing as 90% fibrous glass and 5% cellulose fiber with overall result as None Detected.</b>
<b>Recommendation</b>	<b>None</b>

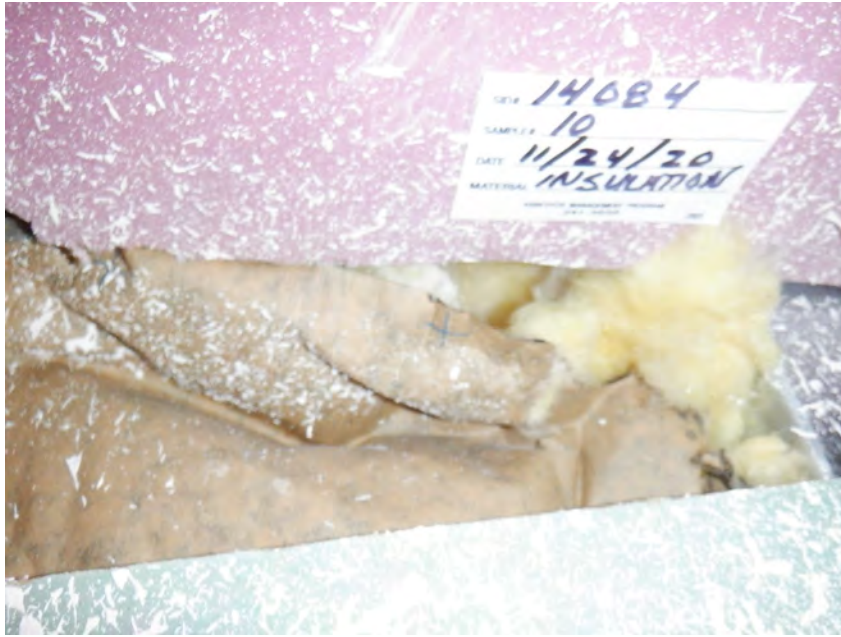
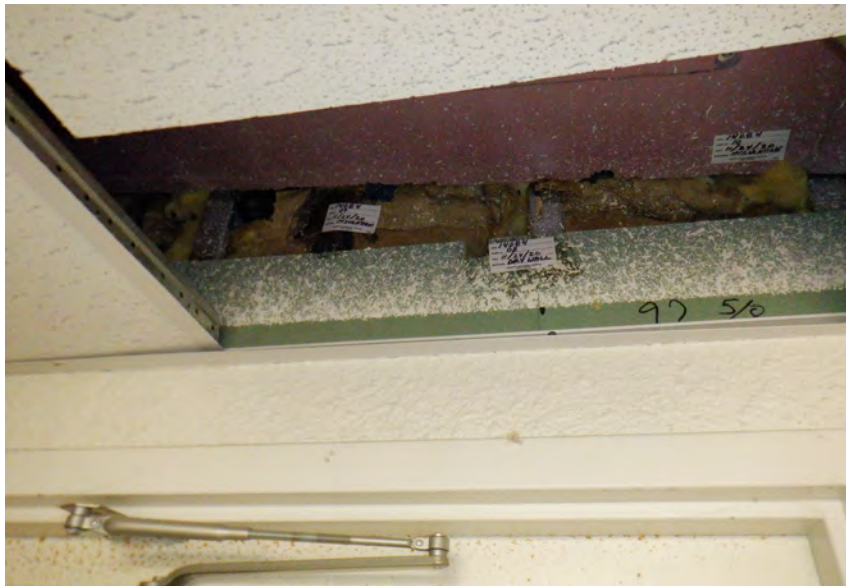
<b>HA Description</b>	<b>Yellow Fiber Glass Batt Insulation</b>
<b>Sample #</b>	<b>SID14084-10</b>
<b>Sample Location / Orientation</b>	<b>South Wall West of Door in Room 05 (Change Room).</b>
<b>Sample/Inspection Results</b>	<b>SID14084-10 – None Detected Analysis revealed the yellow/tan/black insulation with paper backing as 90% fibrous glass and 5% cellulose fiber with overall result as None Detected.</b>
<b>Recommendation</b>	<b>None</b>

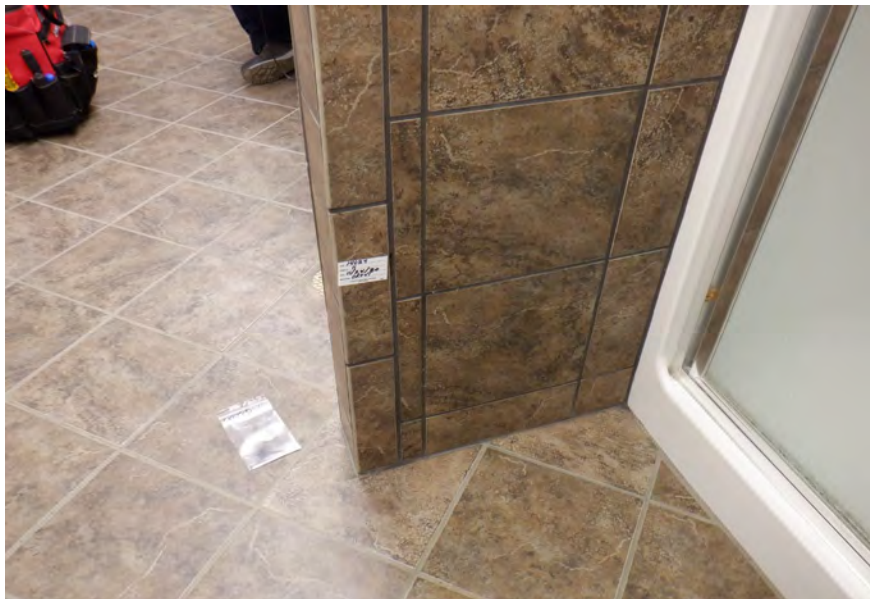
<b>HA Description</b>	<b>Black Grout</b>
	<b>Sample #</b>	<b>SID14084-11</b>
	<b>Sample Location / Orientation</b>	<b>North Side of Wall Divider Between Shower and Locker Area in Room 05 (Change Room).</b>
	<b>Sample/Inspection Results</b>	<b>SID14084-11 – None Detected</b>
	<b>Recommendation</b>	<b>None</b>

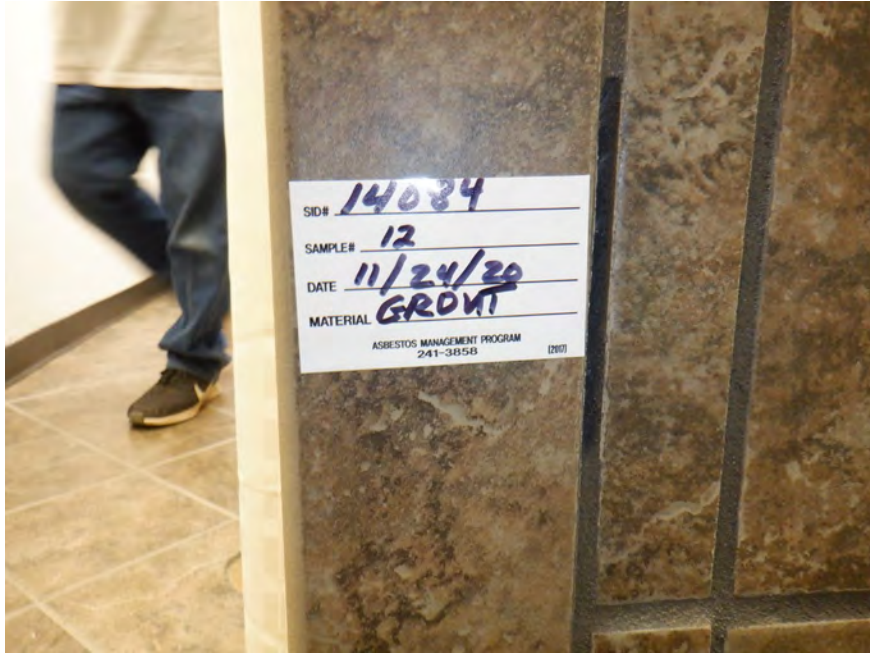
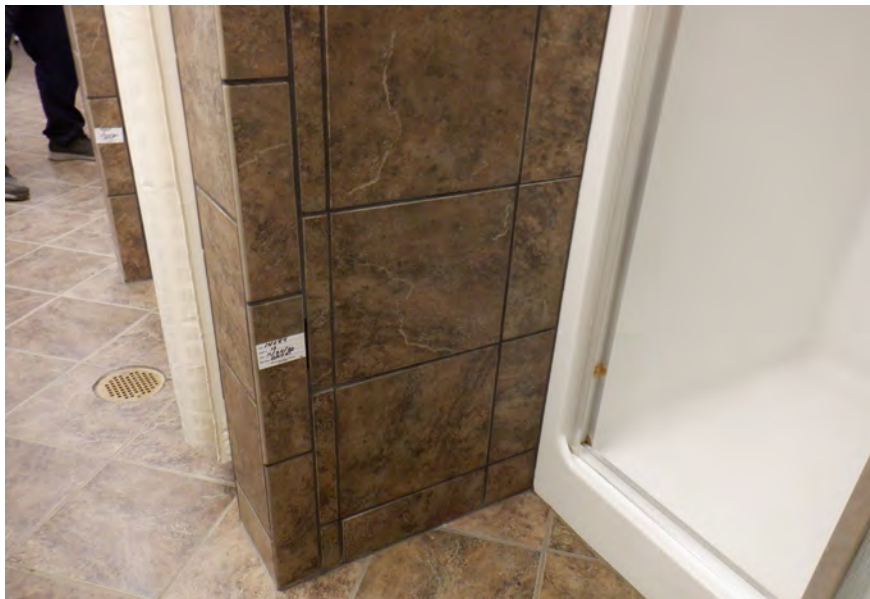
<b>HA Description</b>	<b>Black Grout</b>
	<b>Sample #</b>	<b>SID14084-12</b>
	<b>Sample Location / Orientation</b>	<b>North Side of Wall Divider Between Shower Stalls in Room 05 (Change Room).</b>
	<b>Sample/Inspection Results</b>	<b>SID14084-12 – None Detected</b>
	<b>Recommendation</b>	<b>None</b>

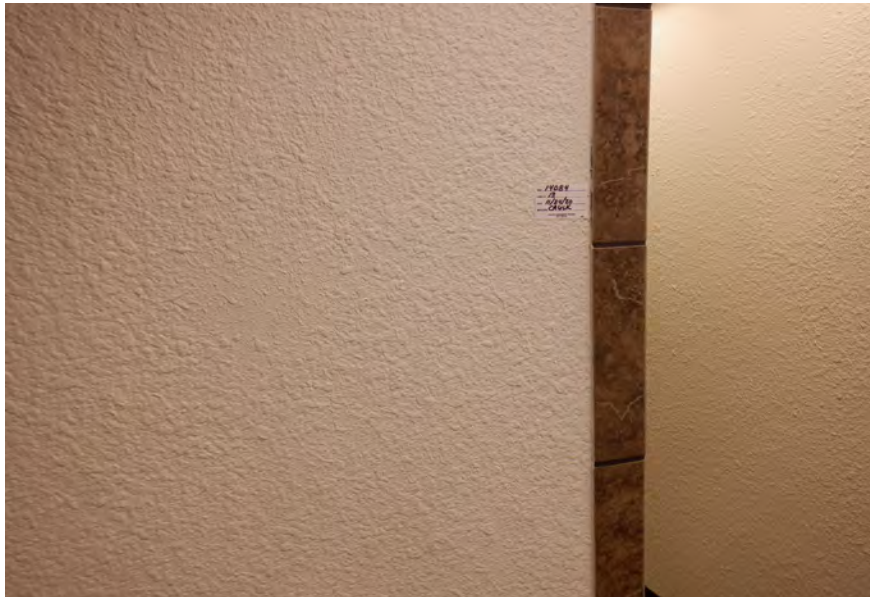
<b>HA Description</b>	<b>White Caulk</b>
	<b>Sample #</b>	<b>SID14084-13</b>
	<b>Sample Location / Orientation</b>	<b>South Wall Divider Between Shower and Locker Area in Room 05 (Change Room).</b>
	<b>Sample/Inspection Results</b>	<b>SID14084-13 – None Detected</b>
	<b>Recommendation</b>	<b>None</b>

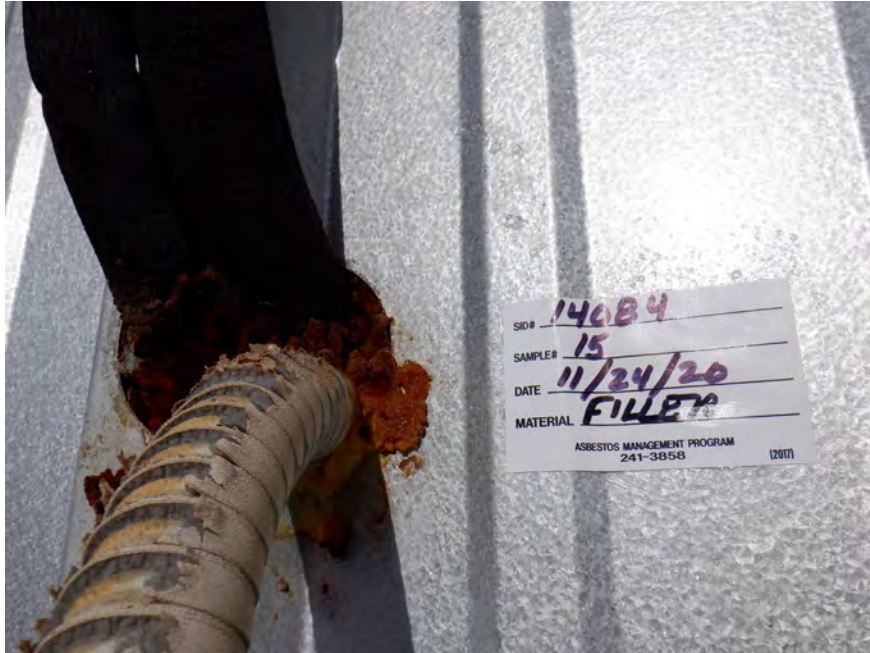
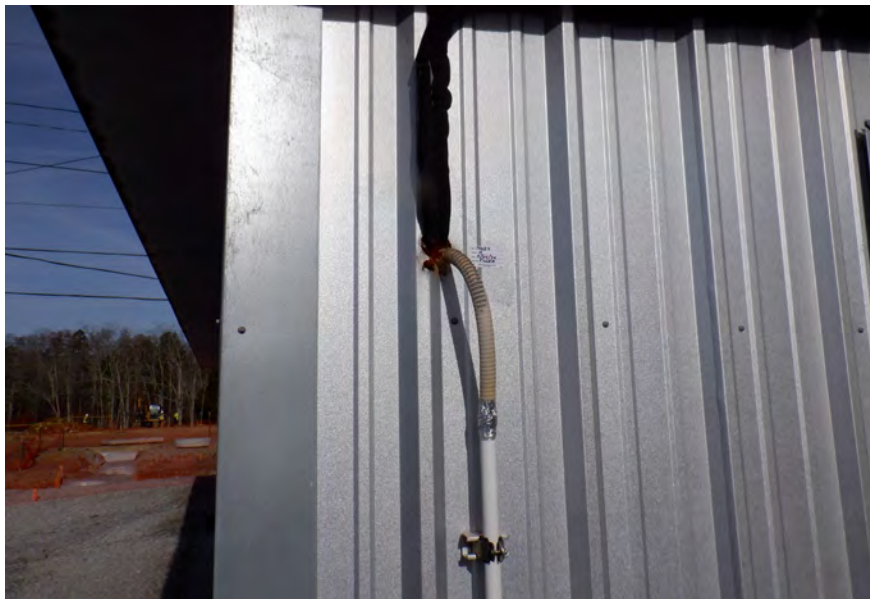
<b>HA Description</b>	<b>Brown Spray Filler</b>
	<b>Sample #</b>	<b>SID14084-15</b>
	<b>Sample Location / Orientation</b>	<b>Outside at SW Corner of Room 05 (Changeroom)</b>
	<b>Sample/Inspection Results</b>	<b>SID14084-15 – None Detected</b>
	<b>Recommendation</b>	<b>None</b>

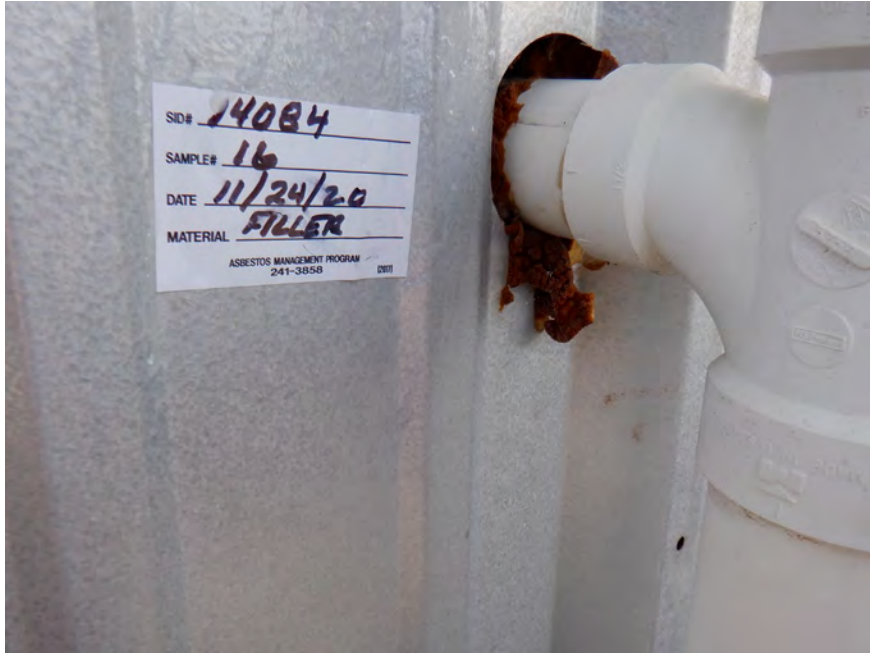
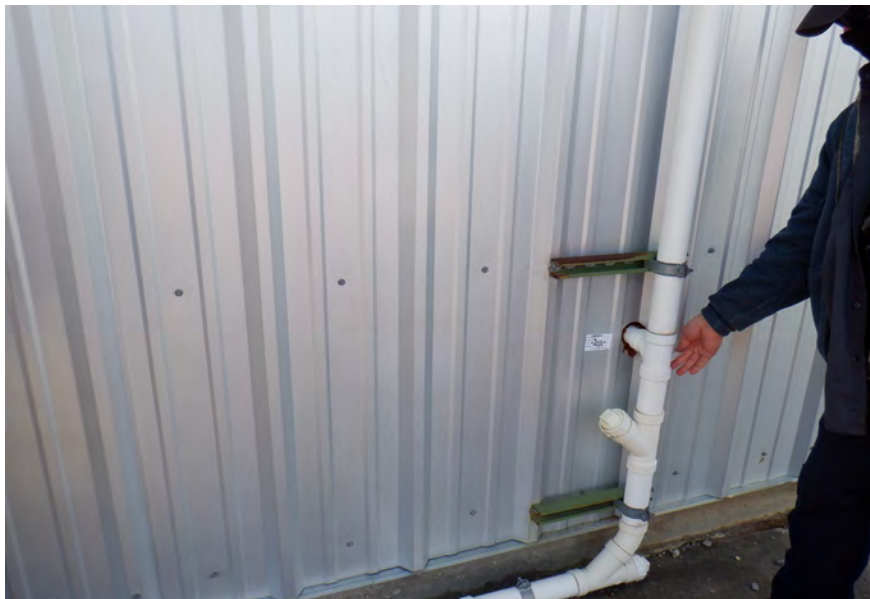
<b>HA Description</b>	Brown Spray Filler
	<b>Sample #</b>	SID14084-16
	<b>Sample Location / Orientation</b>	Outside at West Side of NW Corner of Room 05 (Kitchen).
	<b>Sample/Inspection Results</b>	SID14084-16 – None Detectec
	<b>Recommendation</b>	None

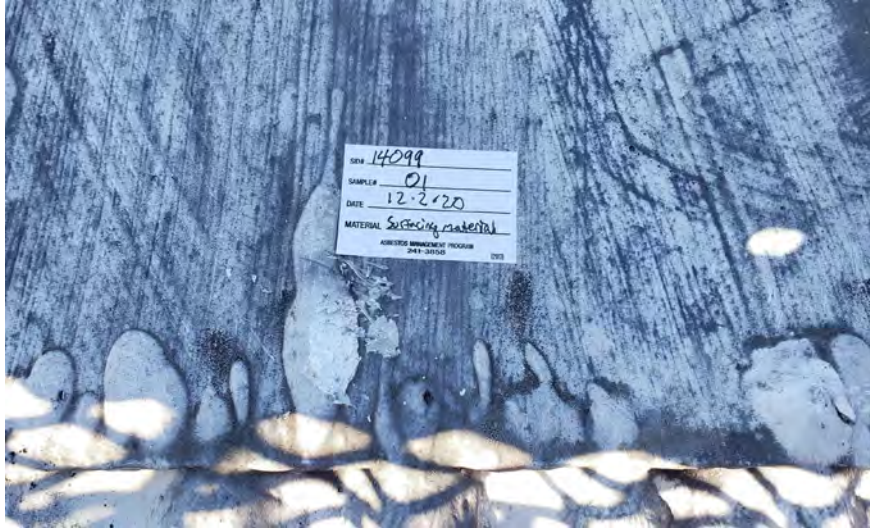
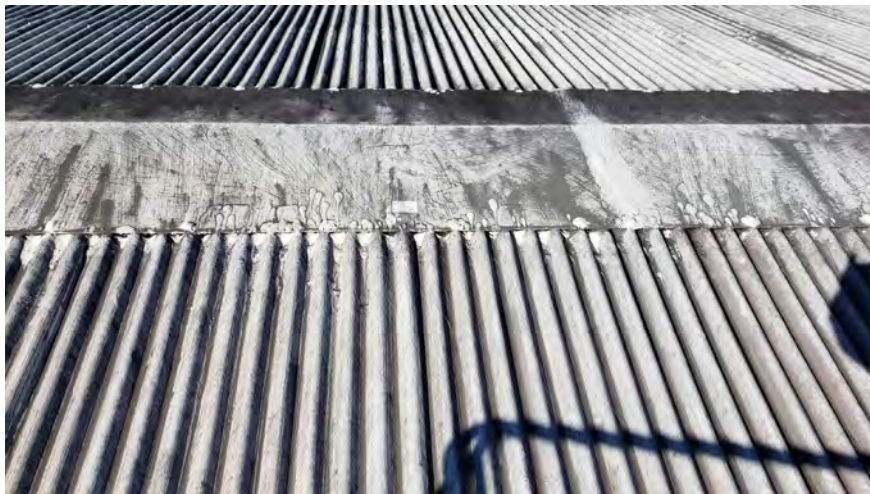
<b>HA Description</b>	<b>White Surfacing Coating</b>
	<b>Sample #</b>	<b>SID14099-01</b>
	<b>Sample Location / Orientation</b>	<b>Center of Original Roof Above Bucket Truck Area (01).</b>
	<b>Sample/Inspection Results</b>	<b>SID14099-01 – None Detected</b>
	<b>Recommendation</b>	<b>None</b>

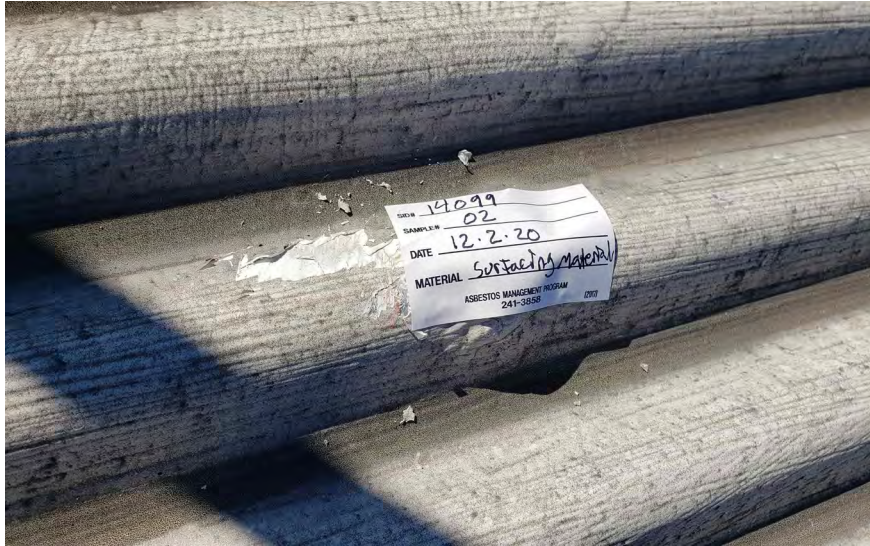
<b>HA Description</b>	<b>White Surfacing Coating</b>
	<b>Sample #</b>	<b>SID14099-02</b>
	<b>Sample Location / Orientation</b>	<b>SW Corner of Original Roof Above Bucket Truck Area (01).</b>
	<b>Sample/Inspection Results</b>	<b>SID14099-02 – None Detected</b>
	<b>Recommendation</b>	<b>None</b>

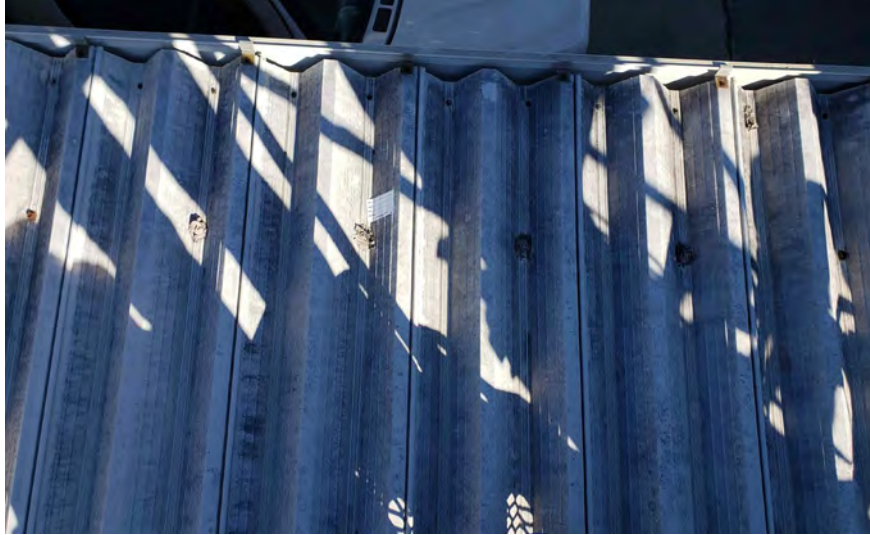
<b>HA Description</b>	White Caulk
	<b>Sample #</b>	SID14099-03
	<b>Sample Location / Orientation</b>	NE Corner of Roof. 20 year add on storage area Roof (04).
	<b>Sample/Inspection Results</b>	SID14099-03 – None Detected
	<b>Recommendation</b>	None

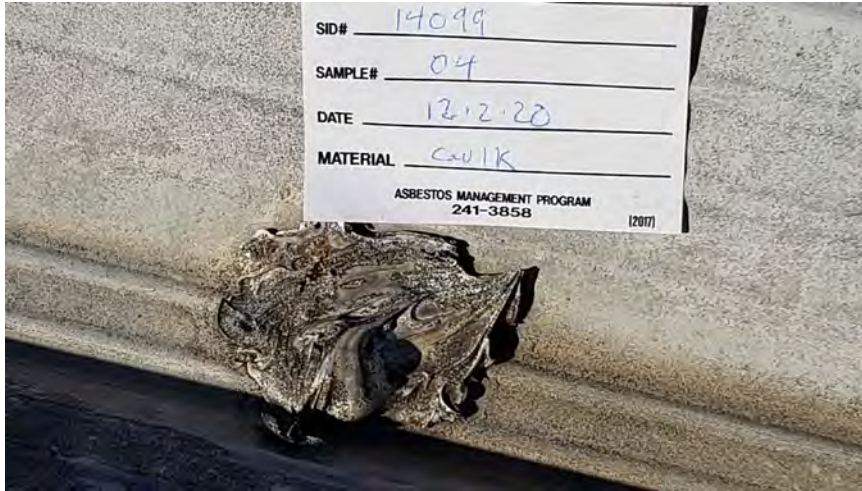
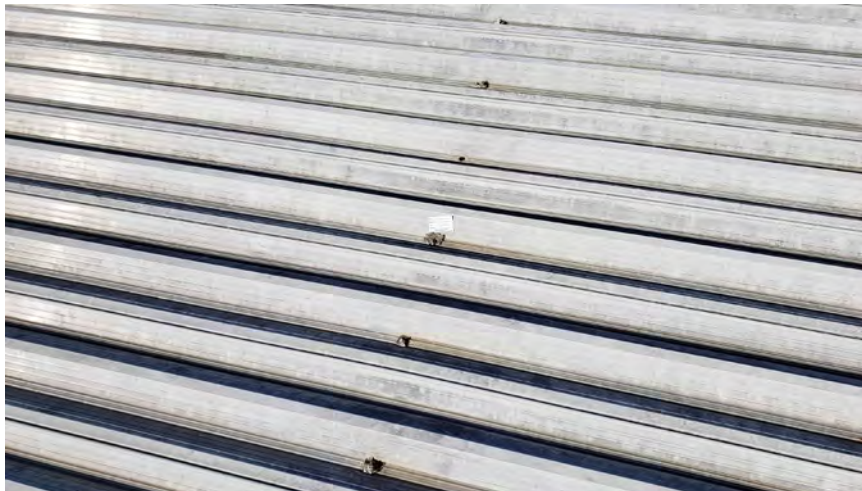
<b>HA Description</b>	White Caulk
	<b>Sample #</b>	SID14099-04
	<b>Sample Location / Orientation</b>	Center of Roof (20 year add on storage area (04)).
	<b>Sample/Inspection Results</b>	SID14099-04 – None Detected
	<b>Recommendation</b>	None

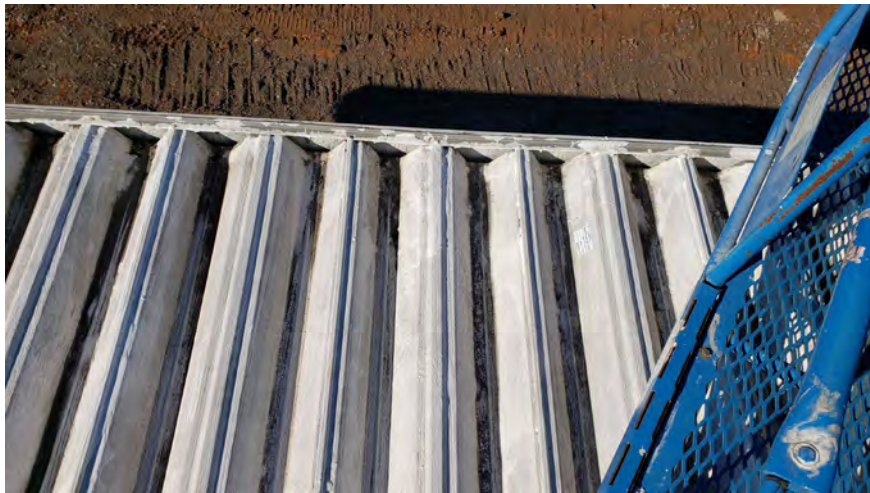
<b>HA Description</b>	<b>White Surfacing Coating</b>
	<b>Sample #</b>	<b>SID14099-05</b>
	<b>Sample Location / Orientation</b>	<b>NE Corner of Roof Above Kitchen 03.</b>
	<b>Sample/Inspection Results</b>	<b>SID14099-05 – None Detected</b>
	<b>Recommendation</b>	<b>None</b>

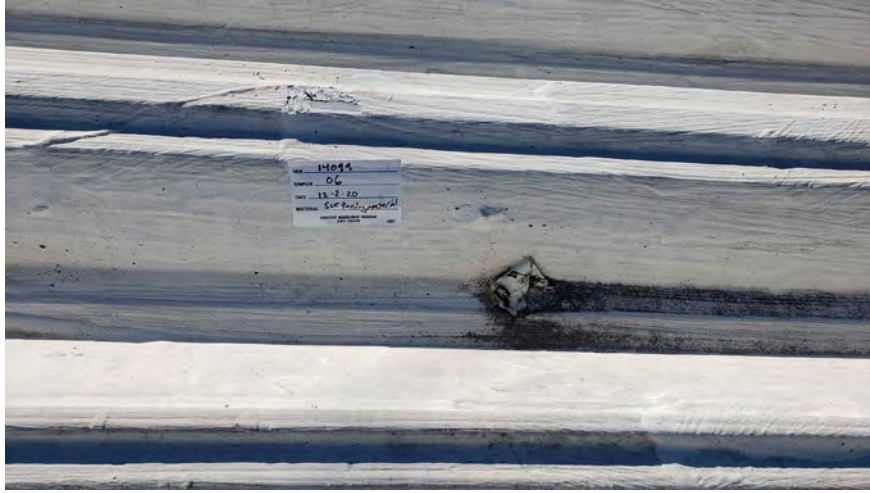
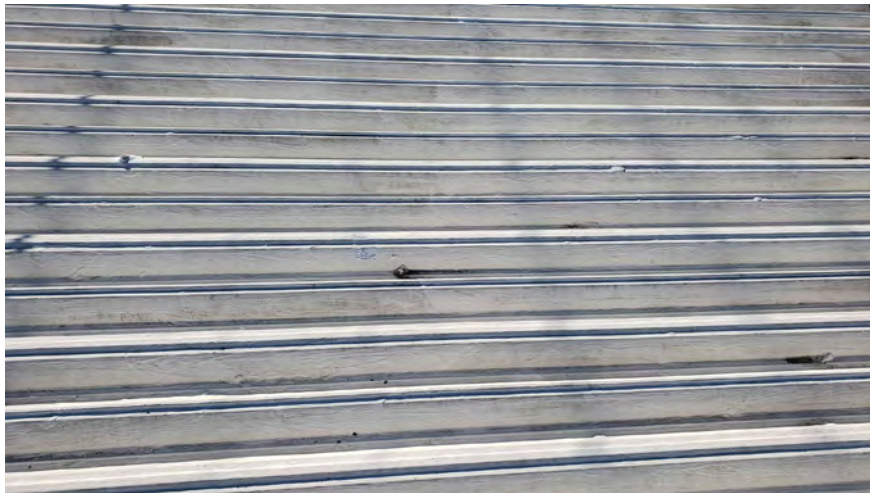
<b>HA Description</b>	<b>White Surfacing Coating</b>
	<b>Sample #</b>	<b>SID14099-06</b>
	<b>Sample Location / Orientation</b>	<b>Center of Roof Above Kitchen 03.</b>
	<b>Sample/Inspection Results</b>	<b>SID14099-06 – None Detected</b>
	<b>Recommendation</b>	<b>None</b>

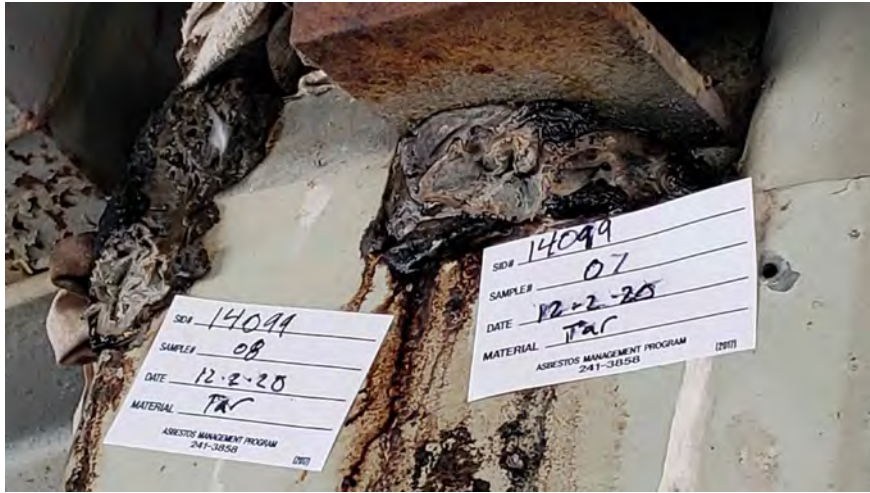
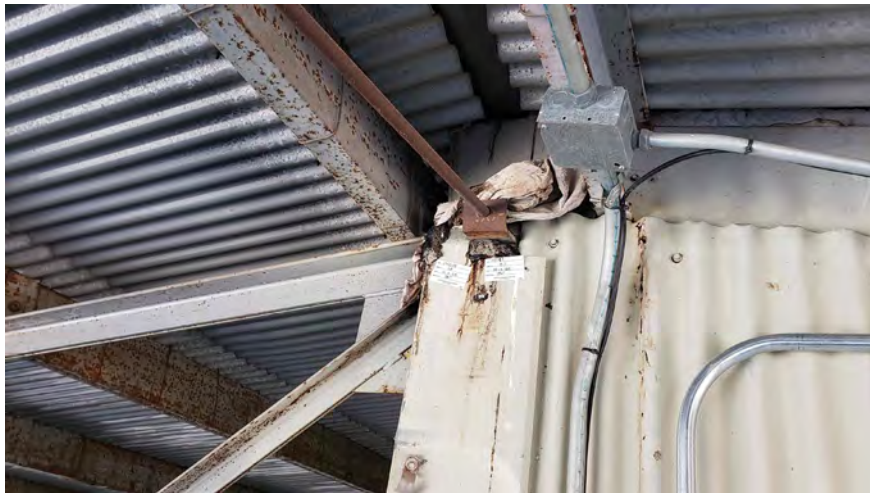
<b>HA Description</b>	<b>Black Tar w/Gray Layers</b>
	<b>Sample #</b>	<b>SID14099-07</b>
	<b>Sample Location / Orientation</b>	<b>Outside SE Corner of Room 02 on Wall Beam near Ceiling. Under Bucket Truck Area (01).</b>
	<b>Sample/Inspection Results</b>	<b>SID14099-07 – 20% Asbestos Chrysotile</b>
	<b>Recommendation</b>	<b>Remove as ACM.</b>

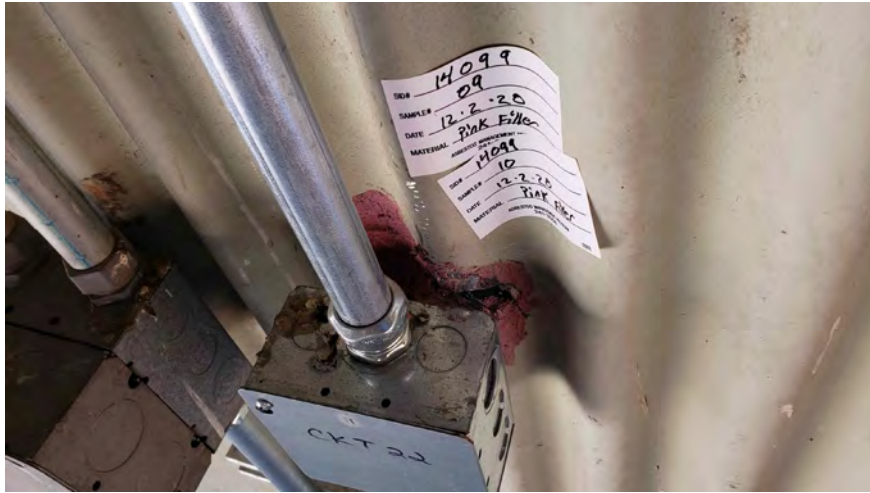
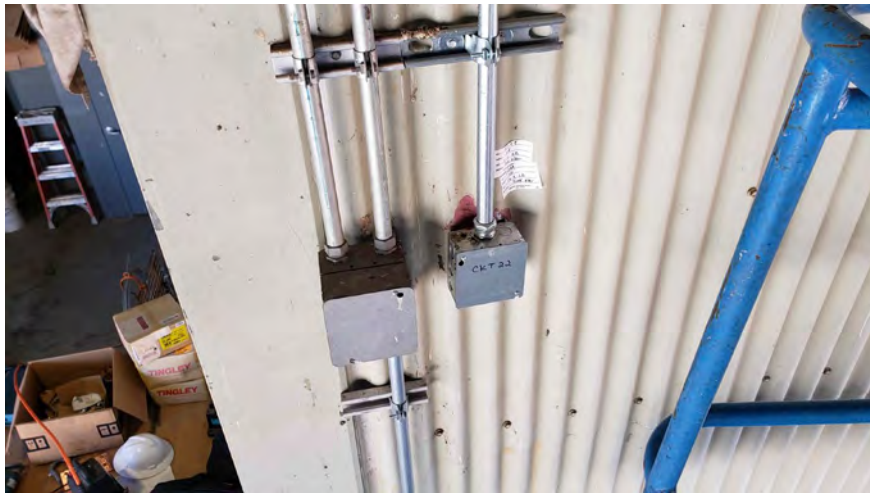
<b>HA Description</b>	Pink Filler Putty Caulk
	<b>Sample #</b>	SID14099-09
	<b>Sample Location / Orientation</b>	Outside SE Corner of Room 02 around conduit. Under Bucket Truck Area (01). Below Samples 07/08.
	<b>Sample/Inspection Results</b>	SID14099-09 – 4% Asbestos Chrysotile
	<b>Recommendation</b>	Remove as ACM.

Sample results for the roof coating, caulking, burnt orange wall filler, and the fiber board panel, were all None Detected; therefore, no asbestos was seen during analysis. However, the black tar filler (similar to roof tar) and the pink wall filler results were 20-25% and 4% respectively. See samples -07, -08, -09, -10 for more details on the wall filler materials.

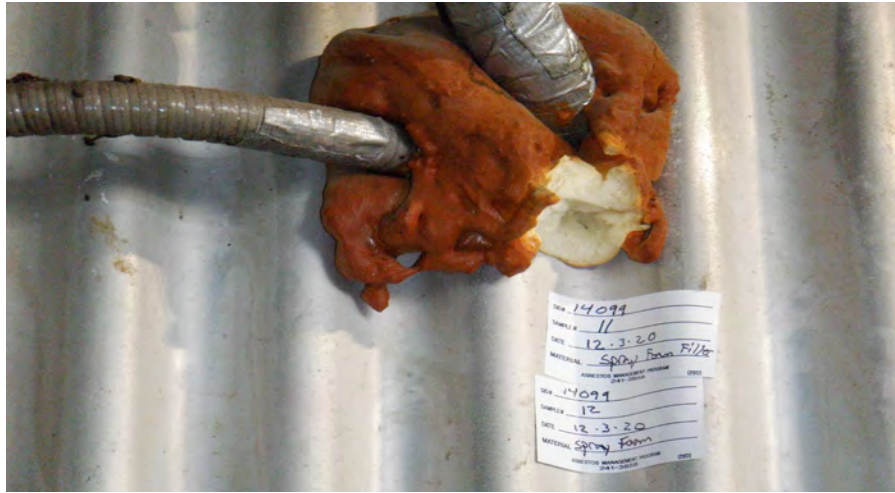
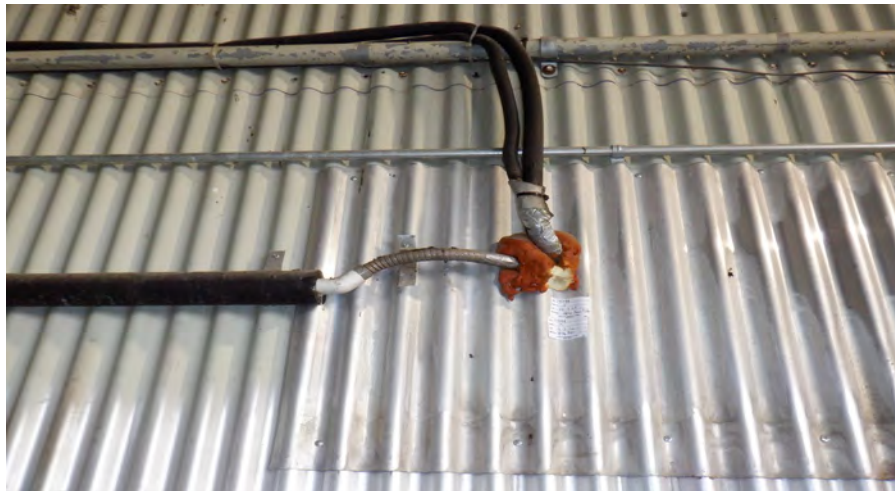
<b>HA Description</b>	<b>Yellow/Burnt Orange Spray Foam Filler</b>
	<b>Sample #</b>	<b>SID14099-11</b>
	<b>Sample Location / Orientation</b>	<b>Outside South Wall of 02 in Storage Area of 01 at 7ft.</b>
	<b>Sample/Inspection Results</b>	<b>SID14099-11 – None Detected</b>
	<b>Recommendation</b>	<b>None</b>

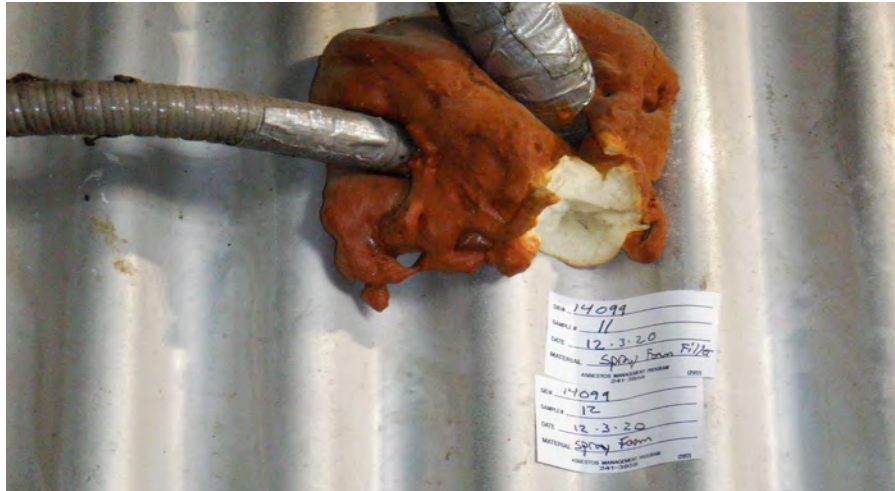
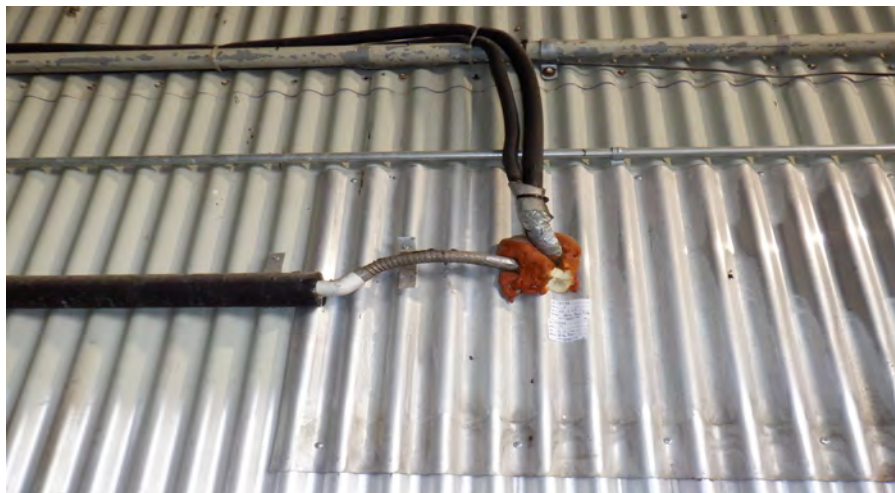
<b>HA Description</b>	<b>Yellow/Burnt Orange Spray Foam Filler</b>
	<b>Sample #</b>	<b>SID14099-12</b>
	<b>Sample Location / Orientation</b>	<b>Outside South Wall of 02 in Storage Area of 01 at 7ft.</b>
	<b>Sample/Inspection Results</b>	<b>SID14099-12 – None Detected</b>
	<b>Recommendation</b>	<b>None</b>

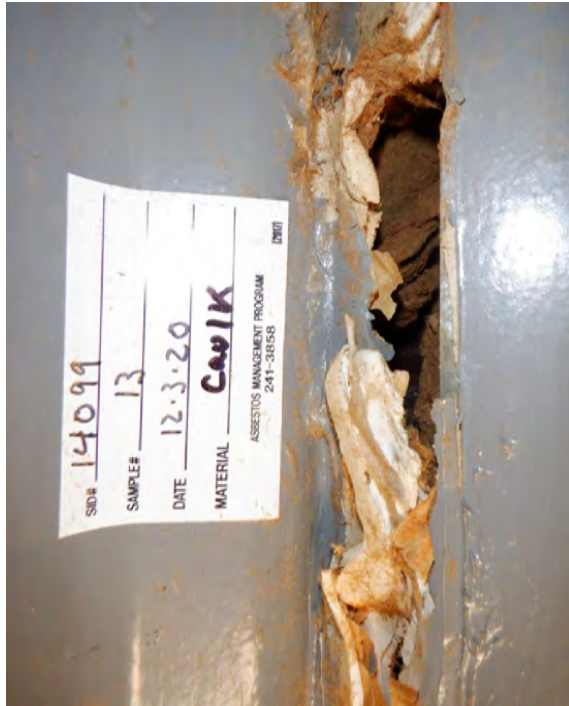
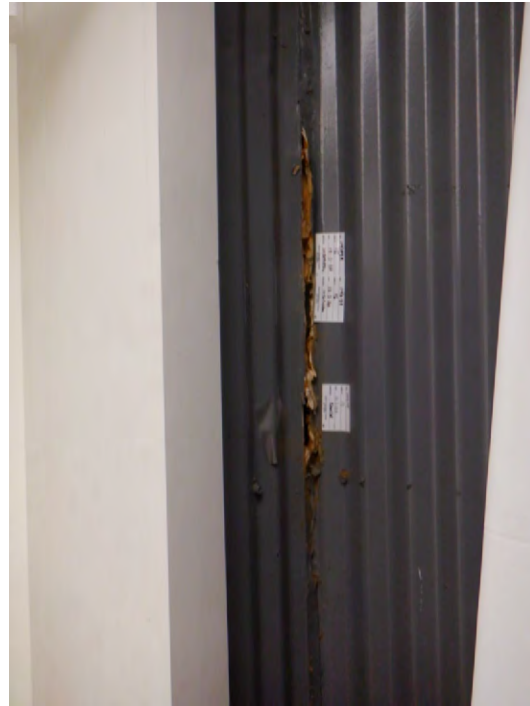
<b>HA Description</b>	White Caulk
	<b>Sample #</b>	SID14099-13
	<b>Sample Location / Orientation</b>	SW Corner of Room 02.
	<b>Sample/Inspection Results</b>	SID14099-13 – None Detected
	<b>Recommendation</b>	None

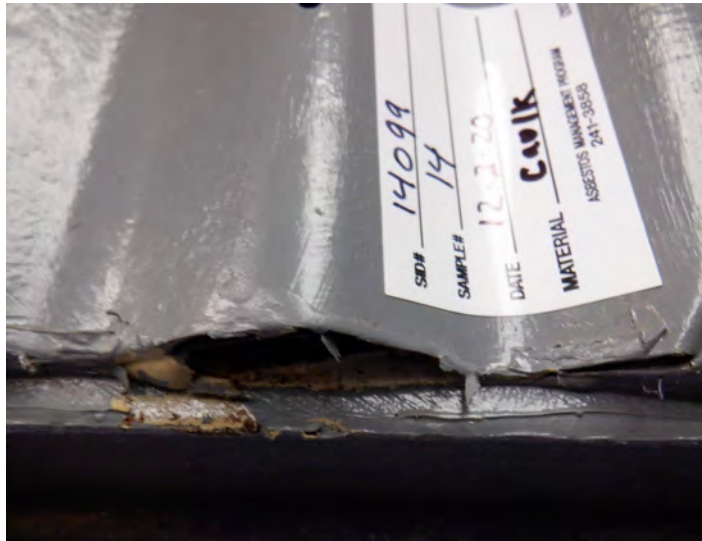
<b>HA Description</b>	<b>White Caulk</b>
	<b>Sample #</b>	<b>SID14099-14</b>
	<b>Sample Location / Orientation</b>	<b>Above East Exterior Door of Room 02.</b>
	<b>Sample/Inspection Results</b>	<b>SID14099-14 – None Detected</b>
	<b>Recommendation</b>	<b>None</b>

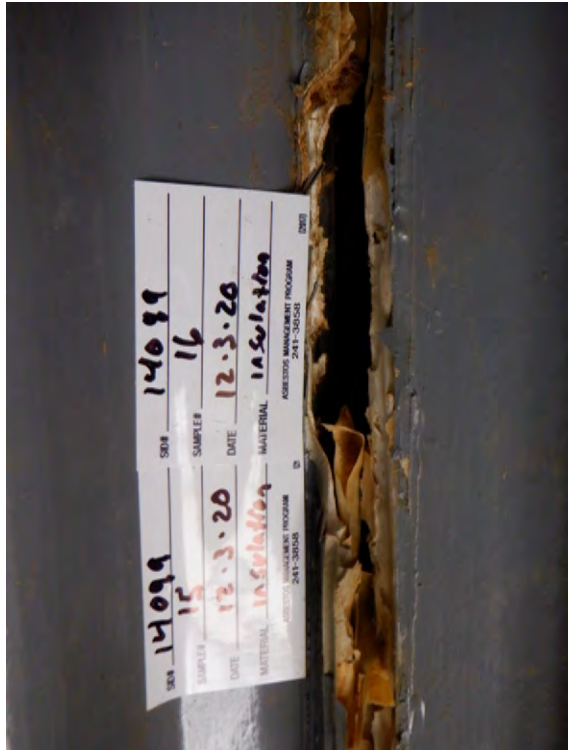
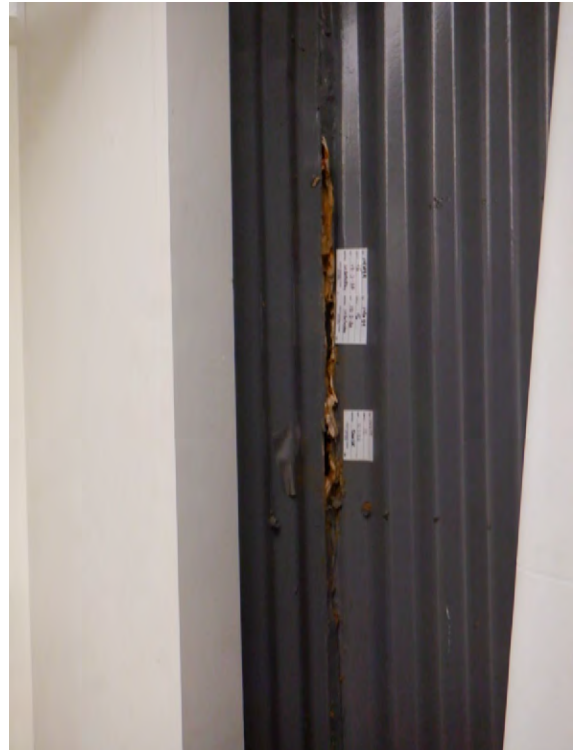
<b>HA Description</b>	Brown Fiber Board w/Paper
	<b>Sample #</b>	SID14099-15
	<b>Sample Location / Orientation</b>	SW Corner Behind Caulk, in Crack between Corrugated Metal Walls.
	<b>Sample/Inspection Results</b>	SID14099-15 – None Detected
	<b>Recommendation</b>	None

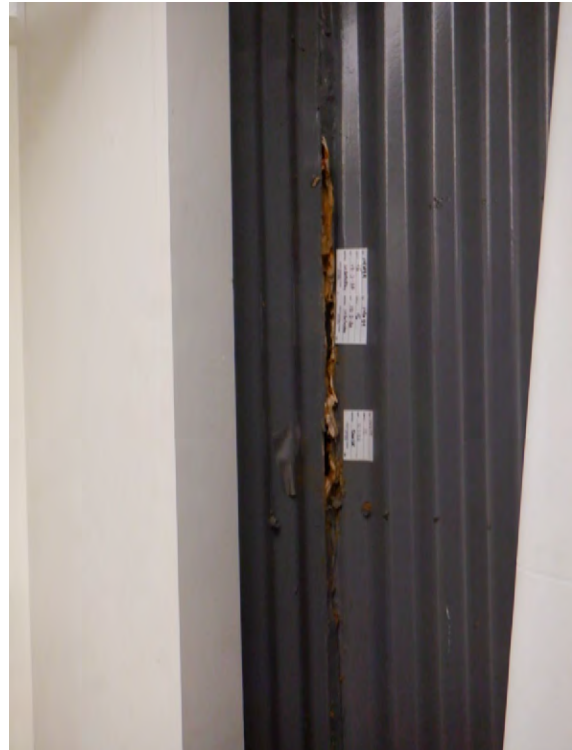
<b>HA Description</b>	Brown Fiber Board w/Paper
	<b>Sample #</b>	SID14099-16
	<b>Sample Location / Orientation</b>	SW Corner Behind Caulk, in Crack between Corrugated Metal Walls.
	<b>Sample/Inspection Results</b>	SID14099-16 – None Detected
	<b>Recommendation</b>	None

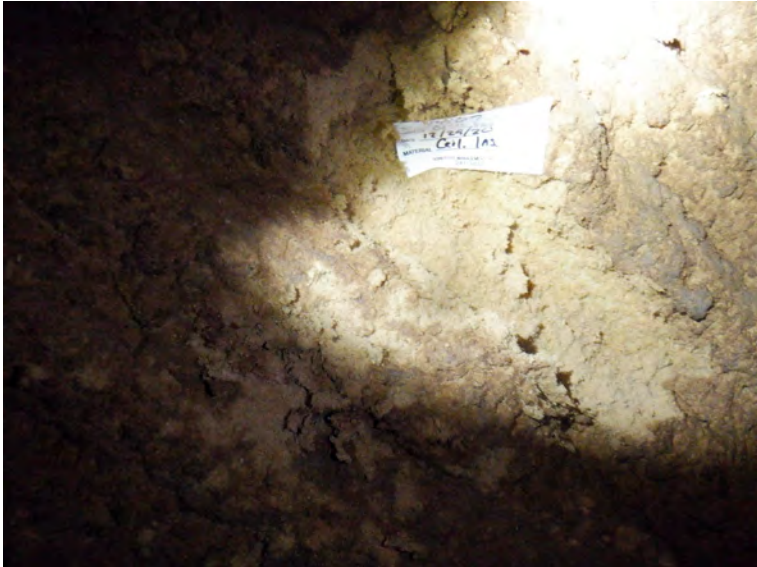
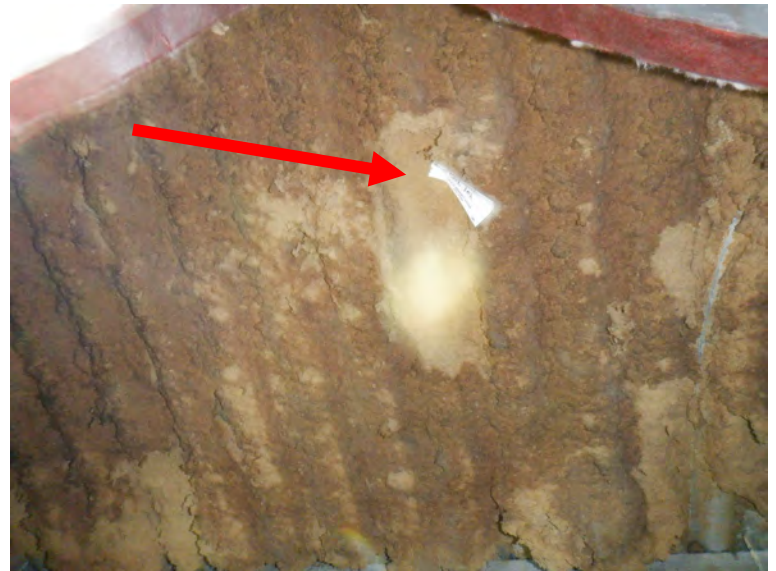
<b>HA Description</b>	Spray Applied Ceiling Insulation
	<b>Sample #</b>	<b>SID14167-01</b>
	<b>Sample Location / Orientation</b>	SID14167-01 – Rm 02; N.W. Corner above upper drop ceiling
	<b>Sample/Inspection Results</b>	<b>SID14167-01 – None Detected</b> <b>Analysis revealed the brown fibrous layer as 95% cellulose.</b>
	<b>Recommendation</b>	None

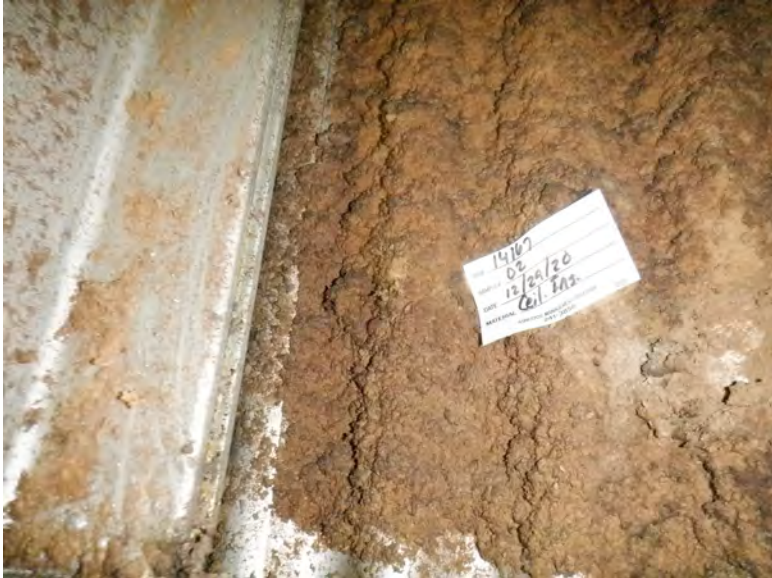
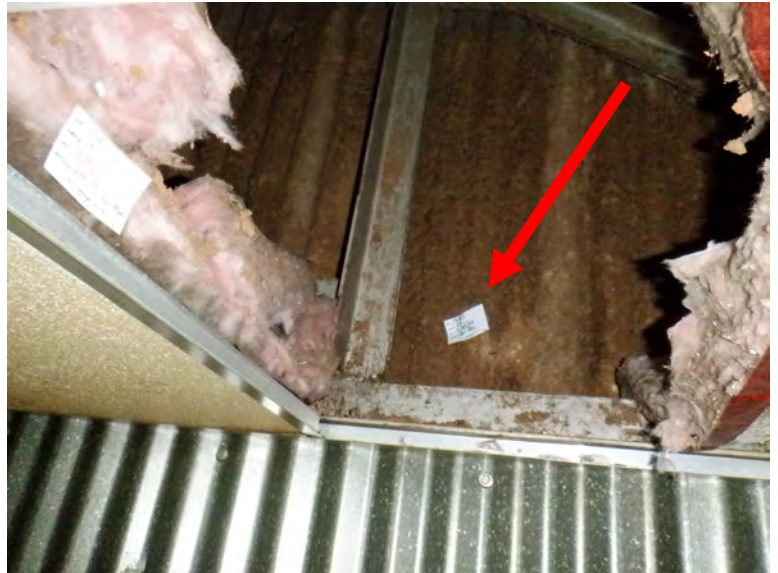
<b>HA Description</b>	Spray Applied Ceiling Insulation
<b>Sample #</b>	SID14167-02
<b>Sample Location / Orientation</b>	SID14167-02 – Rm 02: S.W. Corner above upper drop ceiling
<b>Sample/Inspection Results</b>	SID14167-02 – None Detected Analysis revealed the brown fibrous layer as 95% cellulose.
<b>Recommendation</b>	None

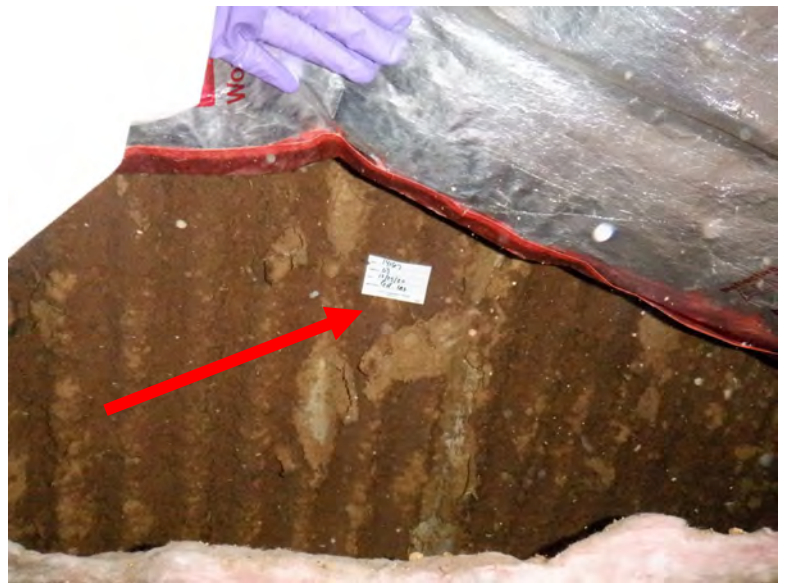
<b>HA Description</b>	Spray Applied Ceiling Insulation
	<b>Sample #</b>	SID14167-03
	<b>Sample Location / Orientation</b>	SID14167-03 – Rm 02; N.E. Corner above upper drop ceiling
	<b>Sample/Inspection Results</b>	SID14167-03 – None Detected Analysis revealed the brown fibrous layer as 95% cellulose.
	<b>Recommendation</b>	None
