**Scope of Work and Specifications**

**CRSF Building Demolition**

**OAK RIDGE NATIONAL LABORATORY**

**March 2021**

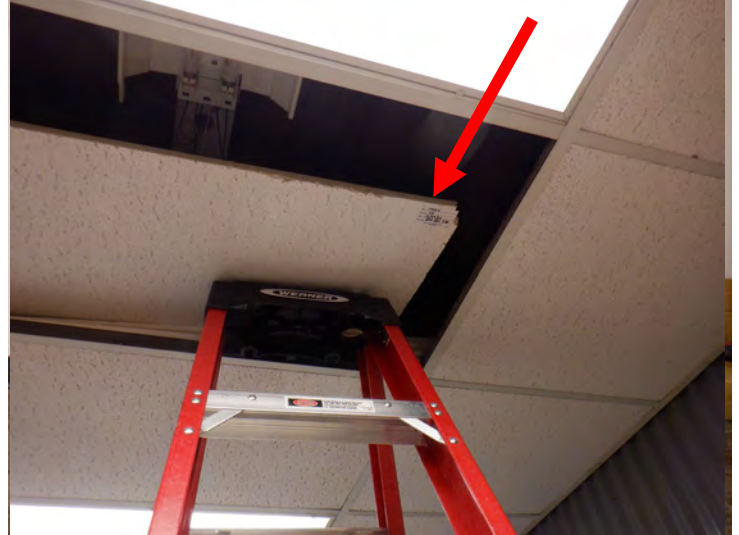
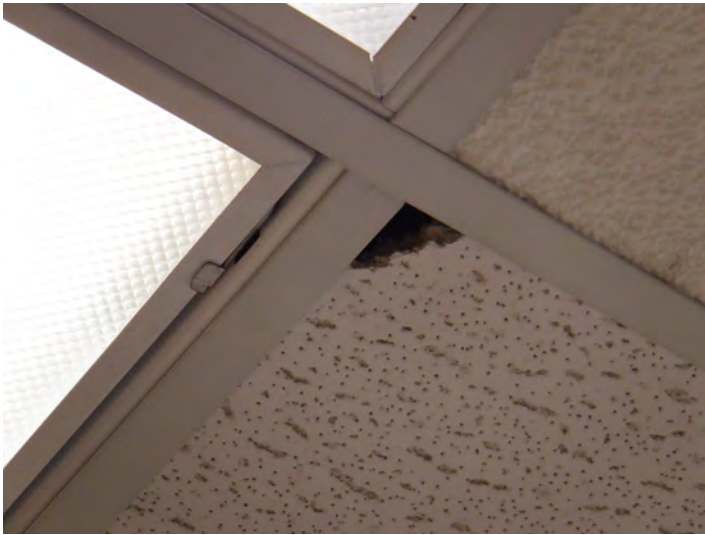
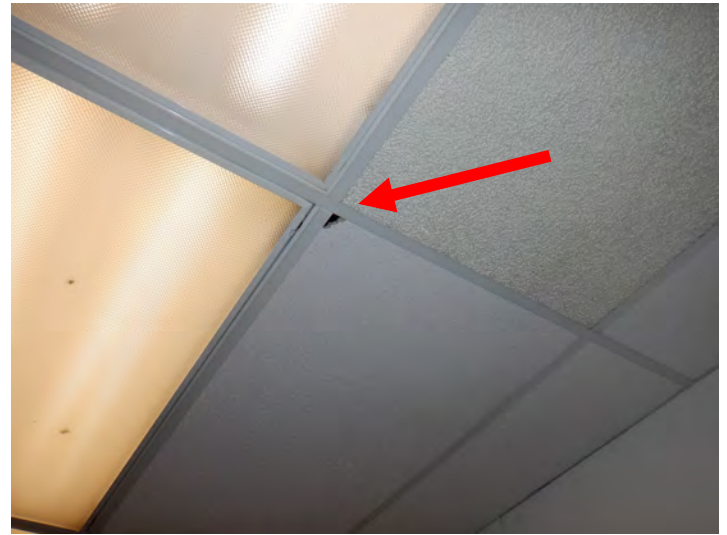
<b>HA Description</b>	2 FT X 2 FT White Cellulose Ceiling Tile, Fissured, Holey (Fissured with Pin Holes)
	<b>Sample #</b>	<b>SID14167-04</b> <b>SID14167-05</b>
	<b>Sample Location / Orientation</b>	SID14167-04 – Rm 02; N.W. Corner of Room SID14167-05 – Rm 02; N.E. Corner of Room
	<b>Sample/Inspection Results</b>	<b>SID14167-04 – None Detected</b> <b>SID14167-05 – None Detected</b>
	<b>Recommendation</b>	None

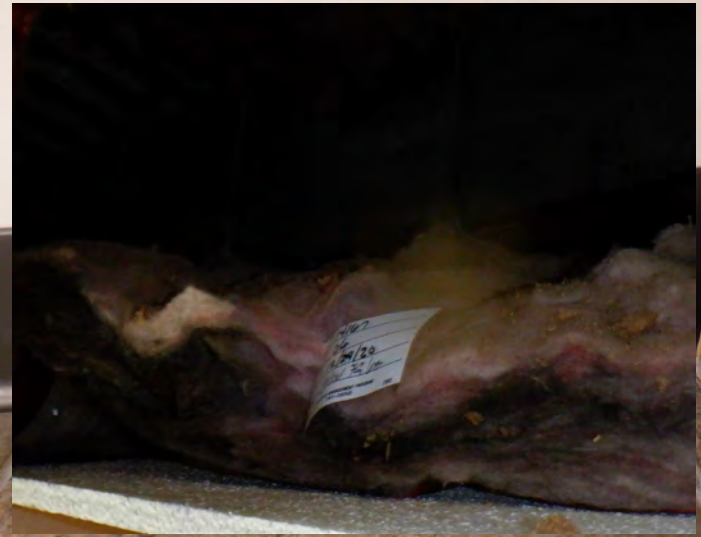
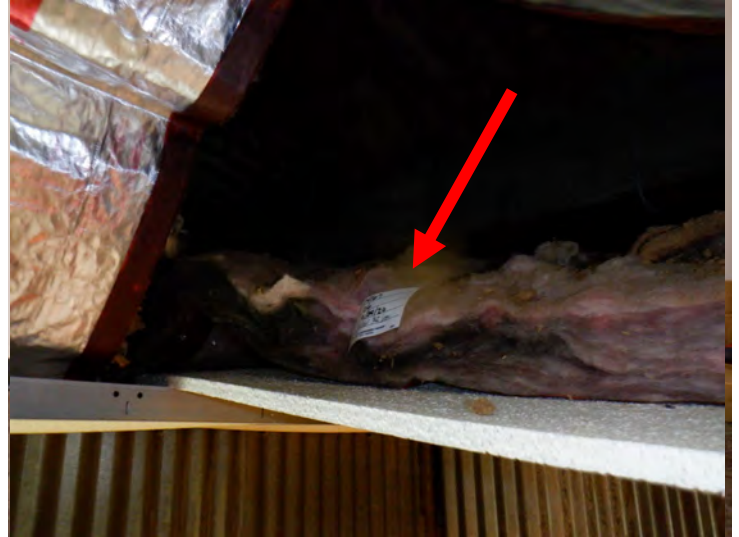
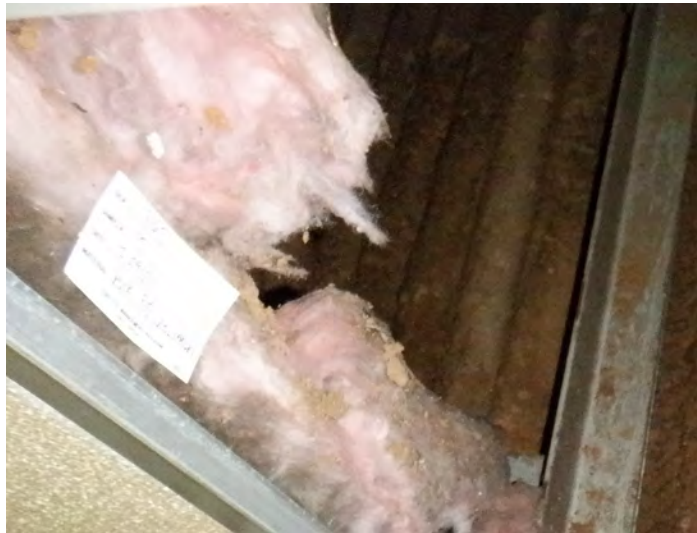
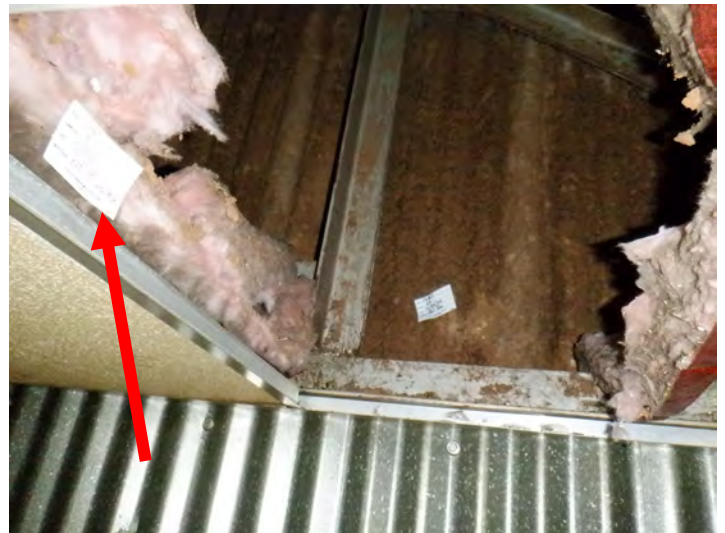
<b>HA Description</b>	Pink Batt Insulation
<b>Sample #</b>	<b>SID14167-06</b> <b>SID14167-07</b>
<b>Sample Location / Orientation</b>	SID14167-06 – Rm 02; N.W. Corner, above lower drop ceiling SID14167-07 – Rm 02; S.W. Corner, above lower drop ceiling
<b>Sample/Inspection Results</b>	SID14167-06 – None Detected SID14167-07 – None Detected Analysis revealed the pink fibrous layer as 95% mineral wool.
<b>Recommendation</b>	None

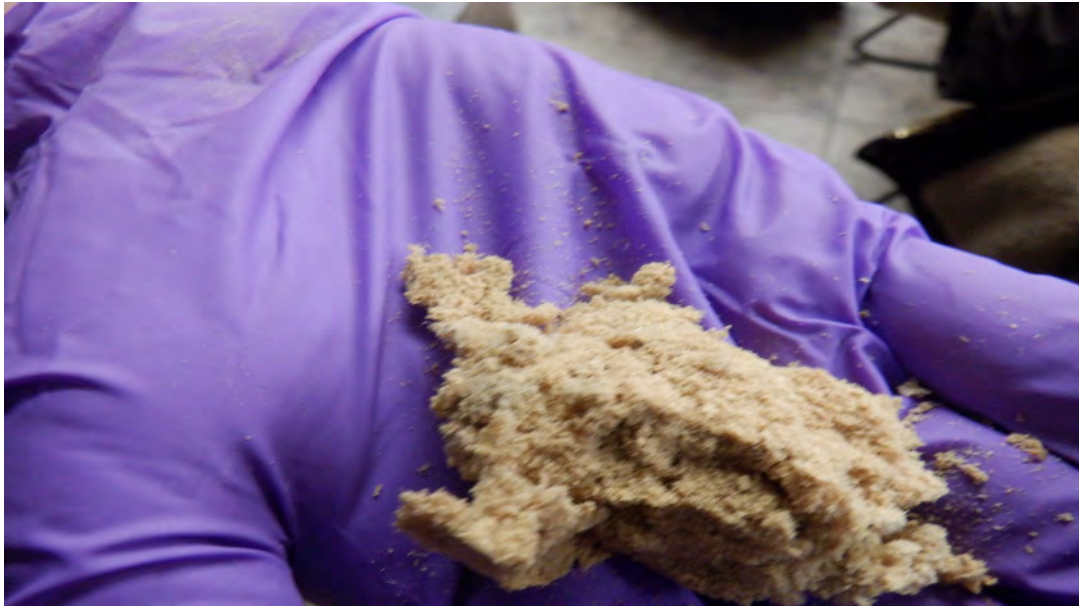
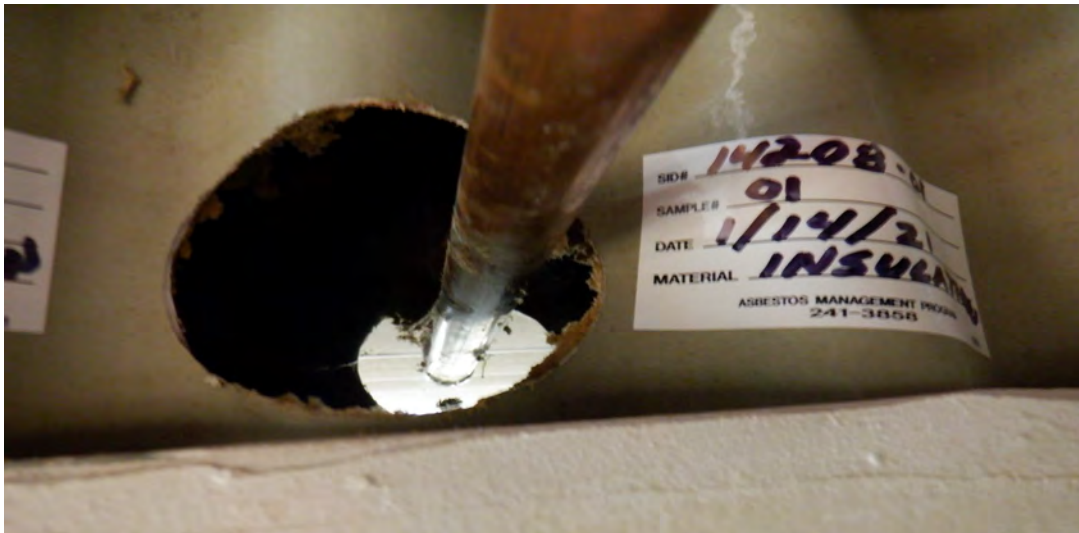
<b>HA Description</b>	Brown batting insulation
<b>Sample #</b>	SID14208-01
<b>Sample Location / Orientation</b>	SID14208-01 – Room 3 - Kitchen Brown batted insulation - SW corner above ceiling in south wall. REF -SID14064 – 25/26
<b>Sample/Inspection Results</b>	SID14208-01 - None Detected
<b>Recommendation</b>	None

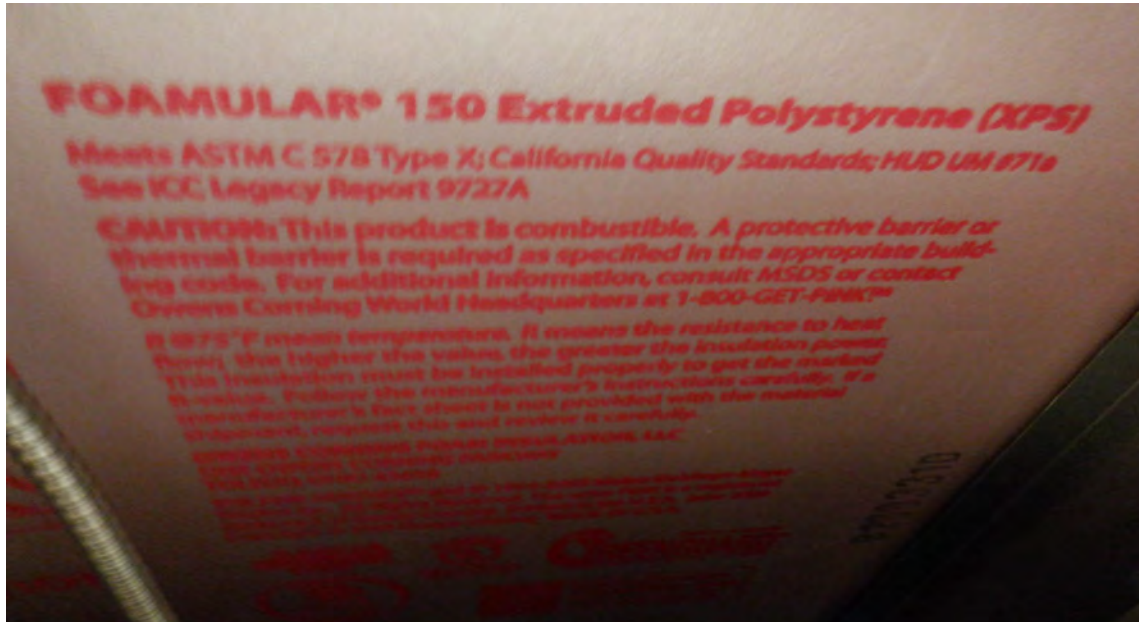
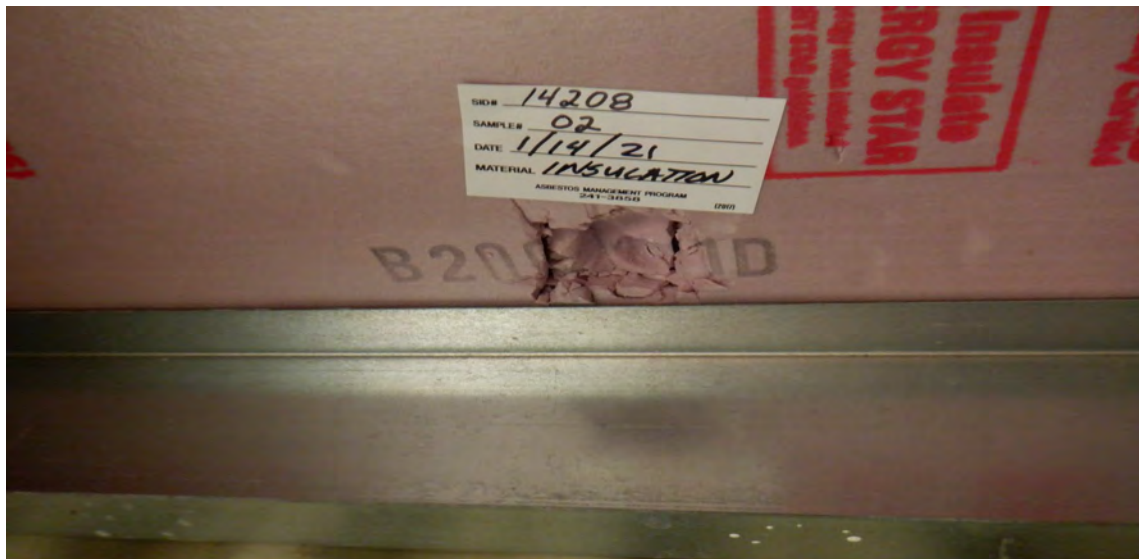
<b>HA Description</b>	Pink greenguard insulation board
<b>Sample #</b>	SID14208-02
<b>Sample Location / Orientation</b>	SID14208-02 – Room 3 (Kitchen) - Pink greenguard insulation board - SW corner above ceiling. SID14064-27/28
<b>Sample/Inspection Results</b>	SID14208-02 - None Detected
<b>Recommendation</b>	None

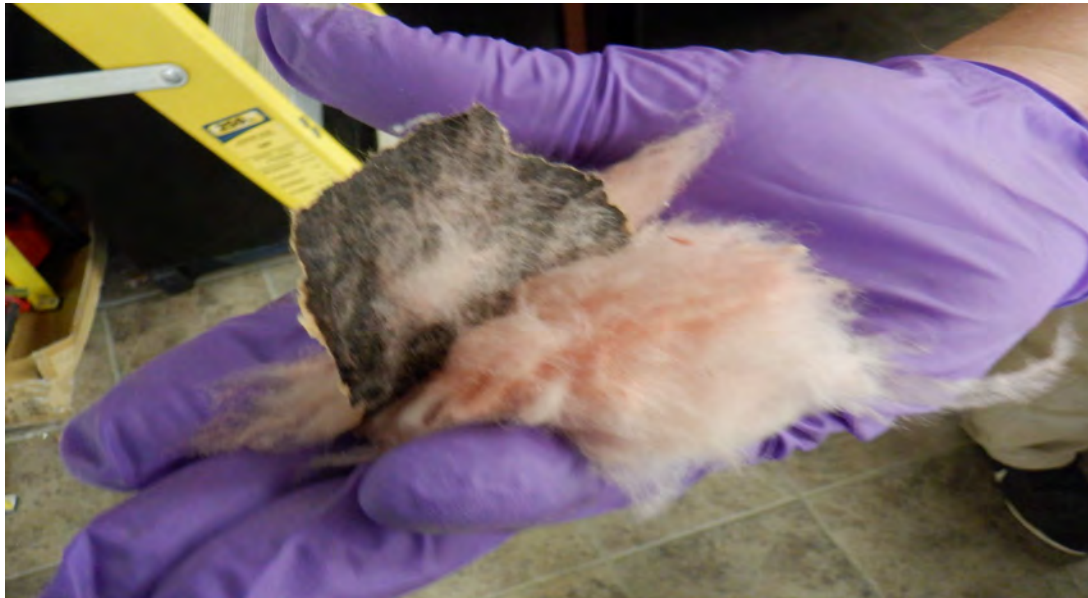
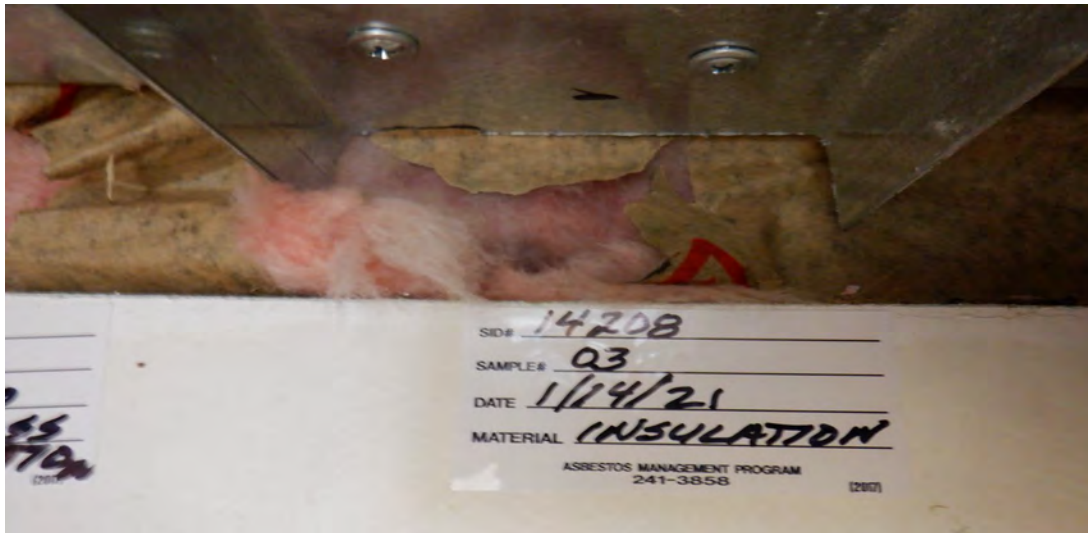
<b>HA Description</b>	Pink fiberglass batting insulation
<b>Sample #</b>	<b>SID14208-03</b>
<b>Sample Location / Orientation</b>	SID14208-03 – Room 3 (Kitchen) - Pink fiberglass insulation batting. SE corner above ceiling in west wall SID14064- 29/30
<b>Sample/Inspection Results</b>	SID14208-03 - None Detected
<b>Recommendation</b>	None

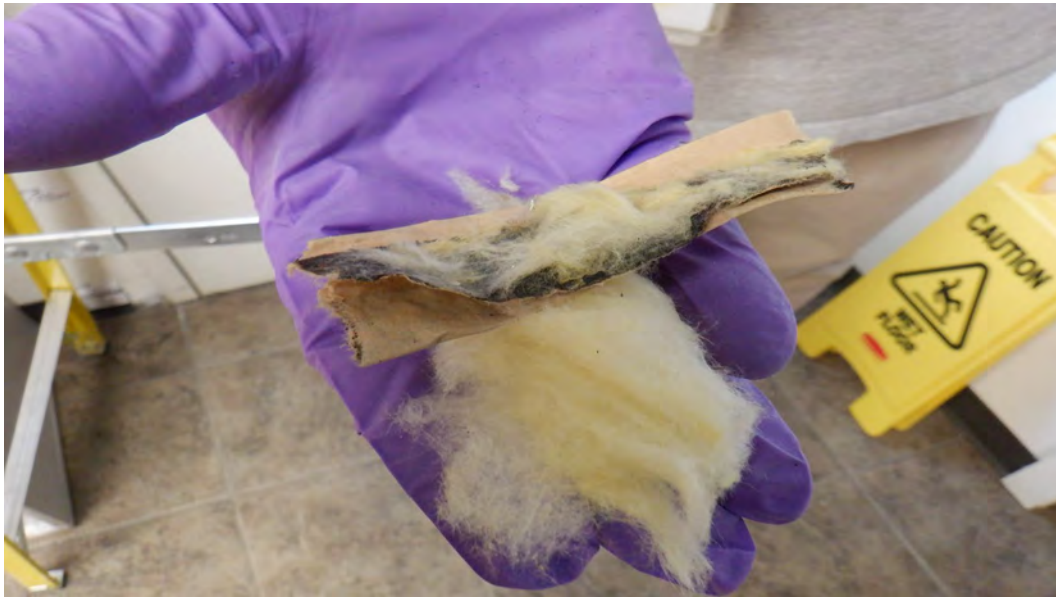
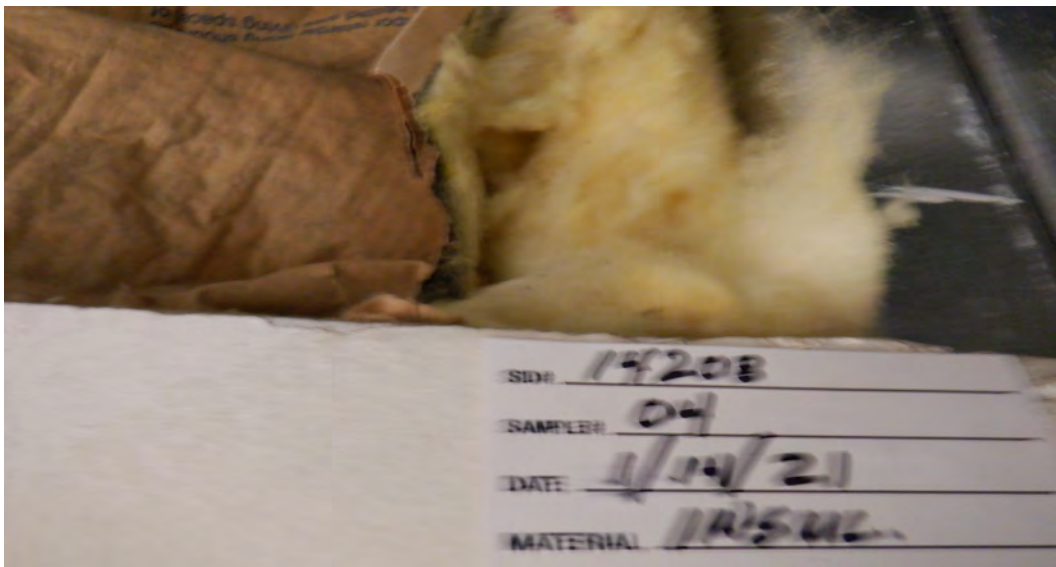
<b>HA Description</b>	Yellow fiberglass batting insulation
<b>Sample #</b>	SID14208-04
<b>Sample Location / Orientation</b>	SID14208-04 – Room 3 (Kitchen) Yellow fiberglass insulation batting. SE corner above ceiling in east wall. SID14064- 33/34
<b>Sample/Inspection Results</b>	SID14208-04 - None Detected
<b>Recommendation</b>	None

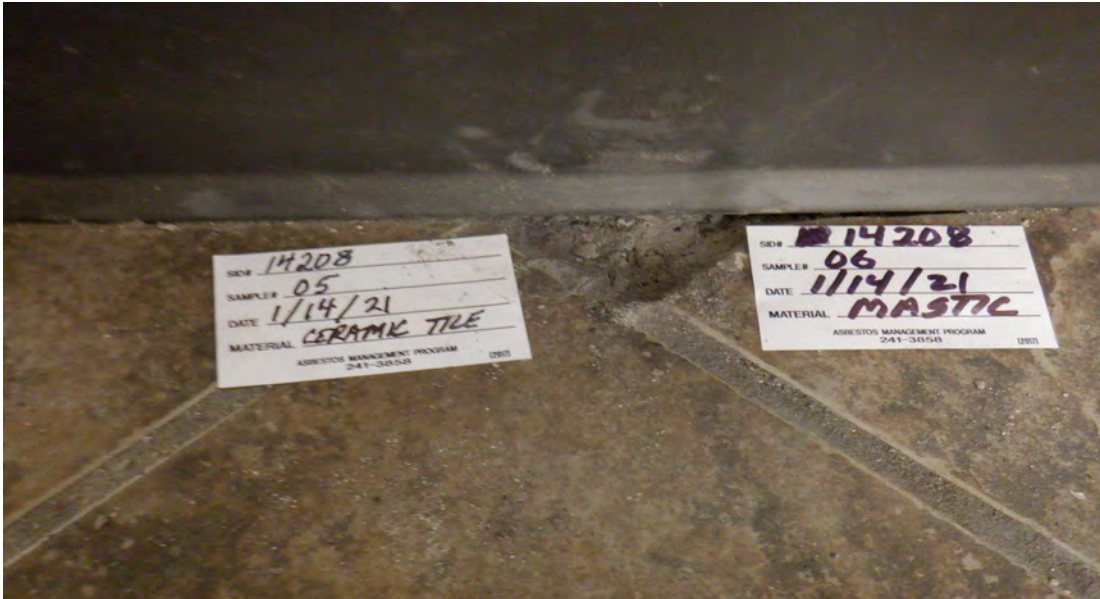
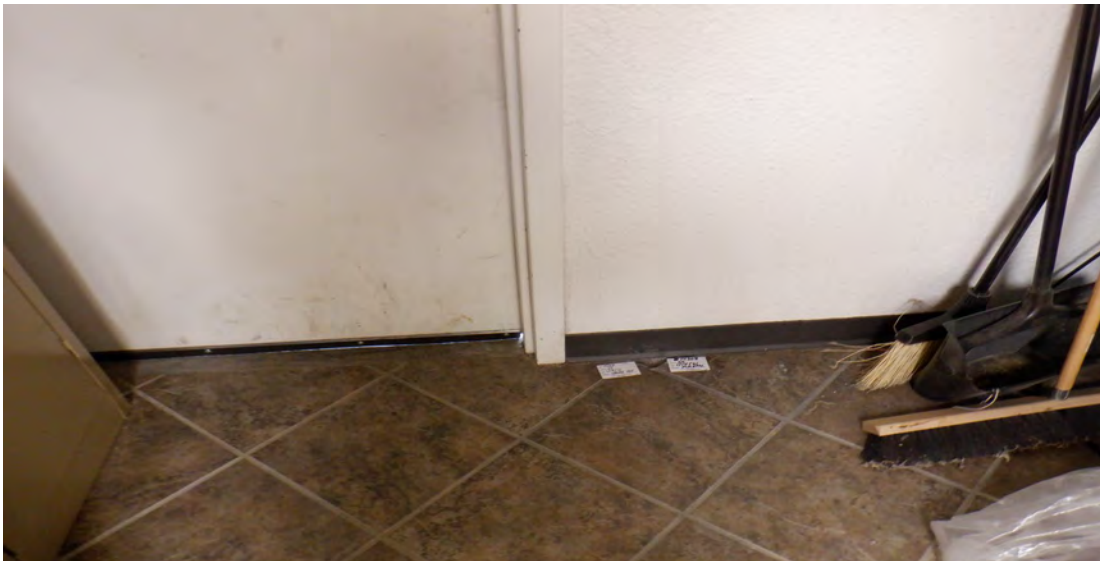
<b>HA Description</b>	12 x 12 tan/brown/black ceramic tile
<b>Sample #</b>	SID14208-05
<b>Sample Location / Orientation</b>	SID14208-05 – Change room. 12 x 12 Tan/brown/black ceramic floor tile - South side by wall, west of door. SID14064- 9/12
<b>Sample/Inspection Results</b>	SID14208-05 - None Detected
<b>Recommendation</b>	None

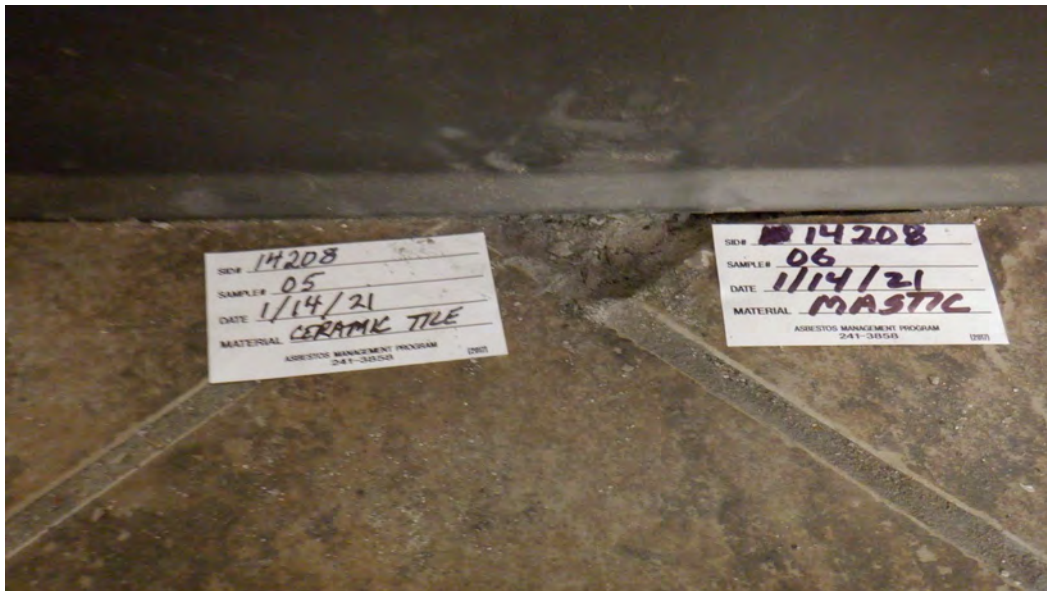
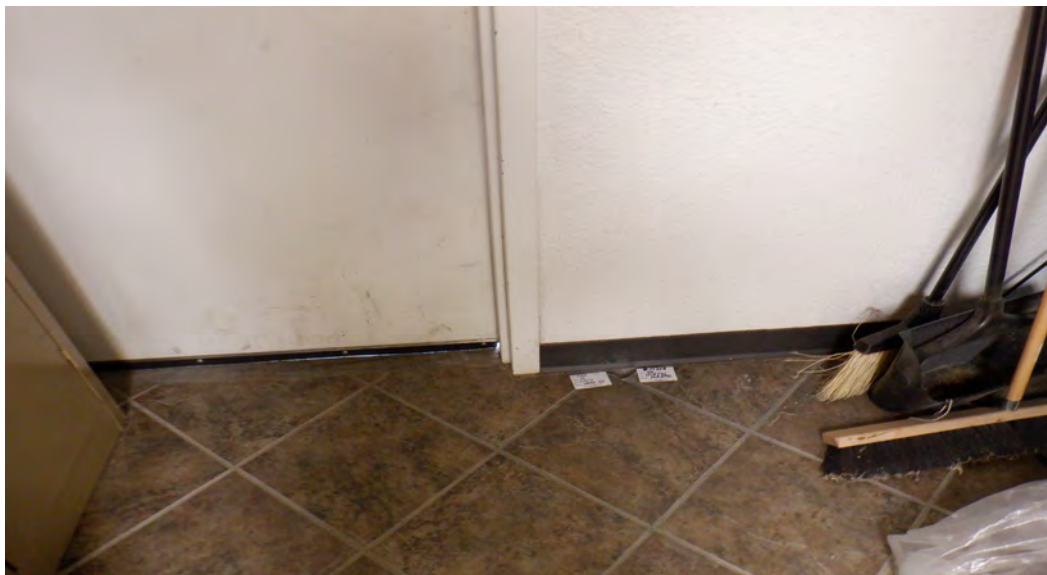
<b>HA Description</b>	Gray mastic under ceramic tile
<b>Sample #</b>	<b>SID14208-06</b>
<b>Sample Location / Orientation</b>	SID14208-06 – Change room. Gray mastic under ceramic floor tile(sample 05). South side by wall, west of door SID14064- 10/13
<b>Sample/Inspection Results</b>	SID14208-06 - None Detected
<b>Recommendation</b>	None

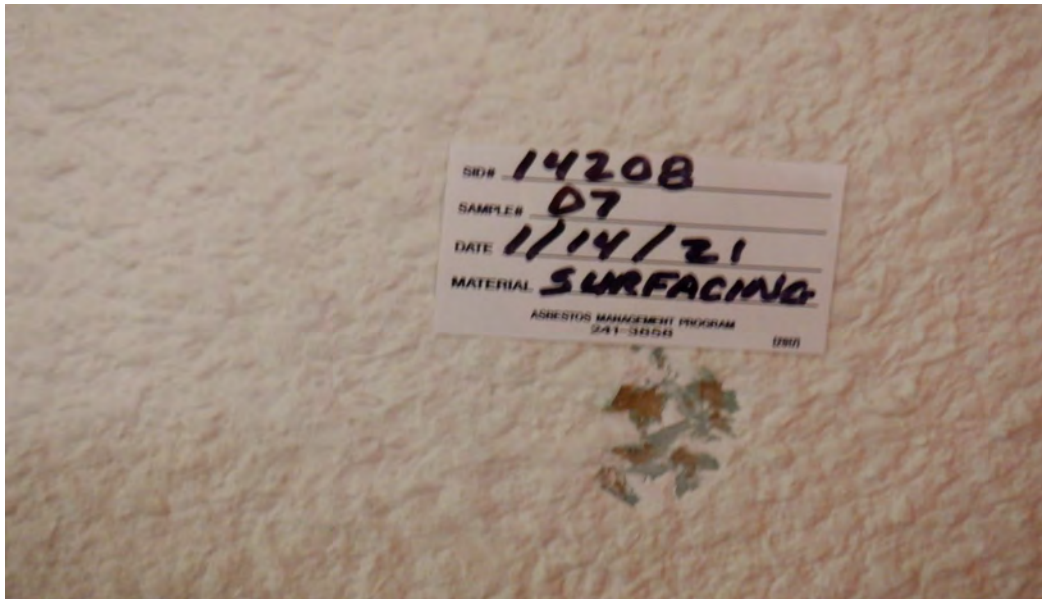
<b>HA Description</b>	White sprayed applied textured material
<b>Sample #</b>	SID14208-07
<b>Sample Location / Orientation</b>	SID14208-07 – Change room. White textured surfacing material - SW corner on west wall. SID14084-5/6
<b>Sample/Inspection Results</b>	SID14208-07 - None Detected
<b>Recommendation</b>	None

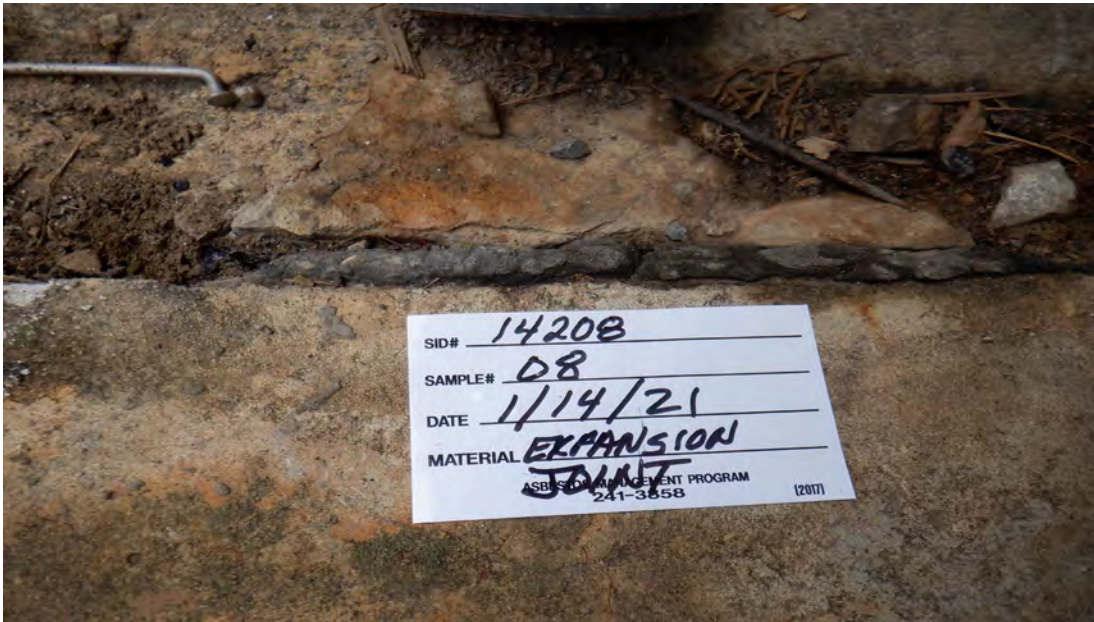
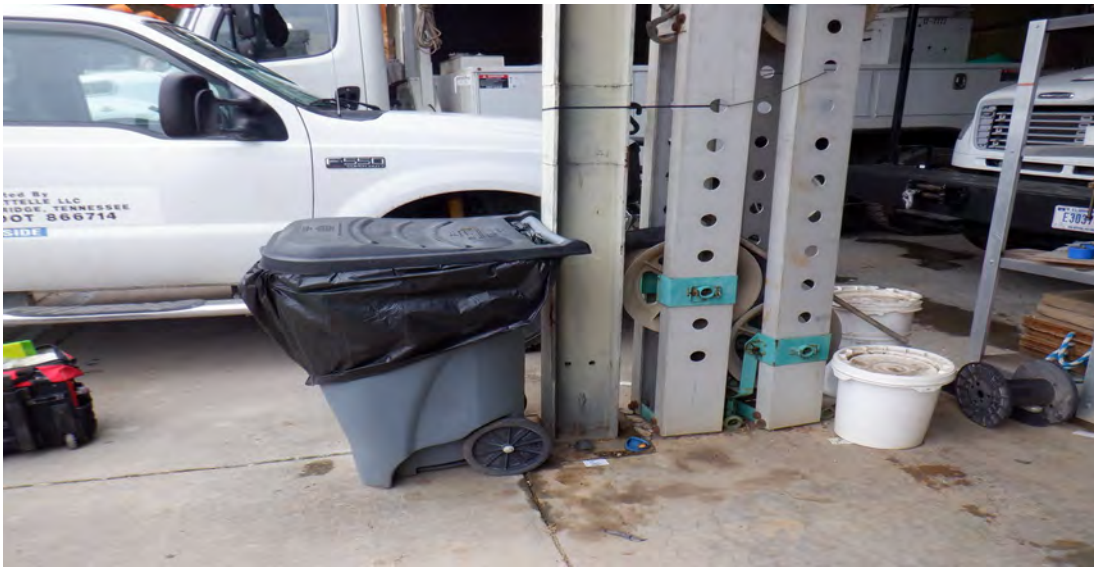
<b>HA Description</b>	Black tar expansion joint
<b>Sample #</b>	SID14208-08
<b>Sample Location / Orientation</b>	SID14208-08 – Bucket truck bay. Black tar expansion joint- South side of bay, center column
<b>Sample/Inspection Results</b>	SID14208-08 - None Detected
<b>Recommendation</b>	None

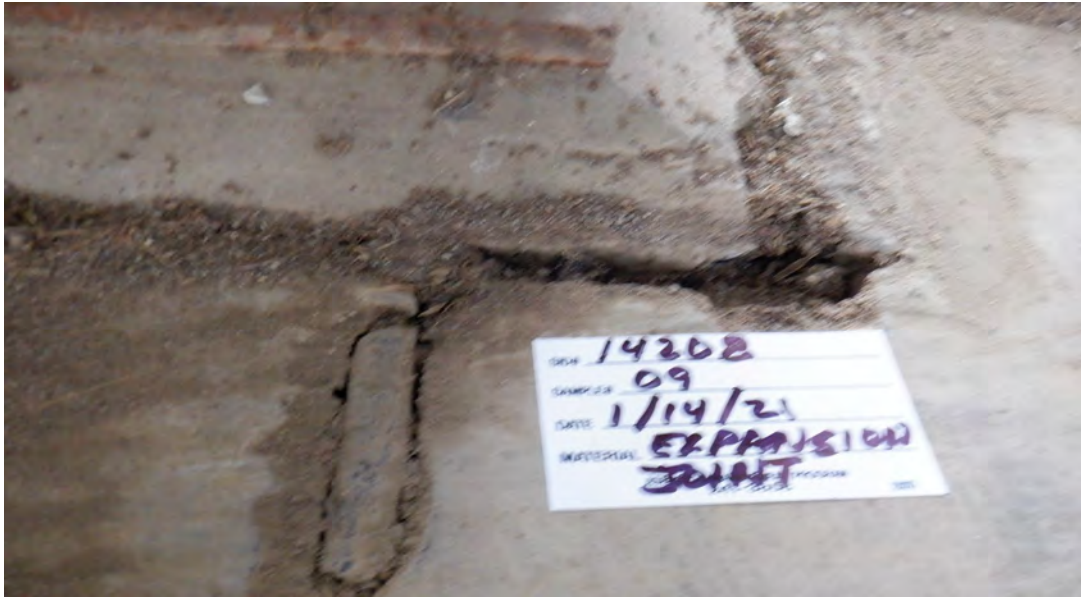
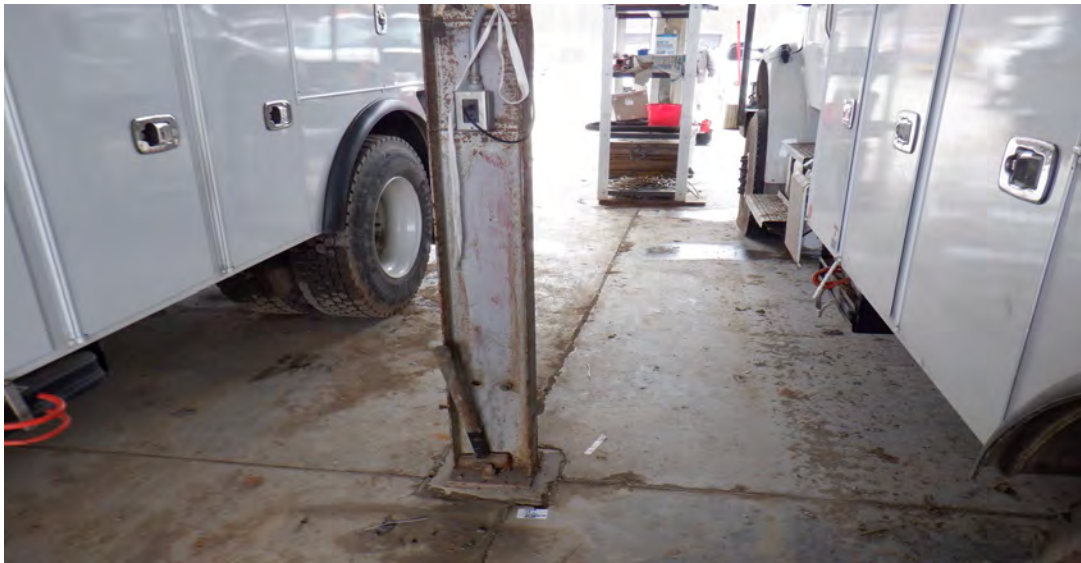
<b>HA Description</b>	Black tar expansion joint
<b>Sample #</b>	SID14208-09
<b>Sample Location / Orientation</b>	SID14208-09 – Bucket truck bay. Black tar expansion joint - Center of bay, center column.
<b>Sample/Inspection Results</b>	SID14208-09 - None Detected
<b>Recommendation</b>	None

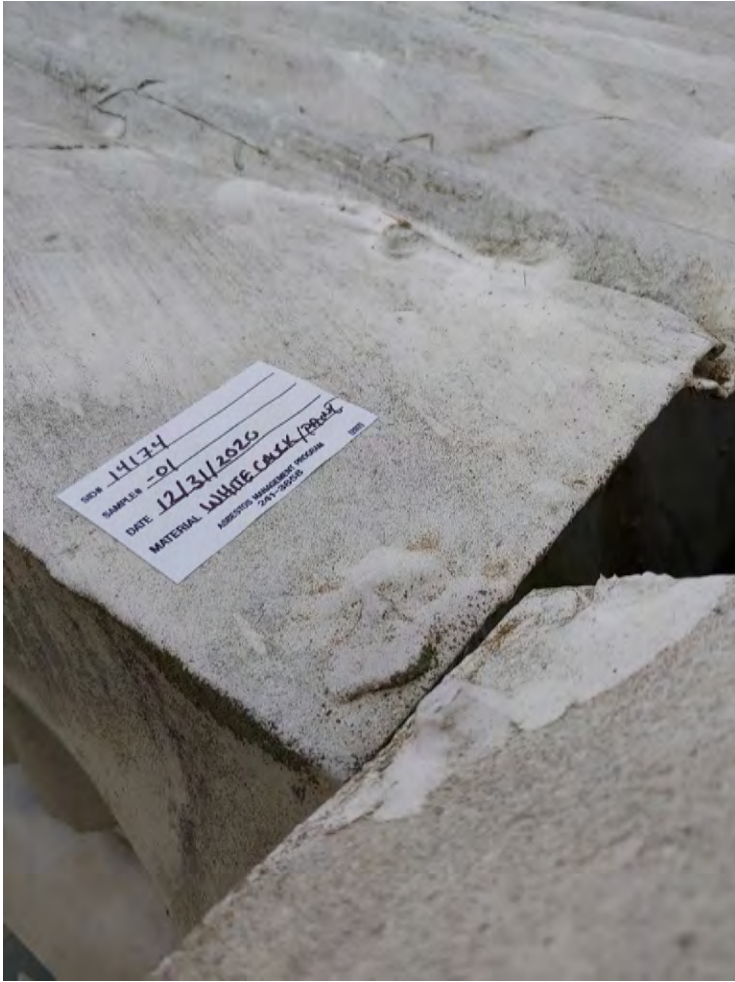
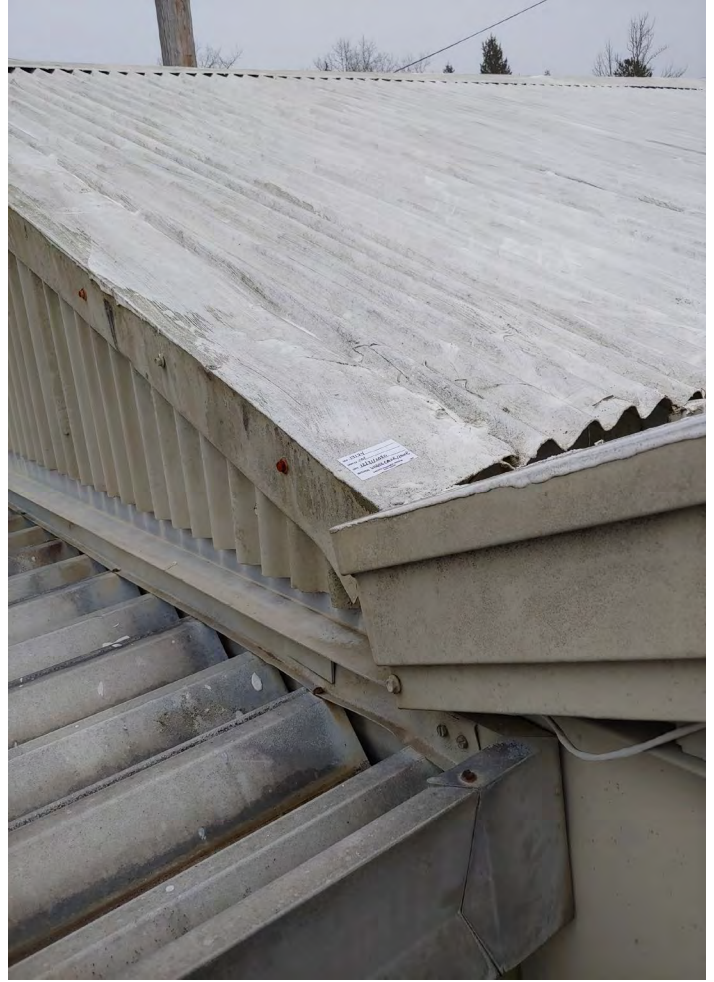
<b>HA Description</b>	WHITE CAULK/PAINT/Roof Coating
	<b>Sample #</b>	<b>SID14174-01</b>
	<b>Sample Location / Orientation</b>	SID14174-01– Southwest corner of roof
	<b>Sample/Inspection Results</b>	SID13947-01 – None Detected
	<b>Recommendation</b>	None

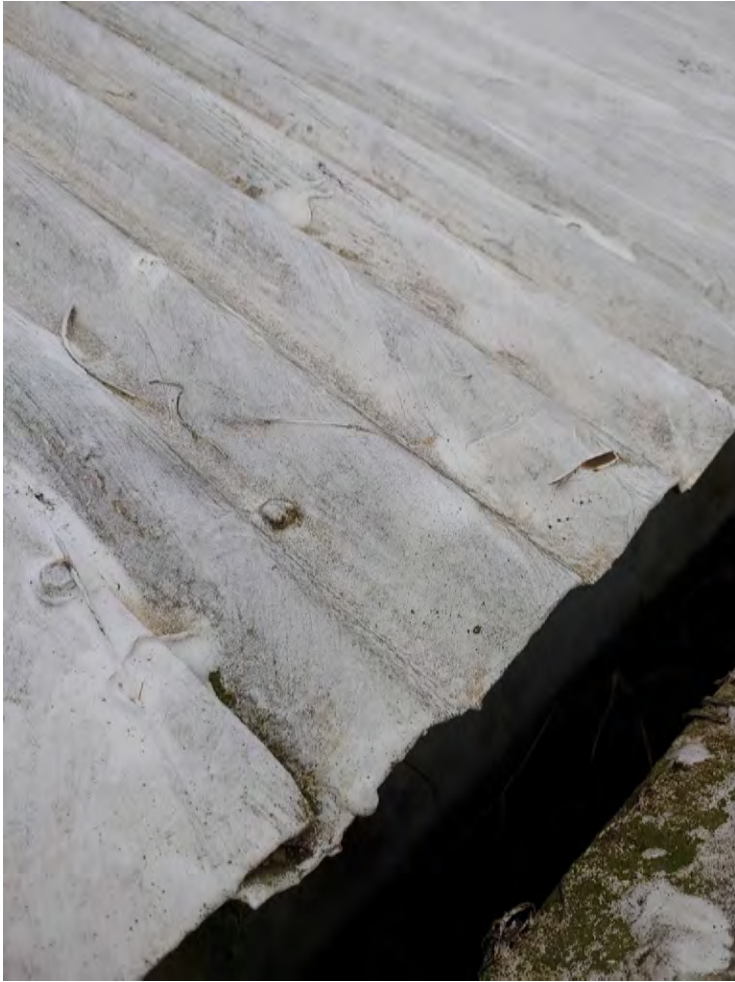
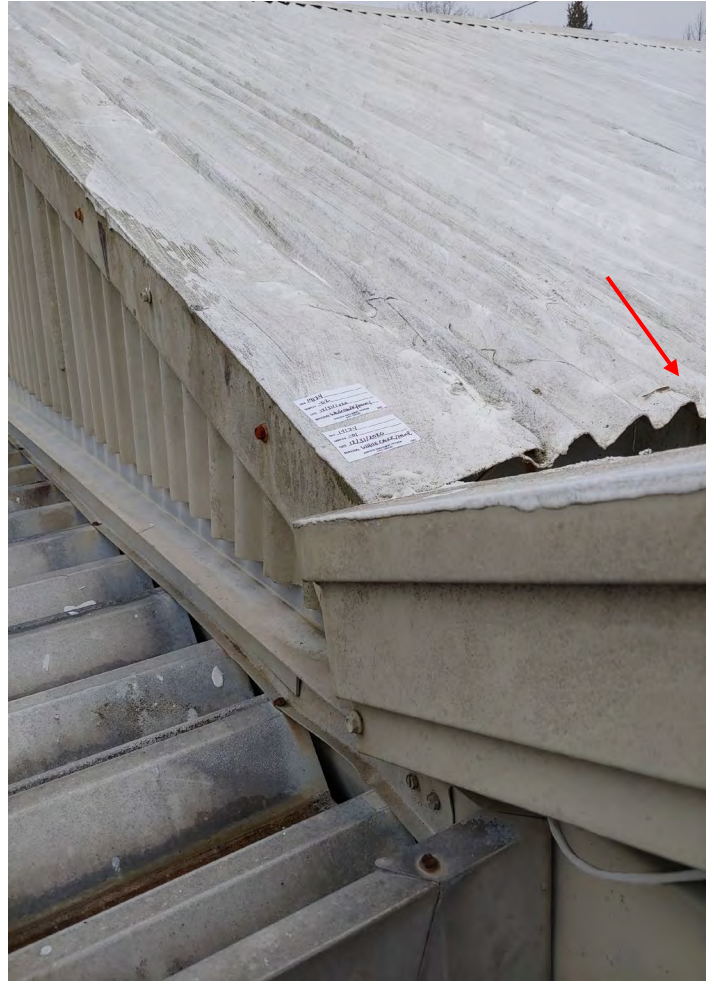
<b>HA Description</b>	WHITE CAULK/PAINT/Roof Coating
	<b>Sample #</b>	<b>SID14174-02</b>
	<b>Sample Location / Orientation</b>	SID14174-02– Center of the south side of the roof
	<b>Sample/Inspection Results</b>	SID13947-02 – None Detected
	<b>Recommendation</b>	None

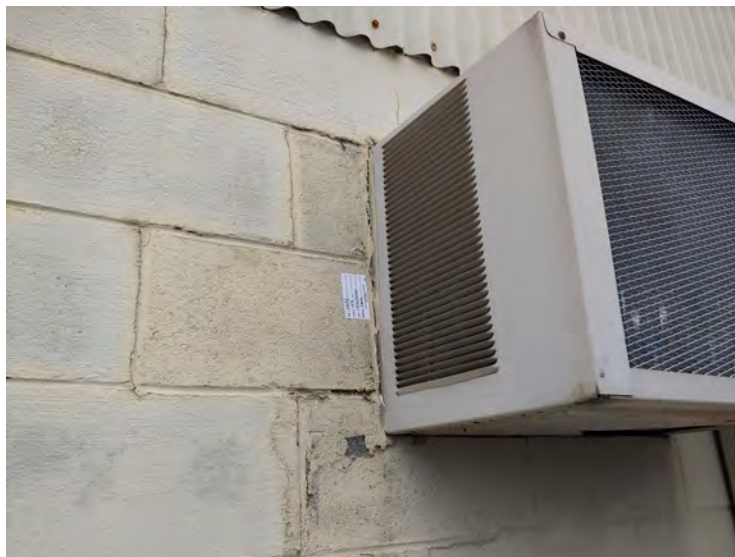
<b>HA Description</b>	WHITE/GRAY CAULK
	<b>Sample #</b>	<b>SID14174-03</b>
	<b>Sample Location / Orientation</b>	SID14174-03– North of AC unit (west side of 7035).
	<b>Sample/Inspection Results</b>	SID13947-03 – None Detected
	<b>Recommendation</b>	None

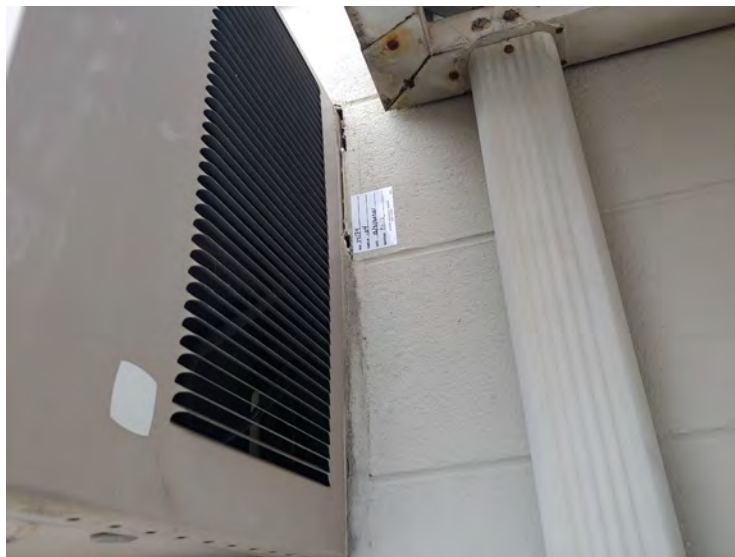
<b>HA Description</b>	WHITE/GRAY CAULK
	<b>Sample #</b>	<b>SID14174-04</b>
	<b>Sample Location / Orientation</b>	SID14174-04– South of AC unit (west side of 7035).
	<b>Sample/Inspection Results</b>	SID13947-04 – None Detected
	<b>Recommendation</b>	None

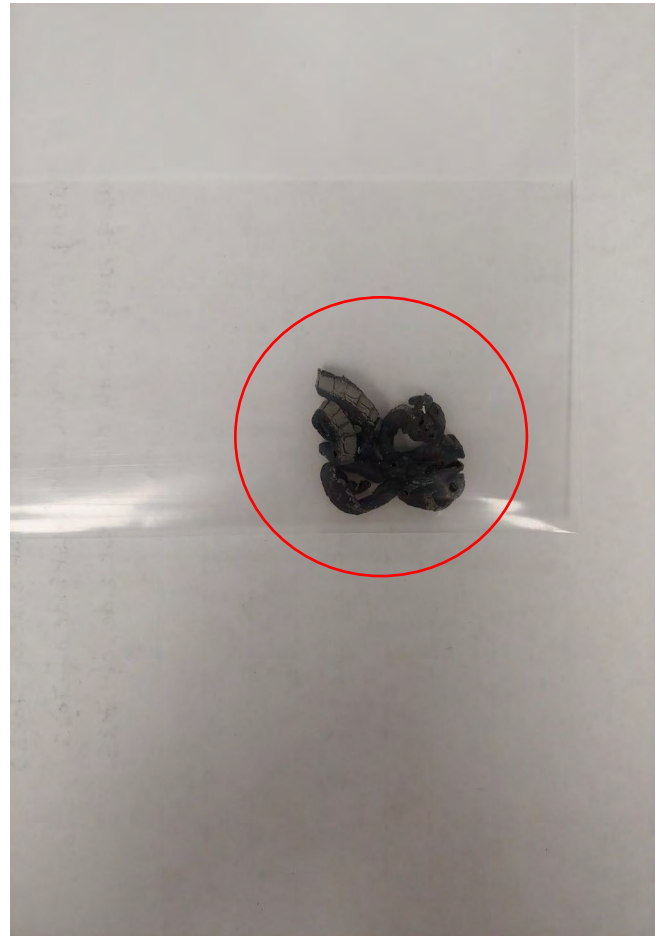
<b>HA Description</b>	BLACK WINDOW GLAZING/CAULK
	<b>Sample #</b>	SID14174-05
	<b>Sample Location / Orientation</b>	SID14174-05– North door, west side of 7035.
	<b>Sample/Inspection Results</b>	SID13947-05 – None Detected
	<b>Recommendation</b>	None

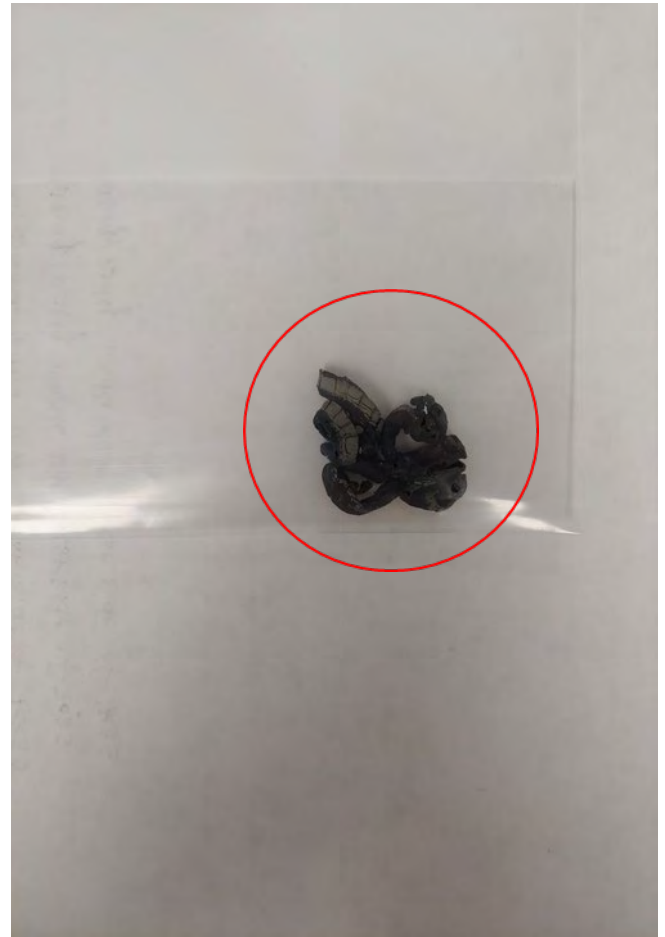
<b>HA Description</b>	BLACK WINDOW GLAZING/CAULK
	<b>Sample #</b>	SID14174-06
	<b>Sample Location / Orientation</b>	SID14174-06– South door, west side of 7035.
	<b>Sample/Inspection Results</b>	SID13947-06 – None Detected
	<b>Recommendation</b>	None

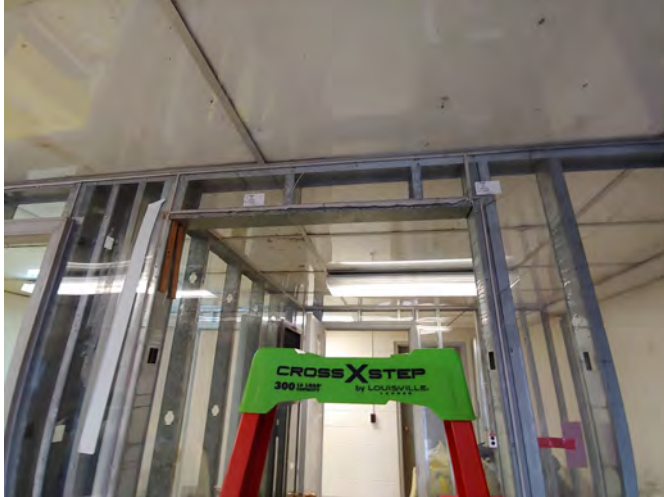
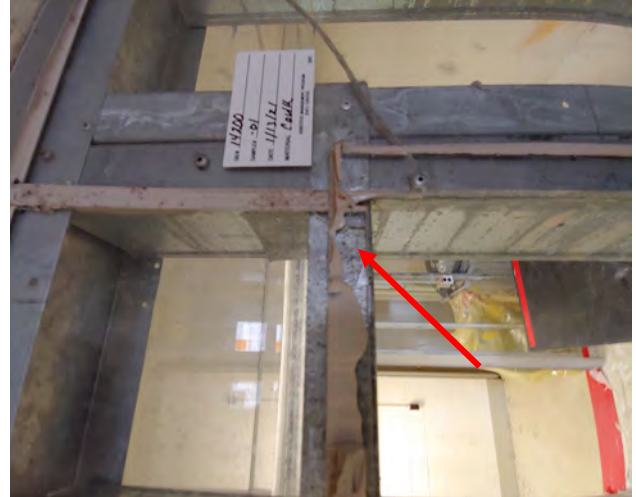
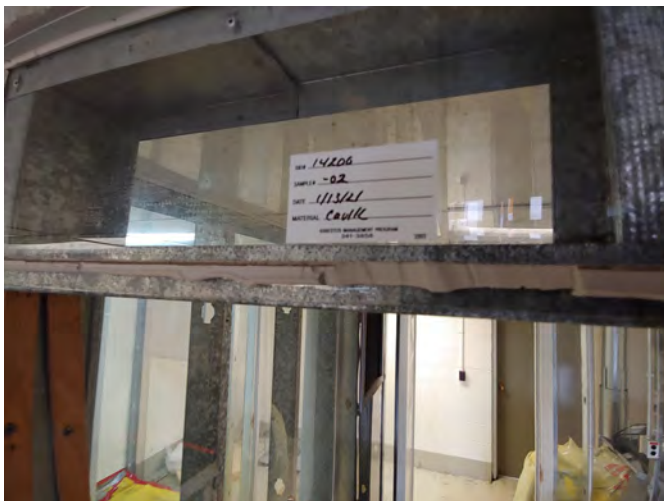
<b>HA Description</b>	GUNMETAL GRAY CAULK
	<b>Sample #</b>	<b>SID14200-01</b> <b>SID14200-02</b>
	<b>Sample Location / Orientation</b>	SID14200-01– Center enclosure, above door south side SID14200-02 – Center enclosure, above door north side
	<b>Sample/Inspection Results</b>	SID14200-01 – None Detected SID14200-02 – None Detected
	<b>Recommendation</b>	None

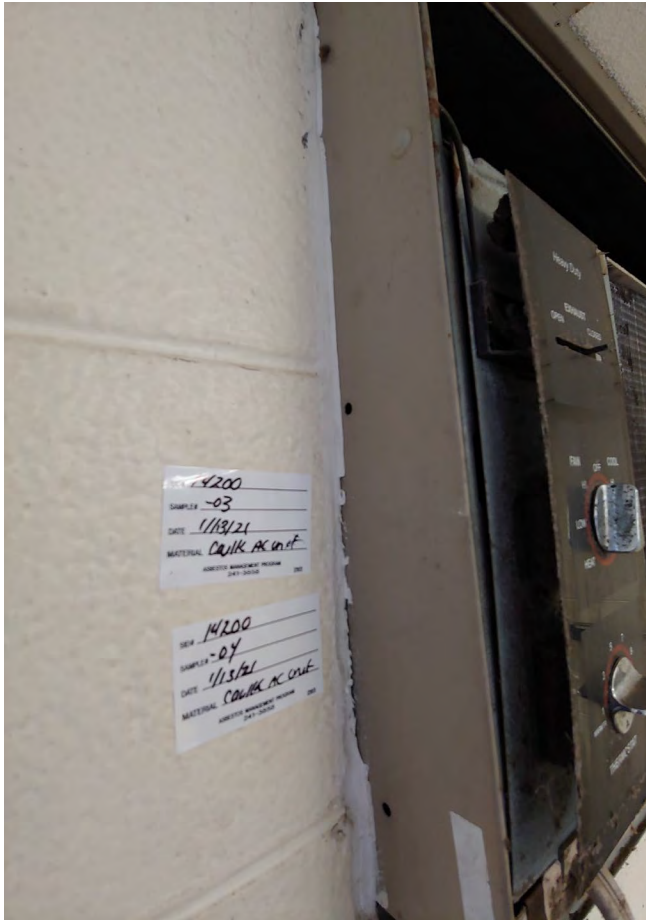
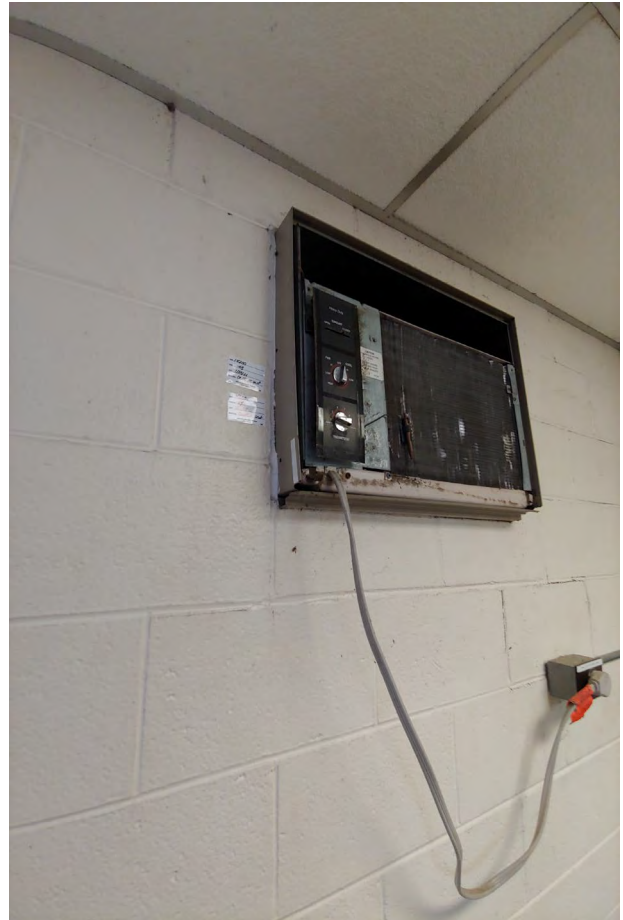
<b>HA Description</b>	WHITE CAULK AROUND AC UNIT
	<b>Sample #</b>	<b>SID14200-03</b> <b>SID14200-04</b>
	<b>Sample Location / Orientation</b>	SID14200-03– Interior west wall by door SID14200-04 – Interior west wall by door
	<b>Sample/Inspection Results</b>	SID14200-03 – None Detected SID14200-04 – None Detected
	<b>Recommendation</b>	None

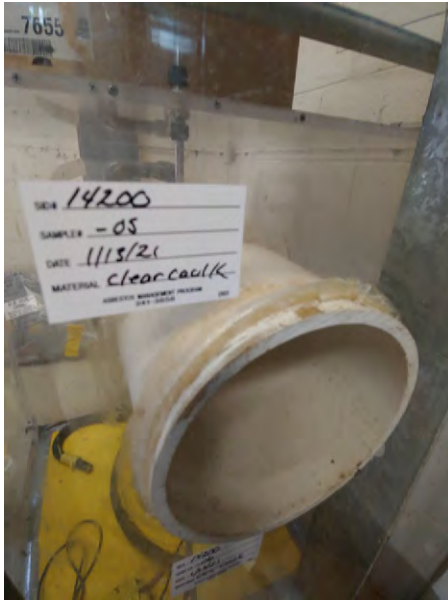
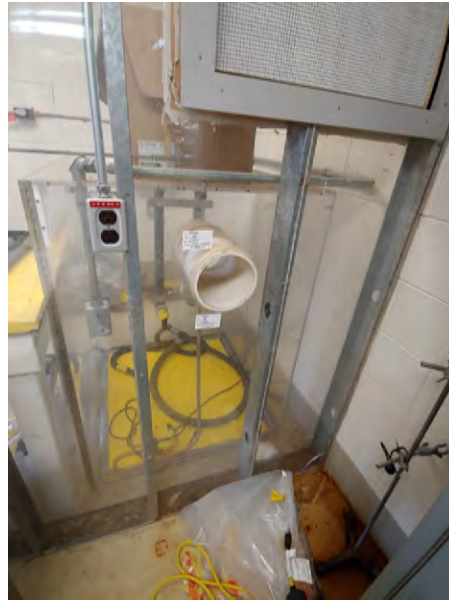
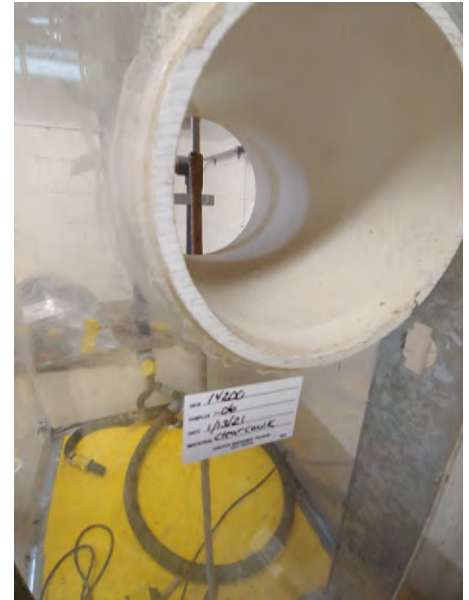
<b>HA Description</b>	CLEAR SILICONE CAULK
	<b>Sample #</b>	SID14200-05 SID14200-06
	<b>Sample Location / Orientation</b>	SID14200-05– West side of interior enclosure SID14200-06– West side of interior enclosure
	<b>Sample/Inspection Results</b>	SID14200-05 – None Detected SID14200-06 – None Detected
	<b>Recommendation</b>	None
