**Scope of Work and Specifications**

**CRSF Building Demolition**

**OAK RIDGE NATIONAL LABORATORY**

**March 2021**

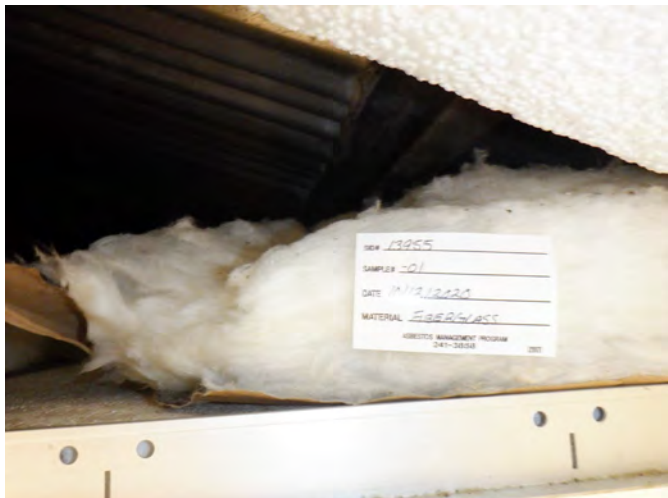
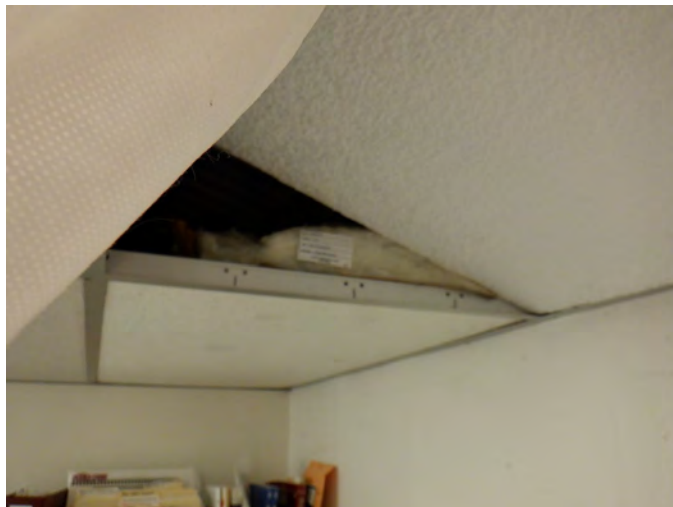
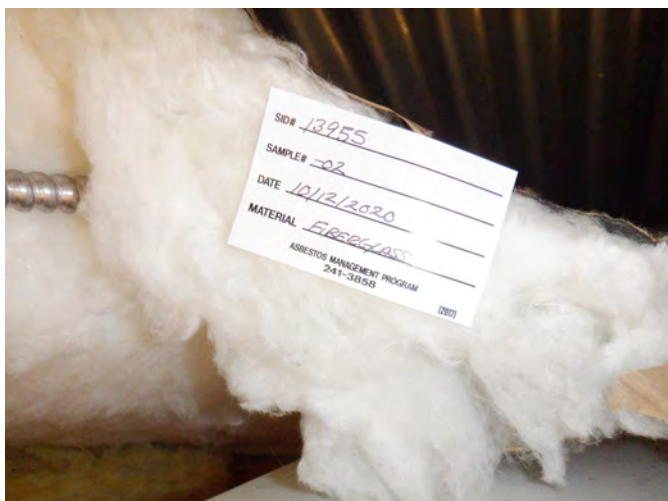
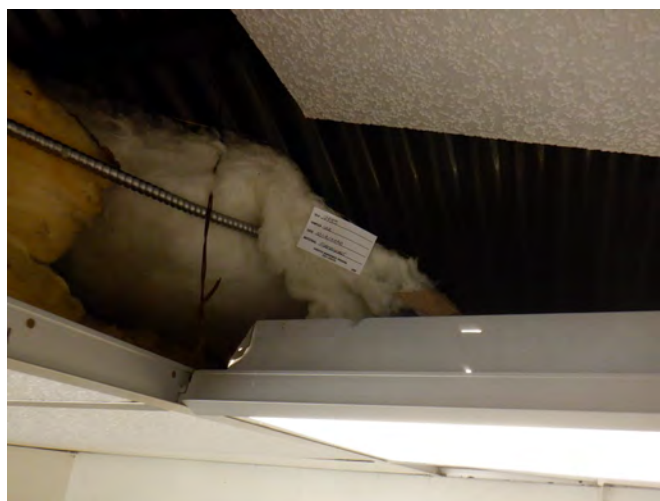
<b>HA Description</b>	WHITE FIBERGLASS INSULATION
	<b>Sample #</b>	<b>SID13955-01</b> <b>SID13955-02</b>
	<b>Sample Location / Orientation</b>	SID13955-01– Above ceiling, north side SID13955-02 – Above ceiling, north side
	<b>Sample/Inspection Results</b>	SID13955-01 – None Detected SID13955-02 – None Detected
	<b>Recommendation</b>	None

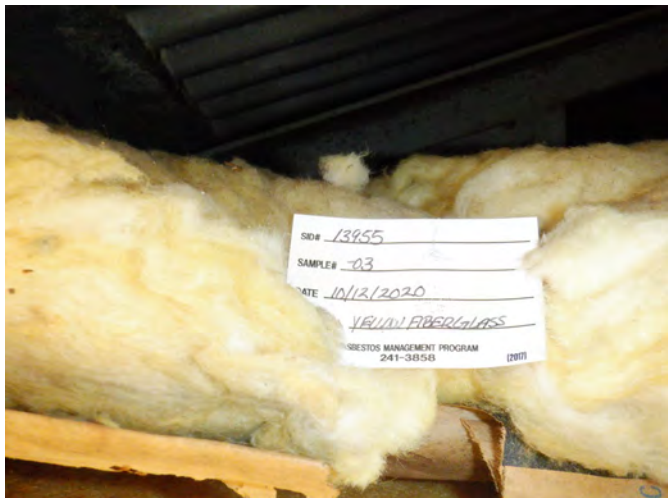
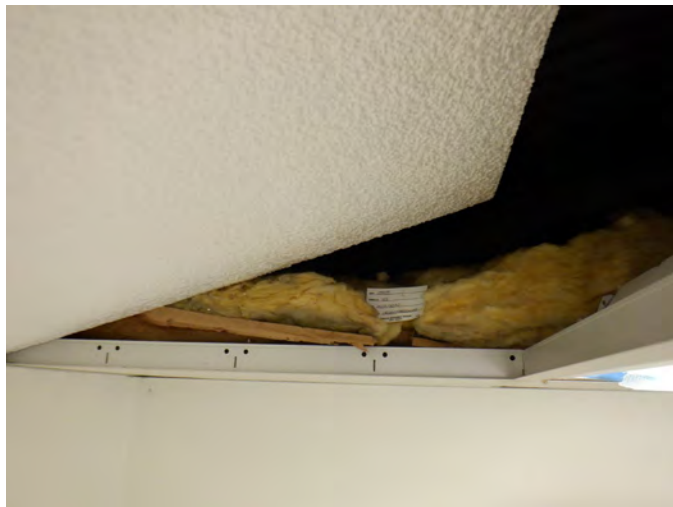
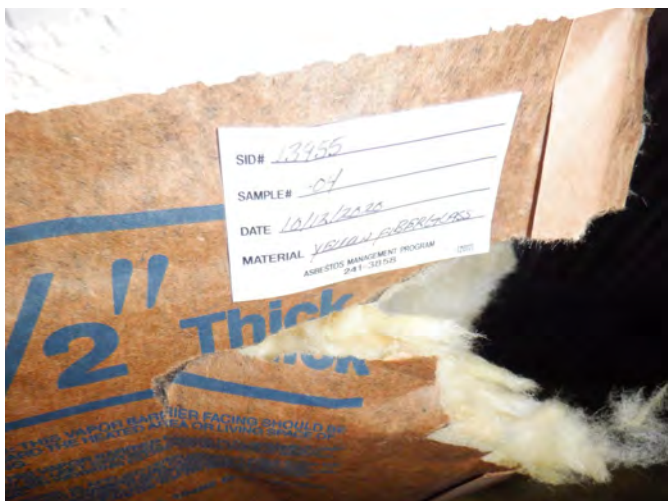
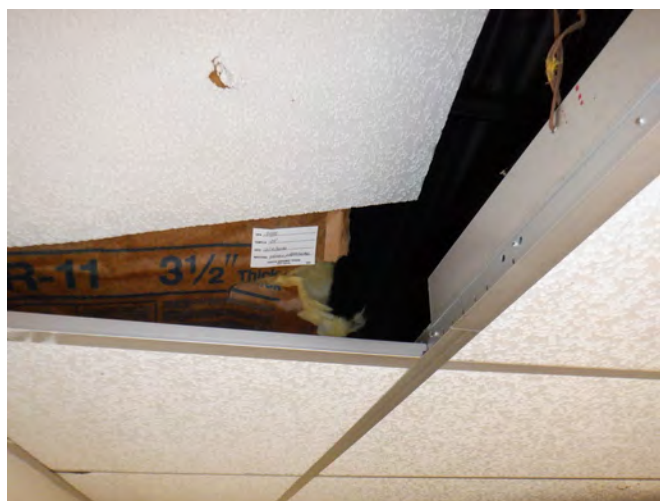
<b>HA Description</b>	YELLOW FIBERGLASS INSULATION
	<b>Sample #</b>	SID13955-03 SID13955-04
	<b>Sample Location / Orientation</b>	SID13955-03– Above ceiling, north side SID13955-04 – Above ceiling, west side
	<b>Sample/Inspection Results</b>	SID13955-03 – None Detected SID13955-04 – None Detected
	<b>Recommendation</b>	None

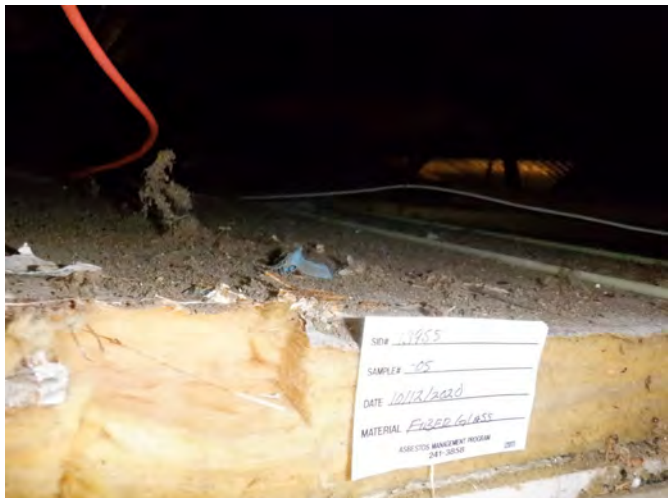
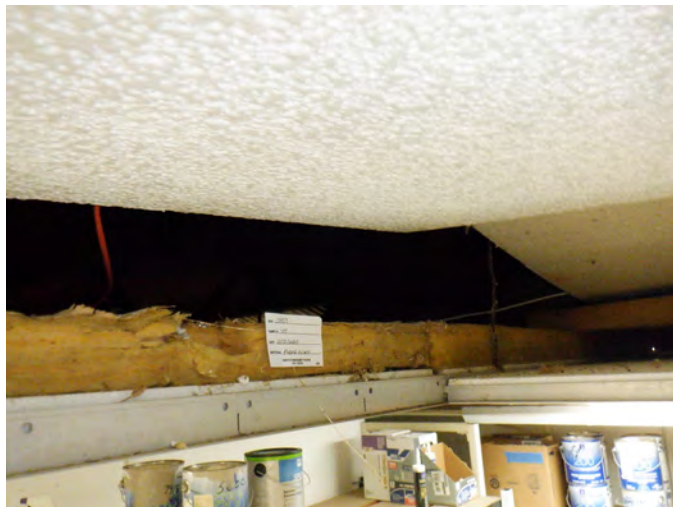
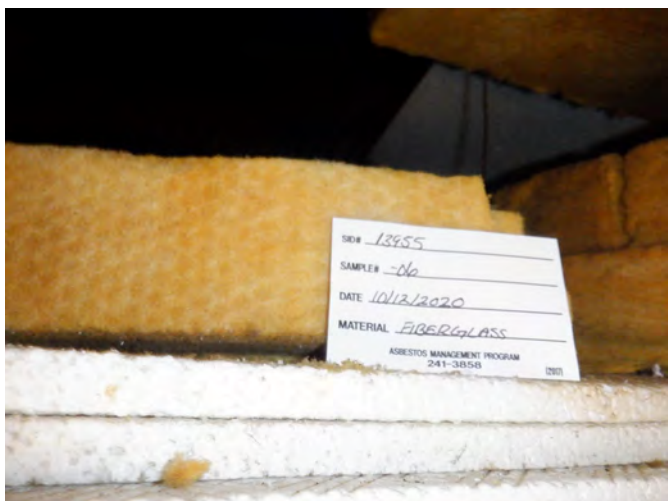
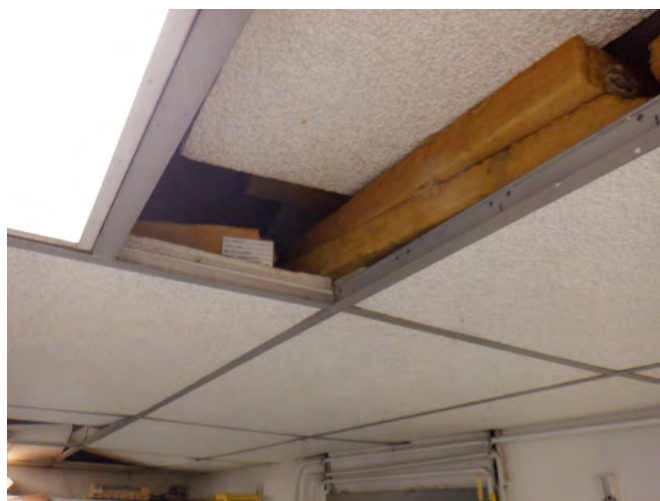
<b>HA Description</b>	YELLOW FIBERGLASS INSULATION W/ ALUMINUM BACKING
	<b>Sample #</b>	<b>SID13955-05</b> <b>SID13955-06</b>
	<b>Sample Location / Orientation</b>	SID13955-05– Above ceiling, east side SID13955-06 – Above ceiling, west side
	<b>Sample/Inspection Results</b>	SID13955-05 – None Detected SID13955-06 – None Detected
	<b>Recommendation</b>	None

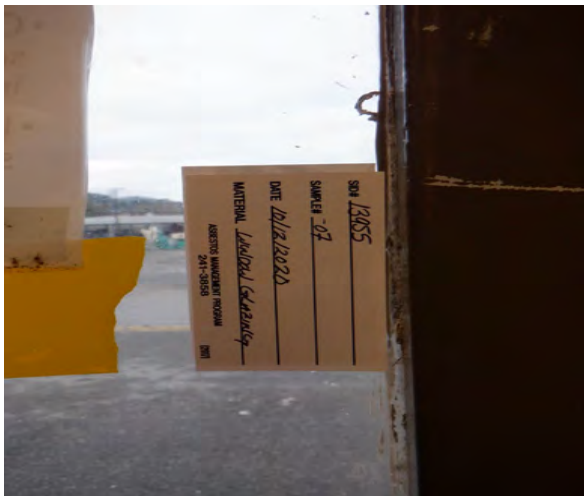
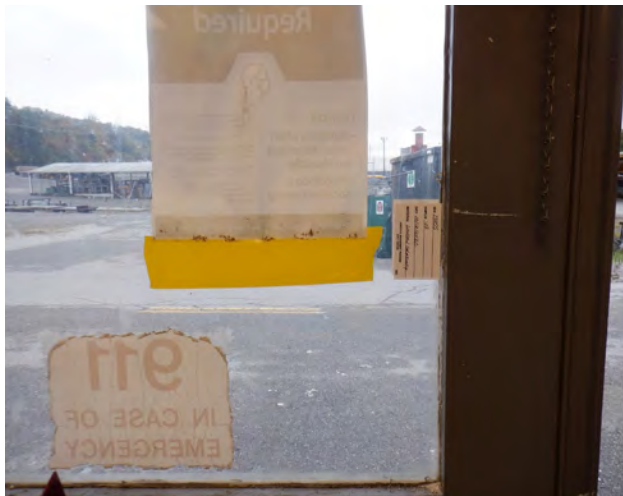
<b>HA Description</b>	WHITE WINDOW GLAZING
	<b>Sample #</b>	SID13955-07 SID13955-08
	<b>Sample Location / Orientation</b>	SID13955-07– Interior door, west side SID13955-08 – Exterior door, west side.
	<b>Sample/Inspection Results</b>	SID13955-07 – None Detected SID13955-08 – None Detected
	<b>Recommendation</b>	None

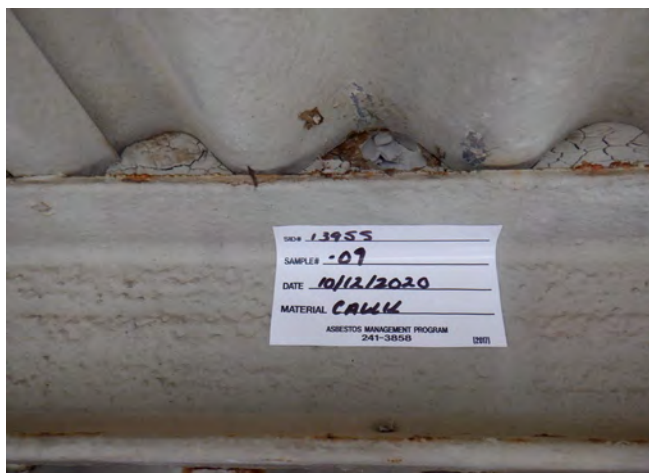
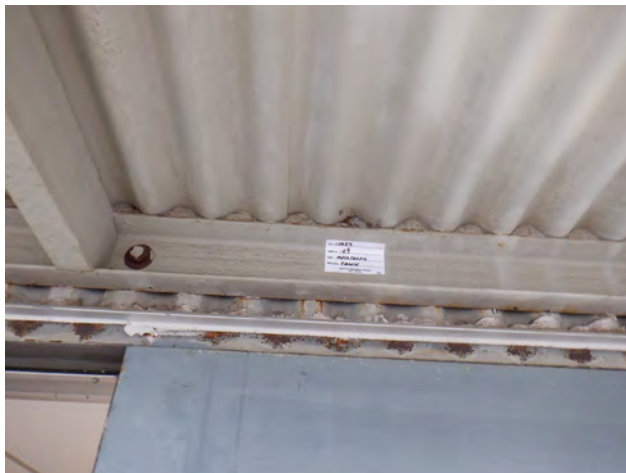
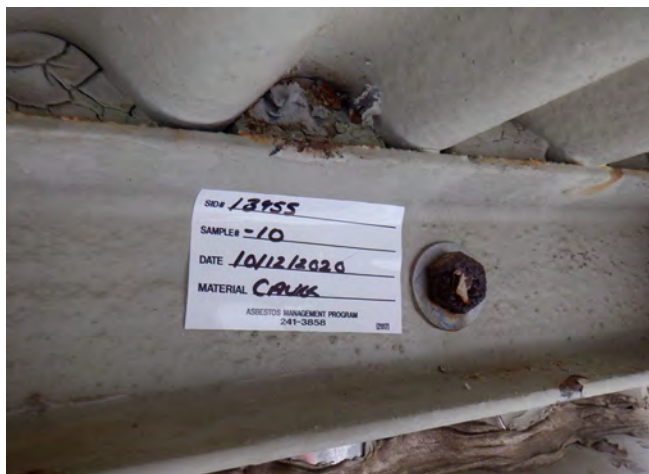
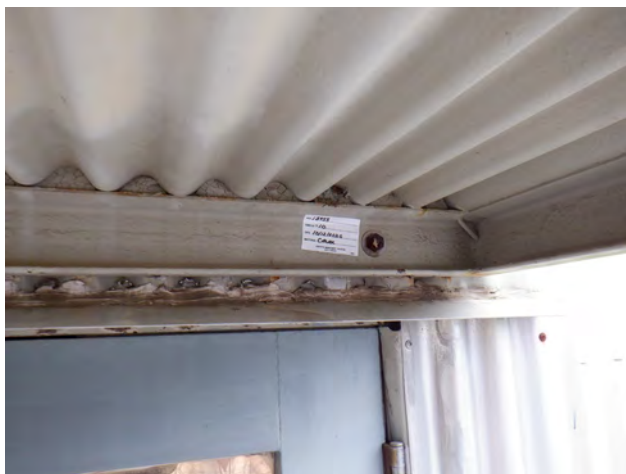
<b>HA Description</b>	GRAY CAULKING
	<b>Sample #</b>	<b>SID13955-09</b> <b>SID13955-10</b>
	<b>Sample Location / Orientation</b>	SID13955-09– Over door, west side SID13955-10 – Over door, west side
	<b>Sample/Inspection Results</b>	SID13955-09 – None Detected SID13955-10 – None Detected
	<b>Recommendation</b>	None

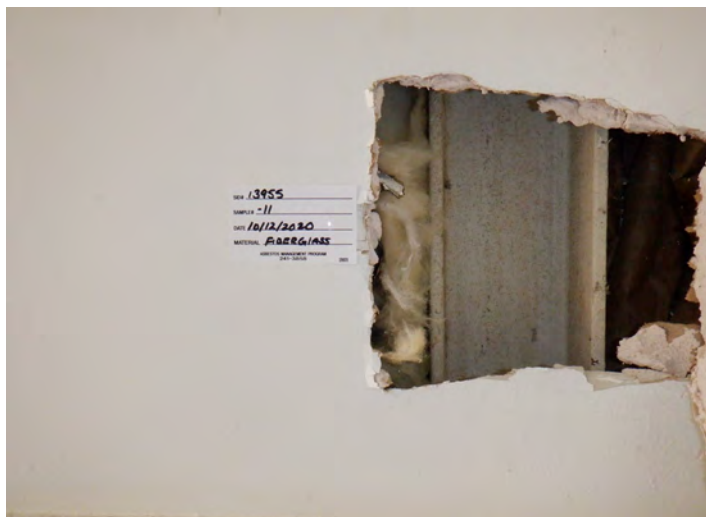
<b>HA Description</b>	WHITE FIBERGLASS INSULATION W/ ALUMINUM BACKING
	<b>Sample #</b>	SID13955-11
	<b>Sample Location / Orientation</b>	SID13955-11– Inside north facing wall.
	<b>Sample/Inspection Results</b>	SID13955-11 – None Detected
	<b>Recommendation</b>	None

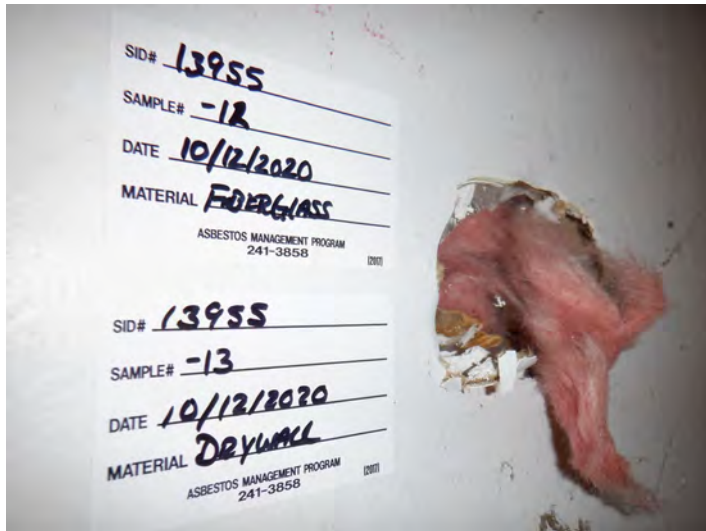
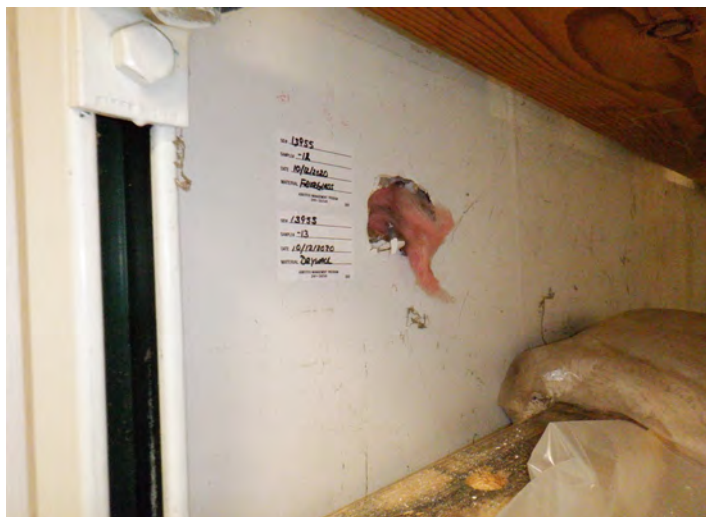
<b>HA Description</b>	PINK FIBERGLASS INSULATION W/ ALUMINUM BACKING
	<b>Sample #</b>	SID13955-12
	<b>Sample Location / Orientation</b>	SID13955-12– Inside dividing wall of east room.
	<b>Sample/Inspection Results</b>	SID13955-12 – None Detected
	<b>Recommendation</b>	None

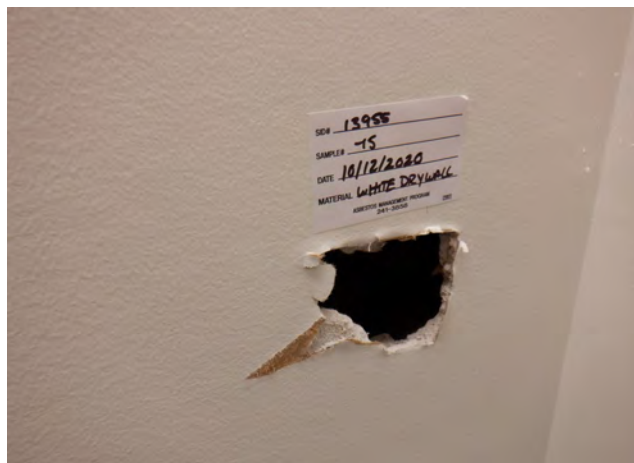
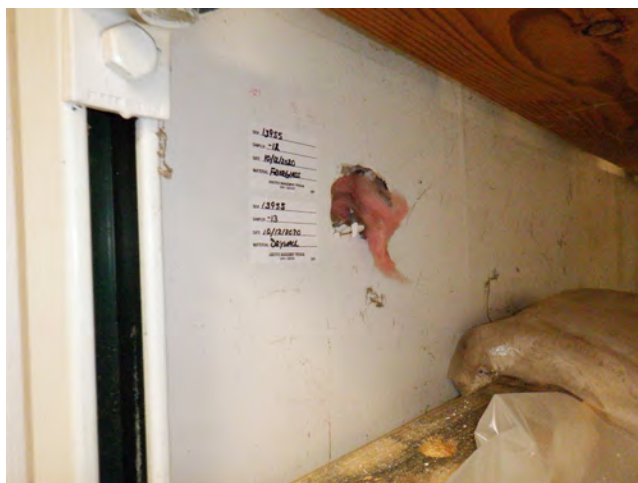
<b>HA Description</b>	WHITE DRYWALL
	<b>Sample #</b>	SID13955-13 SID13955-15
	<b>Sample Location / Orientation</b>	SID13955-13– Inside dividing wall of east room SID13955-15 – Interior wall of northwest side
	<b>Sample/Inspection Results</b>	SID13955-13 – None Detected SID13955-15 – None Detected
	<b>Recommendation</b>	None

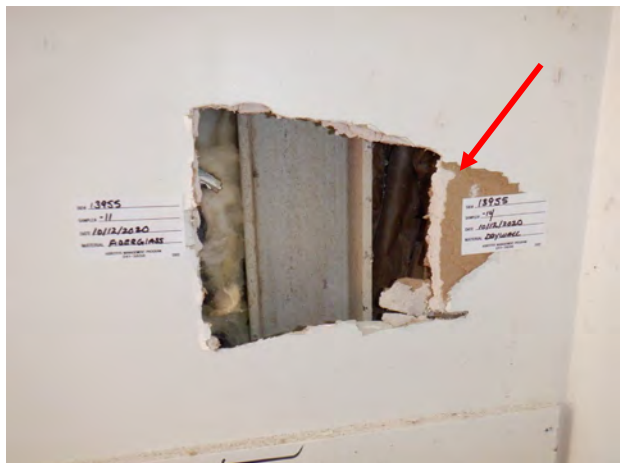
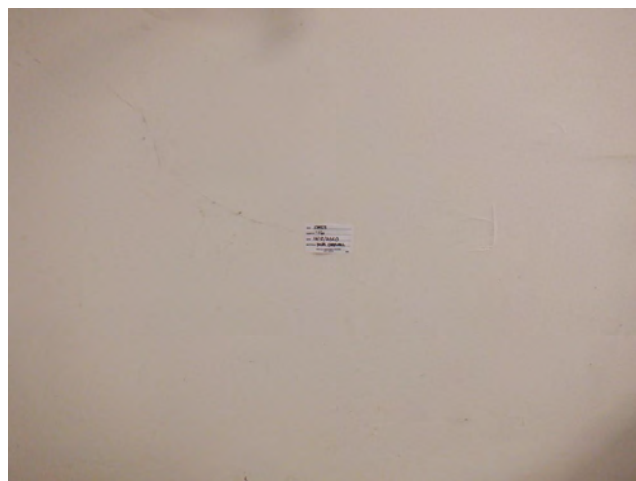
<b>HA Description</b>	PINK DRYWALL
	<b>Sample #</b>	SID13955-14 SID13955-16
	<b>Sample Location / Orientation</b>	SID13955-14 – North wall SID13955-16 – West wall by door.
	<b>Sample/Inspection Results</b>	SID13955-14 – None Detected SID13955-16 – None Detected
	<b>Recommendation</b>	None

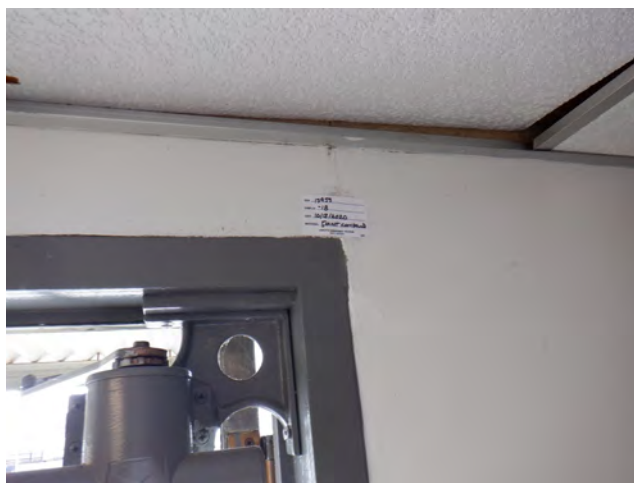
<b>HA Description</b>	JOINT COMPOUND ASSOCIATED W/ PINK DRYWALL
	<b>Sample #</b>	SID13955-17 SID13955-18
	<b>Sample Location / Orientation</b>	SID13955-17 – West wall by door SID13955-18 – Northwest wall over door
	<b>Sample/Inspection Results</b>	SID13955-17 – None Detected SID13955-18 – None Detected
	<b>Recommendation</b>	None

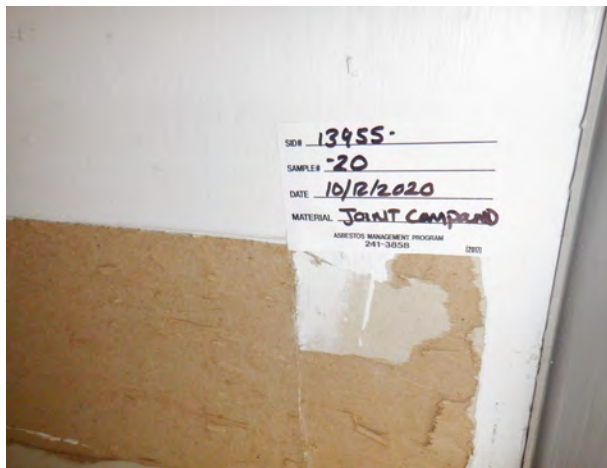
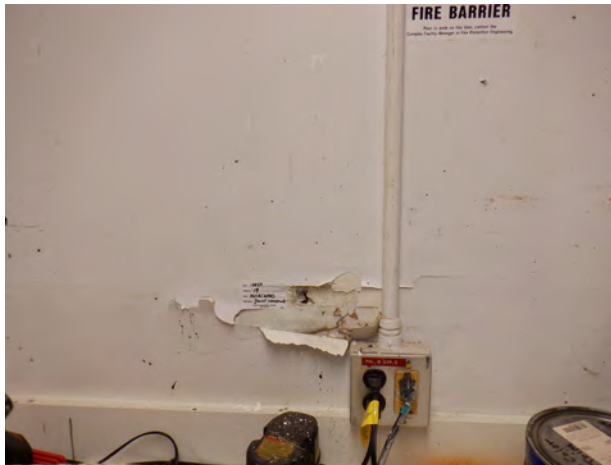
<b>HA Description</b>	JOINT COMPOUND ASSOCIATED W/ WHITE DRYWALL
	<b>Sample #</b>	SID13955-19 SID13955-20
	<b>Sample Location / Orientation</b>	SID13955-19 – South wall, east room SID13955-20 – East dividing wall
	<b>Sample/Inspection Results</b>	SID13955-19 – None Detected SID13955-20 – None Detected
	<b>Recommendation</b>	None

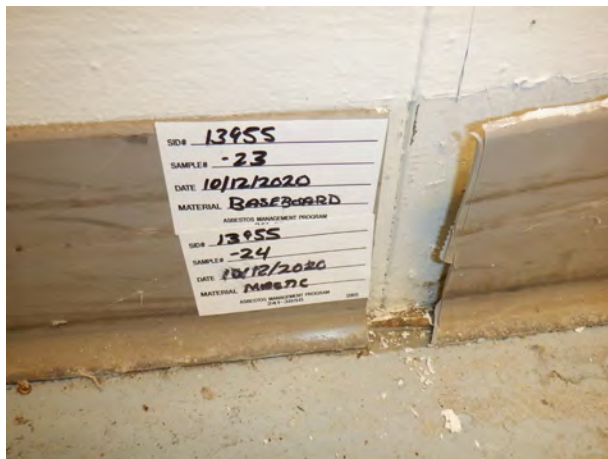
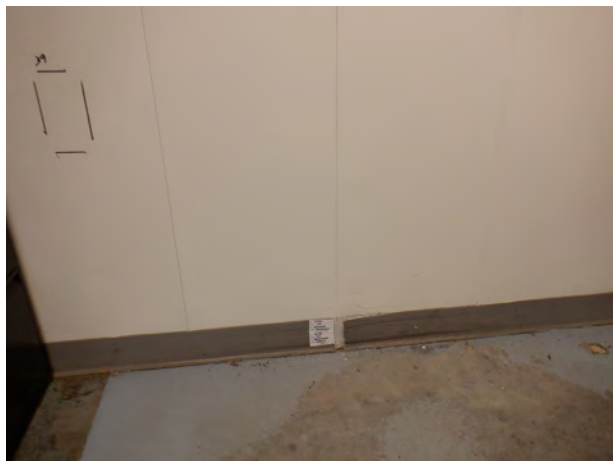
<b>HA Description</b>	GRAY BASEBOARD
	<b>Sample #</b>	SID13955-21 SID13955-23
	<b>Sample Location / Orientation</b>	SID13955-21 – North dividing wall SID13955-23 – North facing wall
	<b>Sample/Inspection Results</b>	SID13955-21 – None Detected SID13955-23 – None Detected
	<b>Recommendation</b>	None

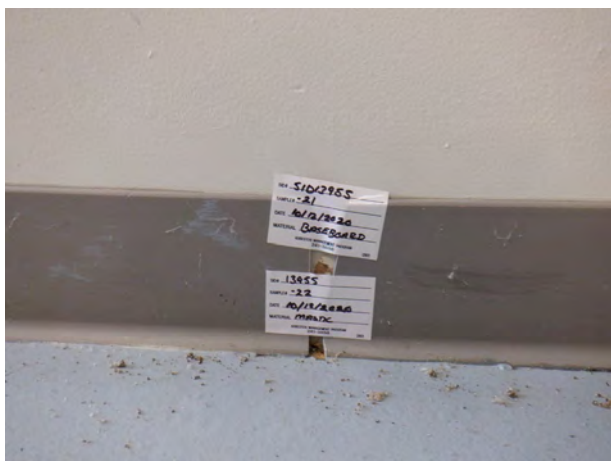
<b>HA Description</b>	MASTIC ASSOCIATED W/ GRAY BASEBOARD
	<b>Sample #</b>	SID13955-22 SID13955-24
	<b>Sample Location / Orientation</b>	SID13955-22 – North dividing wall SID13955-24 – North facing wall
	<b>Sample/Inspection Results</b>	SID13955-22 – None Detected SID13955-24 – None Detected
	<b>Recommendation</b>	None

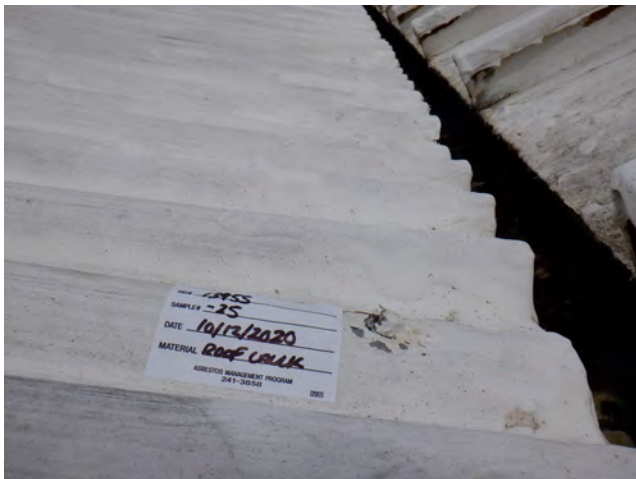
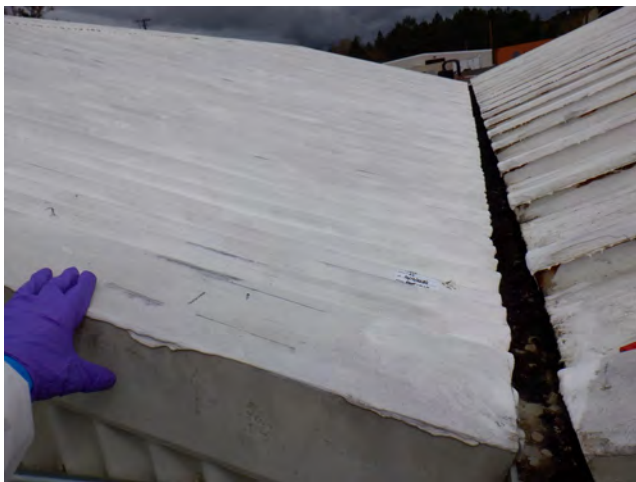
<b>HA Description</b>	WHITE ROOF CAULKING/Coating
	<b>Sample #</b>	<b>SID13955-25</b>
	<b>Sample Location / Orientation</b>	SID13955-25 – South side exterior
	<b>Sample/Inspection Results</b>	SID13955-25 – None Detected
	<b>Recommendation</b>	None

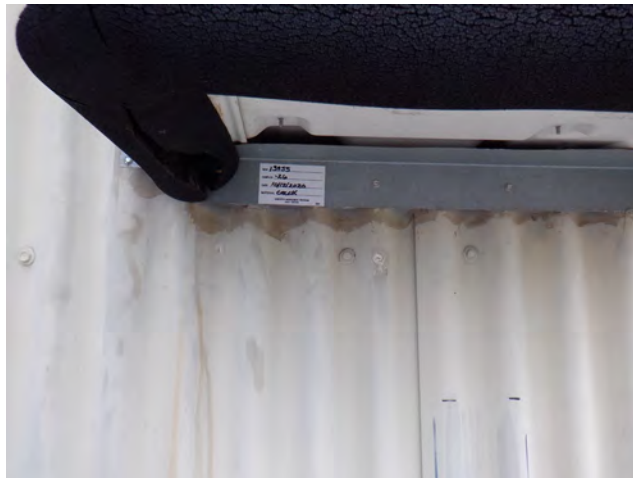
<b>HA Description</b>	GRAY CAULK
	<b>Sample #</b>	<b>SID13955-26</b>
	<b>Sample Location / Orientation</b>	SID13955-26 – Around west side AC unit
	<b>Sample/Inspection Results</b>	SID13955-26 – None Detected
	<b>Recommendation</b>	None

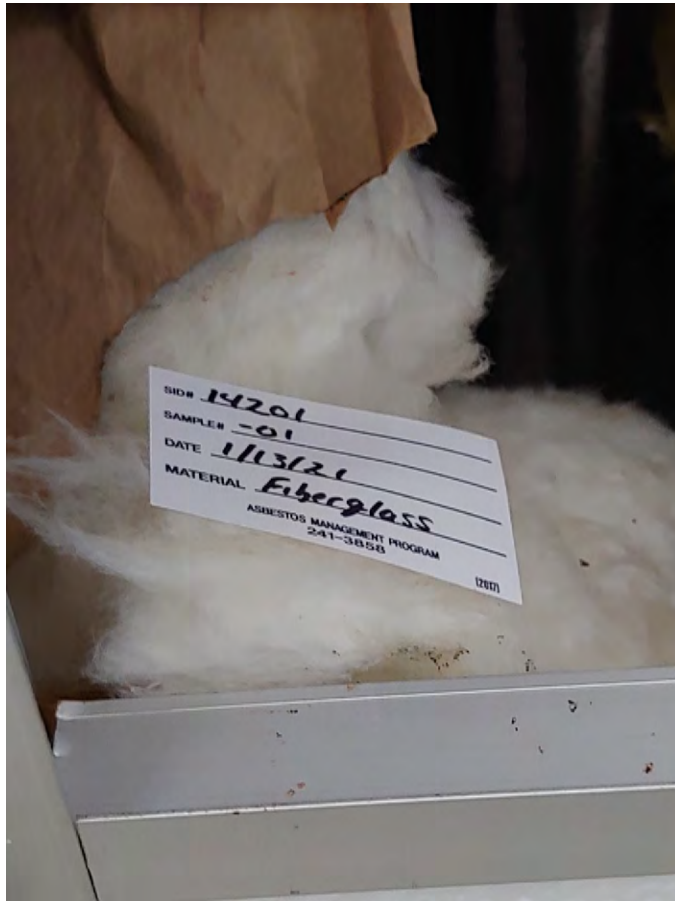
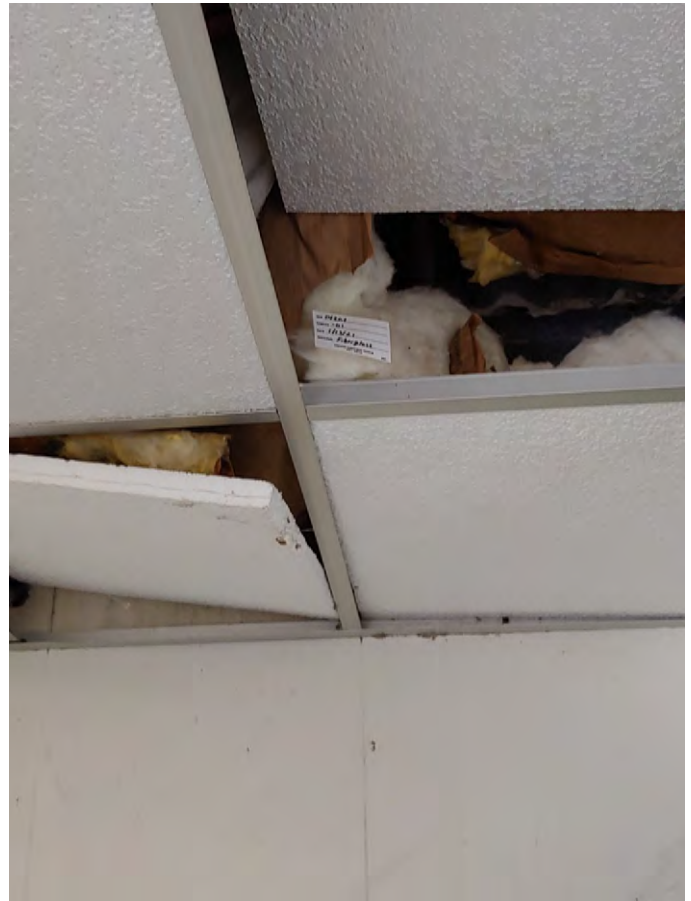
<b>HA-01</b>	<b>HA Description</b>	WHITE FIBERGLASS INSULATION
	<b>Sample #</b>	<b>SID14201-01</b>
	<b>Sample Location / Orientation</b>	SID14201-01– Northwest corner above ceiling of 7035A
	<b>Sample/Inspection Results</b>	SID14201-01 – None Detected
	<b>Recommendation</b>	None

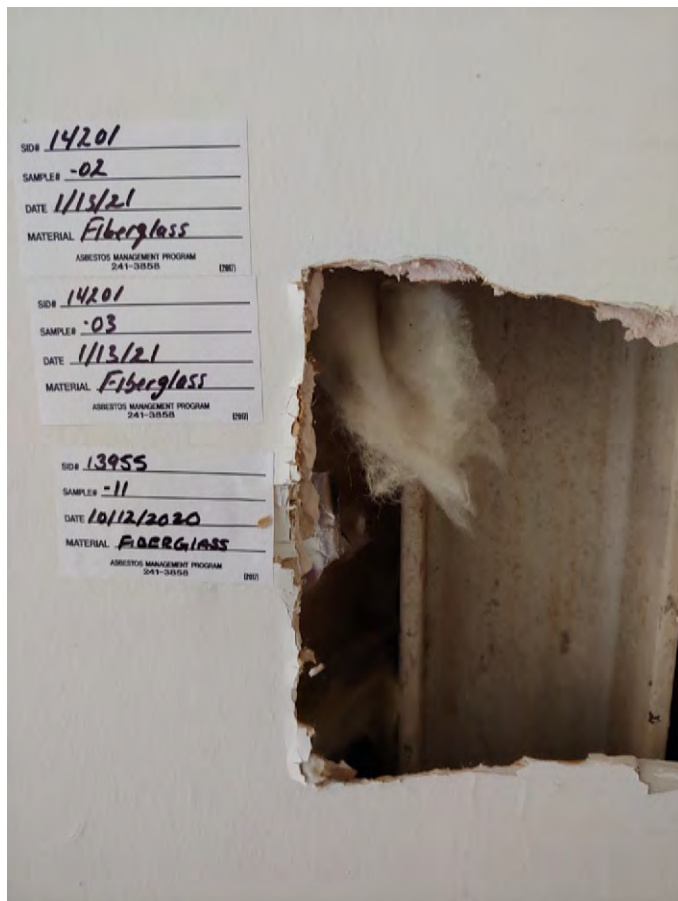
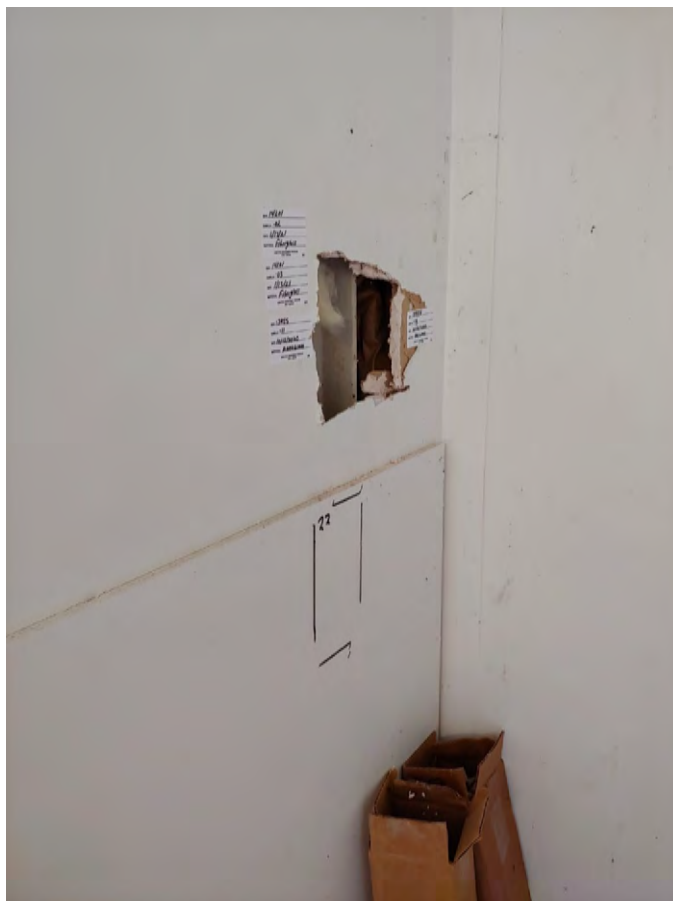
<b>HA-06</b>	<b>HA Description</b>	WHITE FIBERGLASS INSULATION W/ ALUMINUM BACKING
	<b>Sample #</b>	SID14201-02 SID14201-03
	<b>Sample Location / Orientation</b>	SID14201-02– Northwest Wall of 7035A SID14201-03 – Northwest Wall of 7035A
	<b>Sample/Inspection Results</b>	SID14201-02 – None Detected SID14201-03 -- None Detected
	<b>Recommendation</b>	None

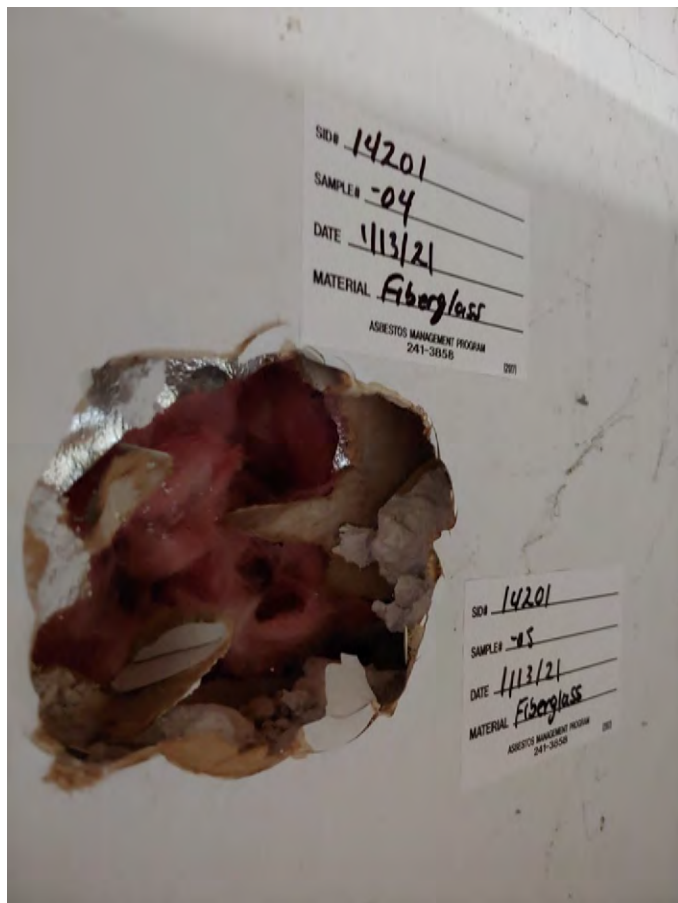
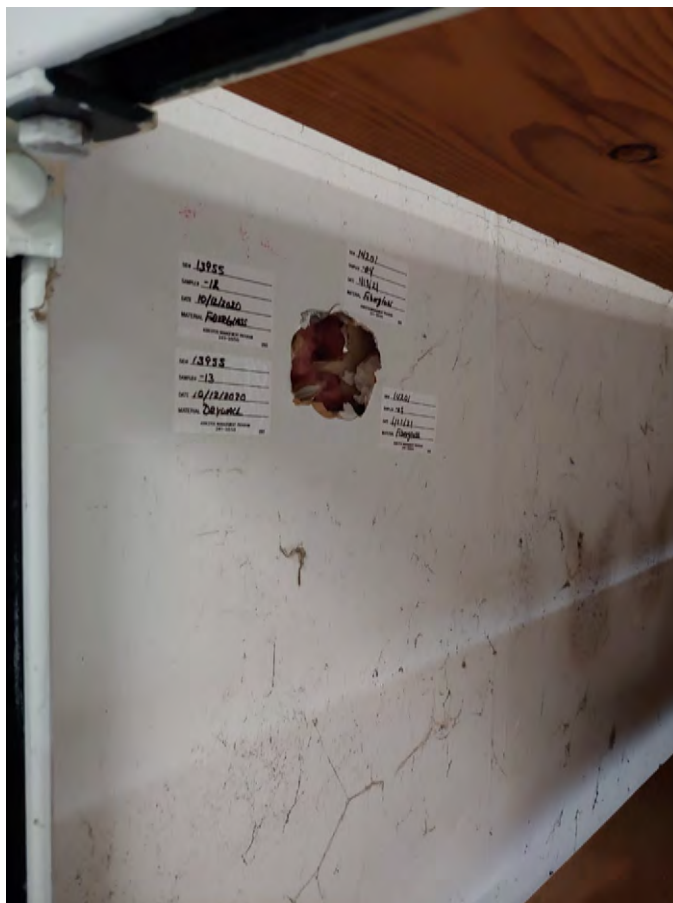
<b>HA-07</b>	<b>HA Description</b>	PINK FIBERGLASS INSULATION W/ ALUMINUM BACKING
	<b>Sample #</b>	SID14201-04 SID14201-05
	<b>Sample Location / Orientation</b>	SID14201-04– Interior wall, east side of 7035A SID14201-05 – Interior wall, east side of 7035A
	<b>Sample/Inspection Results</b>	SID14201-04 – None Detected SID14201-05 -- None Detected
	<b>Recommendation</b>	None

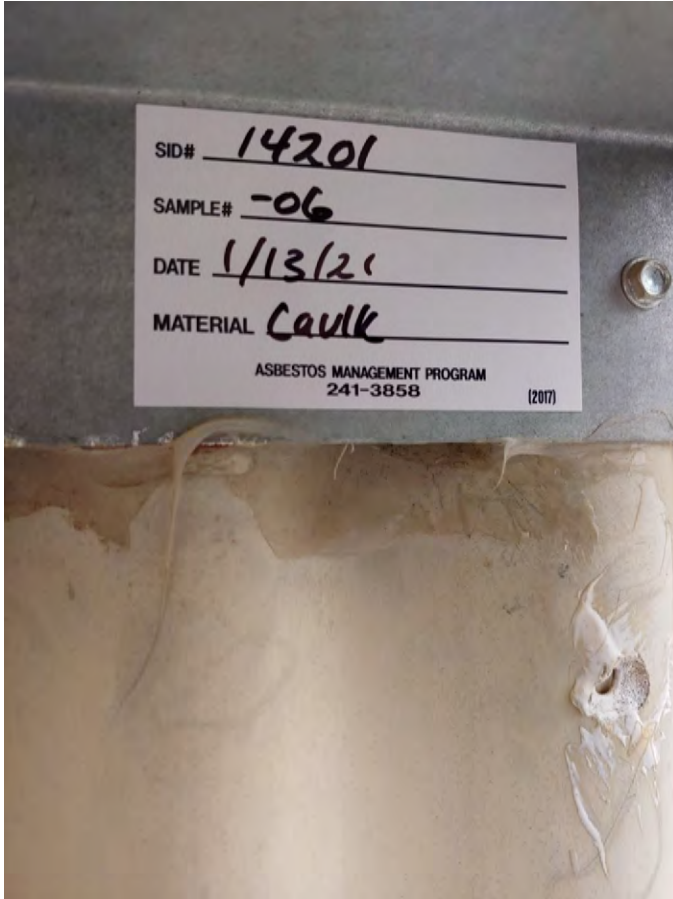
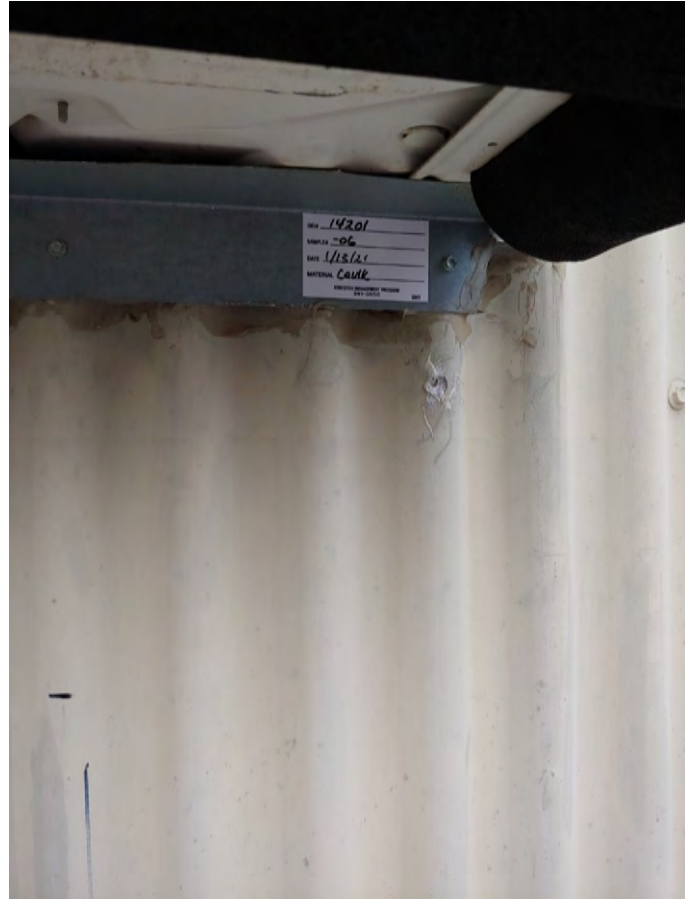
<b>HA-15</b>	<b>HA Description</b>	GRAY CAULK AROUND AC UNIT
	<b>Sample #</b>	<b>SID14201-06</b>
	<b>Sample Location / Orientation</b>	SID14201-06– West side exterior of 7035A
	<b>Sample/Inspection Results</b>	SID14201-06 – None Detected
	<b>Recommendation</b>	None

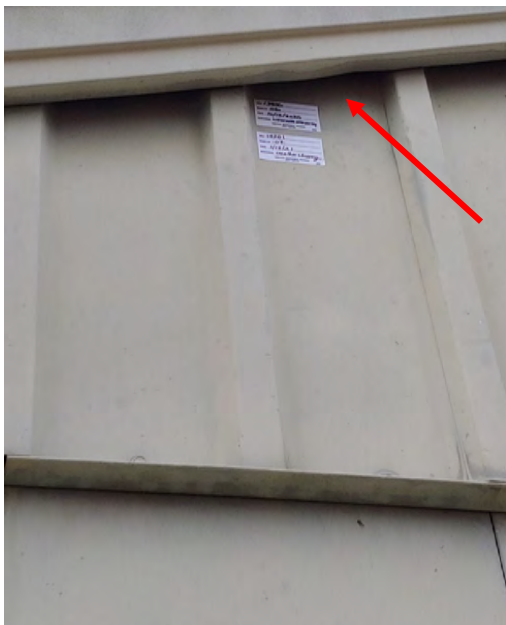
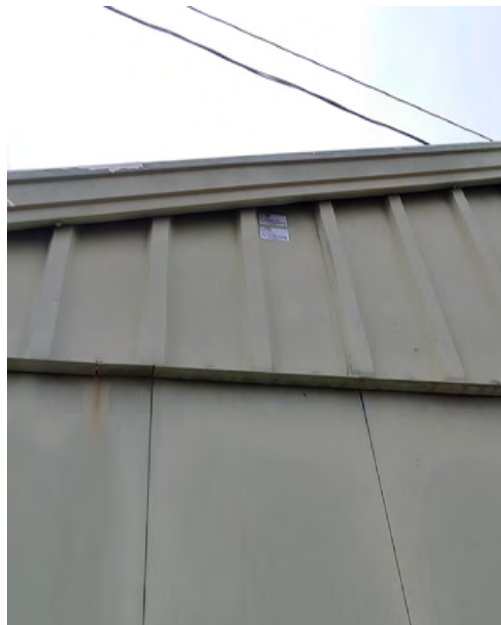
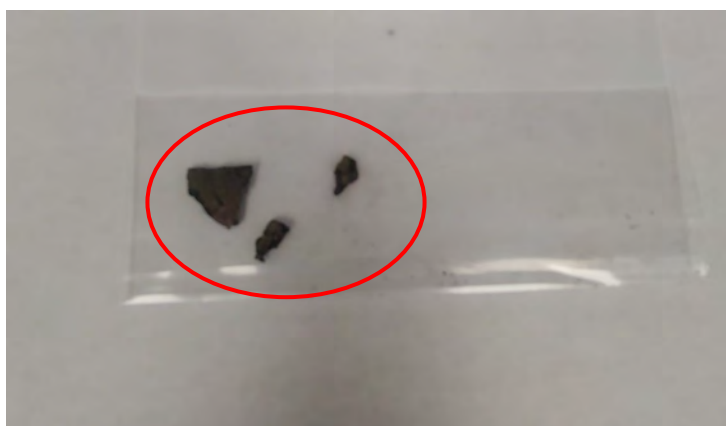
<b>HA-17</b>	<b>HA Description</b>	BLACK WEATHER STRIPPING
	<b>Sample #</b>	<b>SID14201-07</b>
	<b>Sample Location / Orientation</b>	SID14201-07– Southeast corner of 7035B exterior
	<b>Sample/Inspection Results</b>	SID14201-07 – None Detected
	<b>Recommendation</b>	None

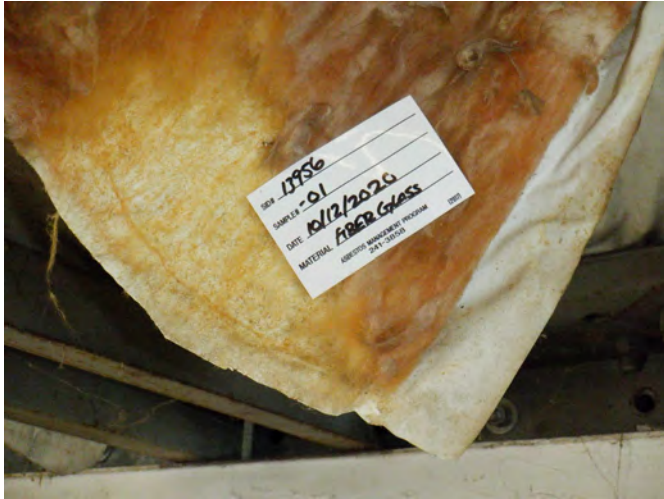
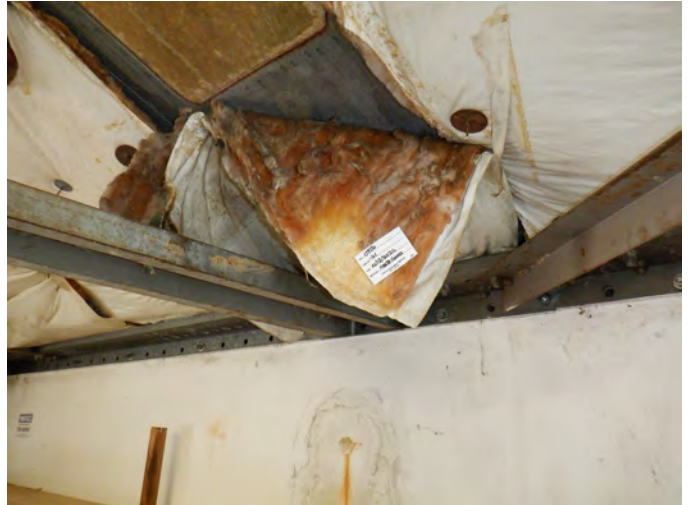
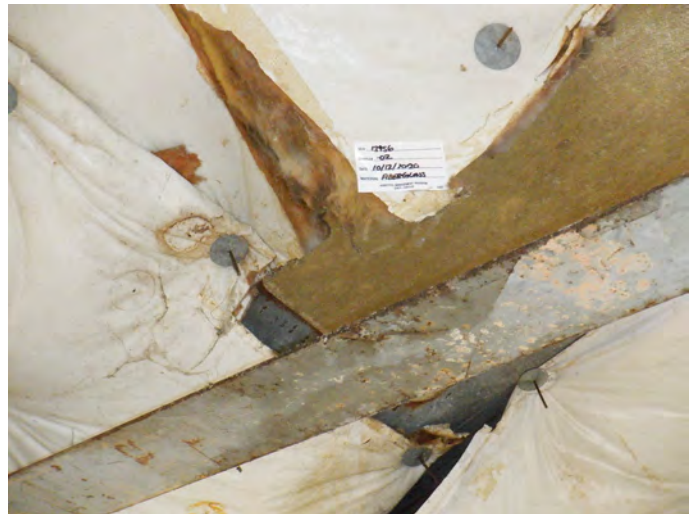
<b>HA Description</b>	YELLOW FIBERGLASS INSULATION CEILING
	<b>Sample #</b>	SID13956-01 SID13956-02
	<b>Sample Location / Orientation</b>	SID13956-01 – South side of building SID13956-02 – North side of building
	<b>Sample/Inspection Results</b>	SID13956-01 – None Detected SID13956-02 – None Detected
	<b>Recommendation</b>	None

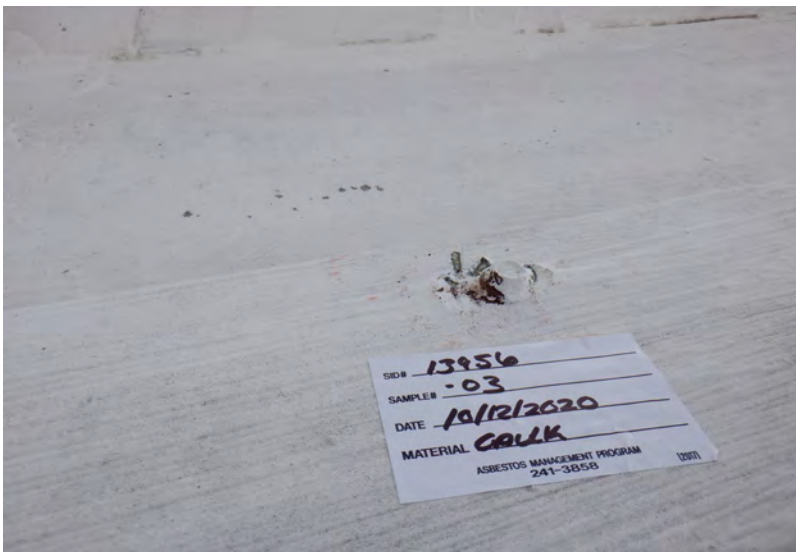
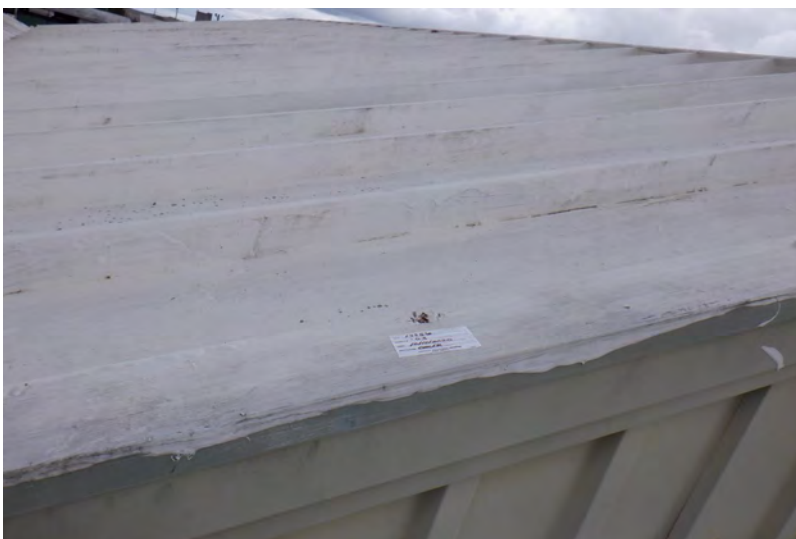
<b>HA Description</b>	WHITE ROOF CAULKING/Coating
	<b>Sample #</b>	<b>SID13956-03</b>
	<b>Sample Location / Orientation</b>	SID13956-03 – East side exterior
	<b>Sample/Inspection Results</b>	SID13956-03 – None Detected
	<b>Recommendation</b>	None

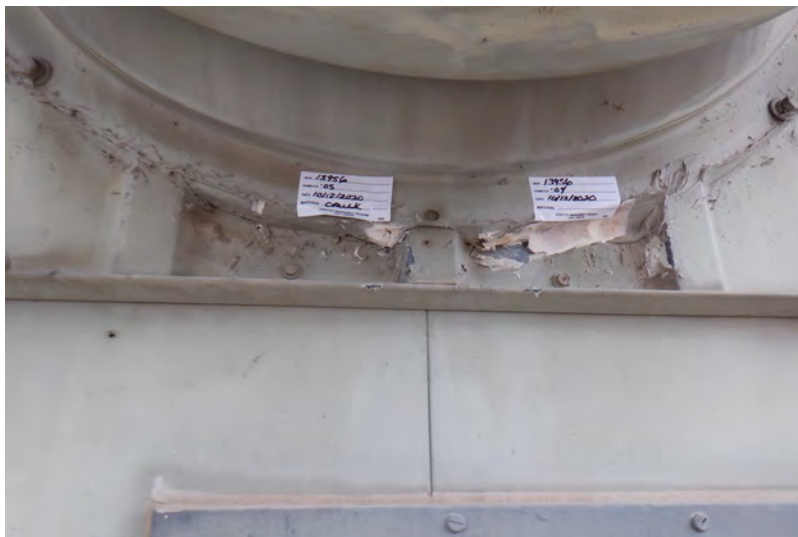
<b>HA Description</b>	GRAY CAULK/TAPE
	<b>Sample #</b>	<b>SID13956-04</b> <b>SID13956-05</b>
	<b>Sample Location / Orientation</b>	SID13956-04 – Base of fan, east side exterior SID13956-05 – Base of fan, east side exterior
	<b>Sample/Inspection Results</b>	SID13956-04 – None Detected SID13956-05 -- None Detected
	<b>Recommendation</b>	None

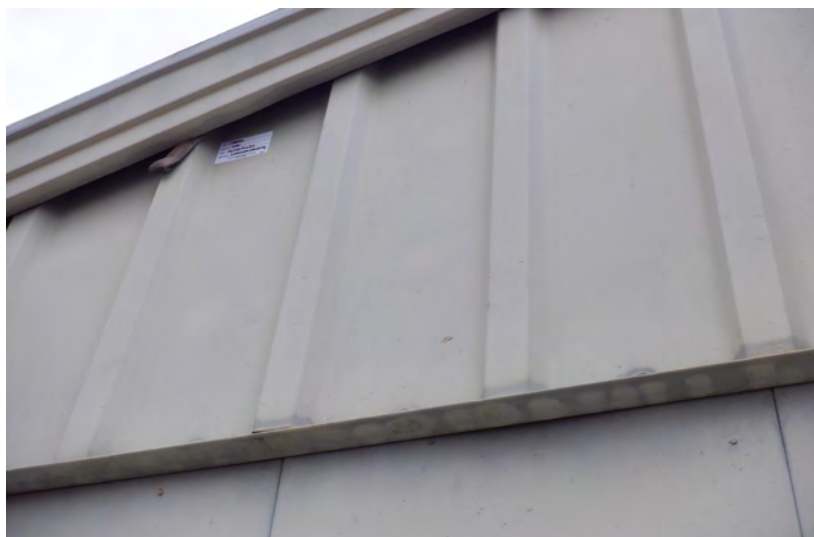
<b>HA Description</b>	BLACK WEATHER STRIPPING
	<b>Sample #</b>	SID13956-06
	<b>Sample Location / Orientation</b>	SID13956-06 – East side exterior
	<b>Sample/Inspection Results</b>	SID13956-06 – None Detected
	<b>Recommendation</b>	None

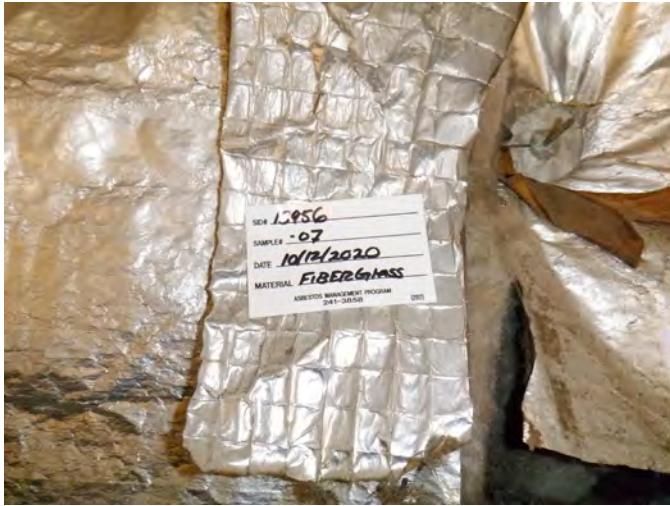
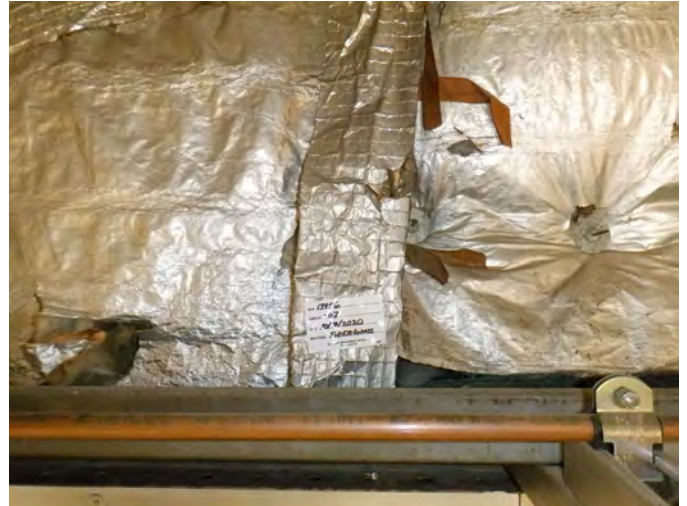
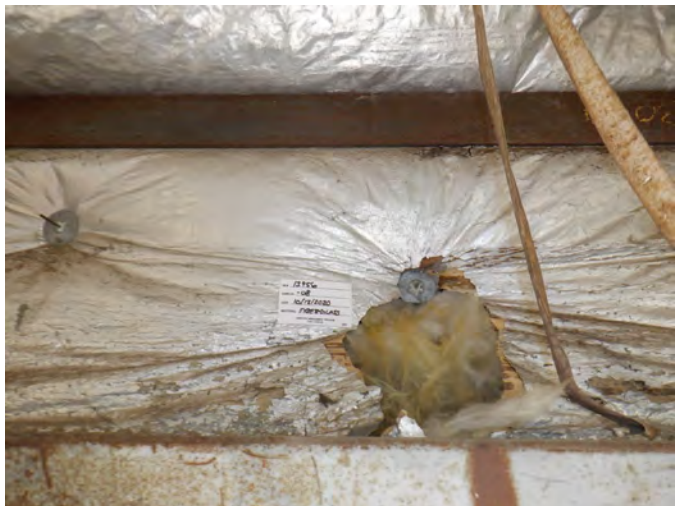
<b>HA Description</b>	YELLOW FIBERGLASS INSULATION WITH ALUMINIUM BACKING
	<b>Sample #</b>	<b>SID13956-07</b> <b>SID13956-08</b>
	<b>Sample Location / Orientation</b>	SID13956-07 – East side wall over door. SID13956-08 – West side wall over door.
	<b>Sample/Inspection Results</b>	SID13956-07 – None Detected SID13956-08 -- None Detected
	<b>Recommendation</b>	None
