**Scope of Work and Specifications**

**CRSF Building Demolition**

**OAK RIDGE NATIONAL LABORATORY**

**March 2021**

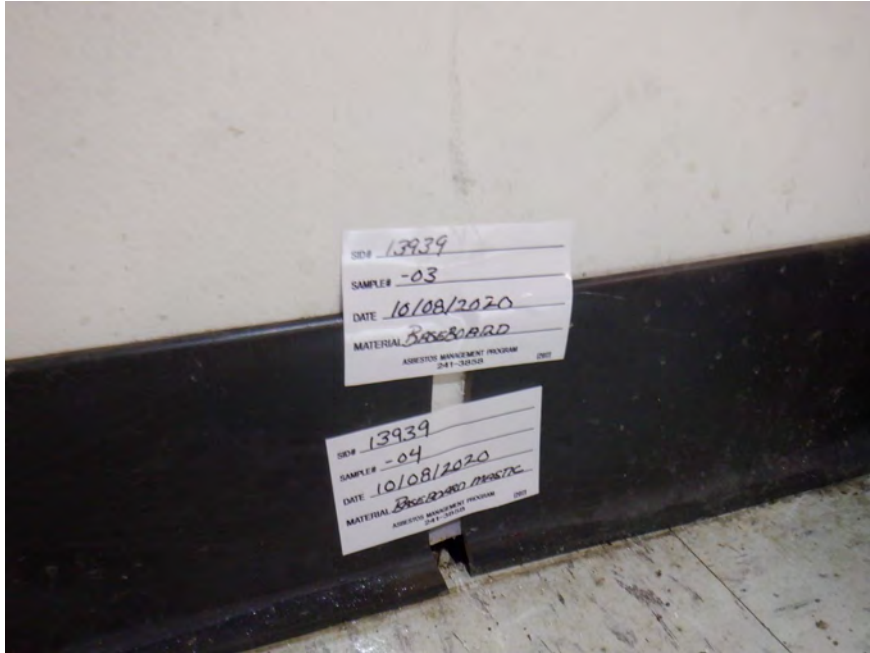
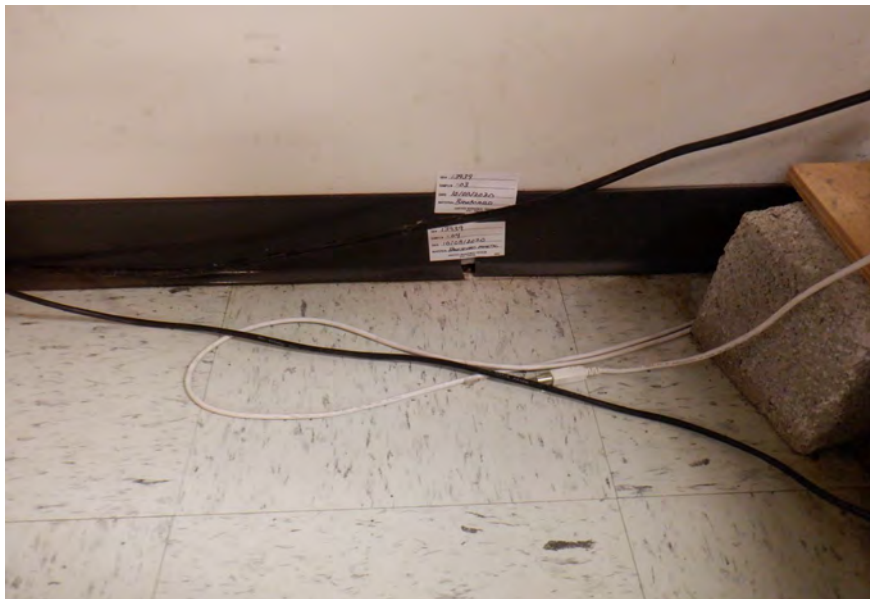
<b>HA Description</b>	<b>Black baseboard</b>
	<b>Sample #</b>	<b>SID13939-03</b>
	<b>Sample Location / Orientation</b>	<b>North wall</b>
	<b>Sample/Inspection Results</b>	<b>SID13939-03 – None Detected</b>
	<b>Recommendation</b>	<b>None</b>

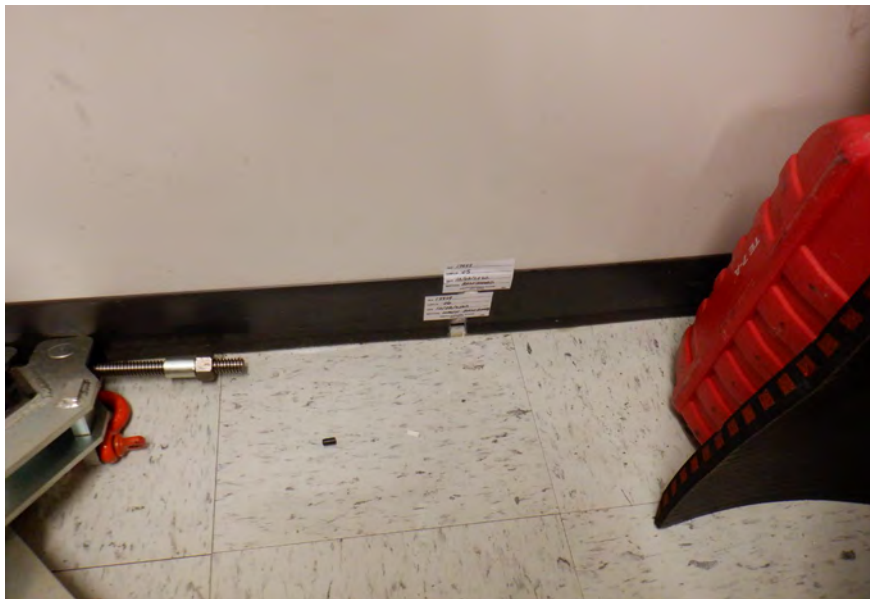
<b>HA Description</b>	Black baseboard
	<b>Sample #</b>	SID13939-05
	<b>Sample Location / Orientation</b>	North wall
	<b>Sample/Inspection Results</b>	SID13939-05 – None Detected
	<b>Recommendation</b>	None

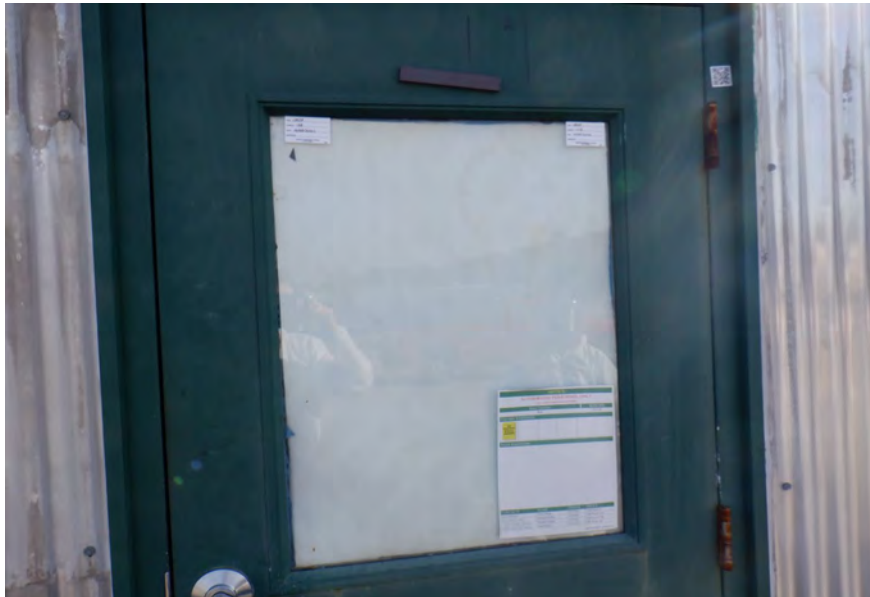
<b>HA Description</b>	<b>Black window caulk</b>
	<b>Sample #</b>	<b>SID13939-07</b>
	<b>Sample Location / Orientation</b>	<b>Outside west facing door.</b>
	<b>Sample/Inspection Results</b>	<b>SID13939-07 – None Detected</b>
	<b>Recommendation</b>	<b>None</b>

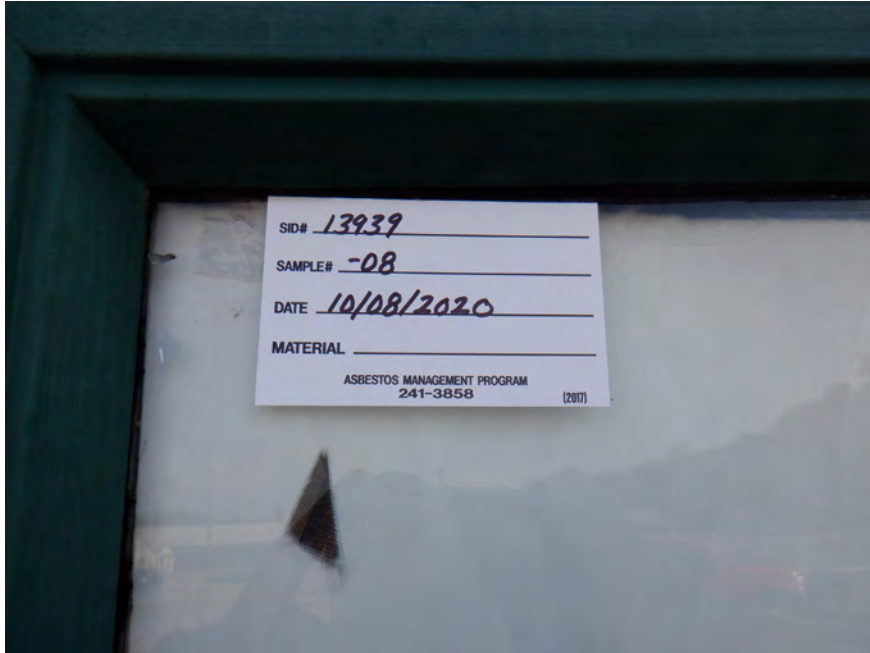
<b>HA Description</b>	Black window caulk
	<b>Sample #</b>	SID13939-08
	<b>Sample Location / Orientation</b>	Outside west facing door.
	<b>Sample/Inspection Results</b>	SID13939-08 – None Detected
	<b>Recommendation</b>	None

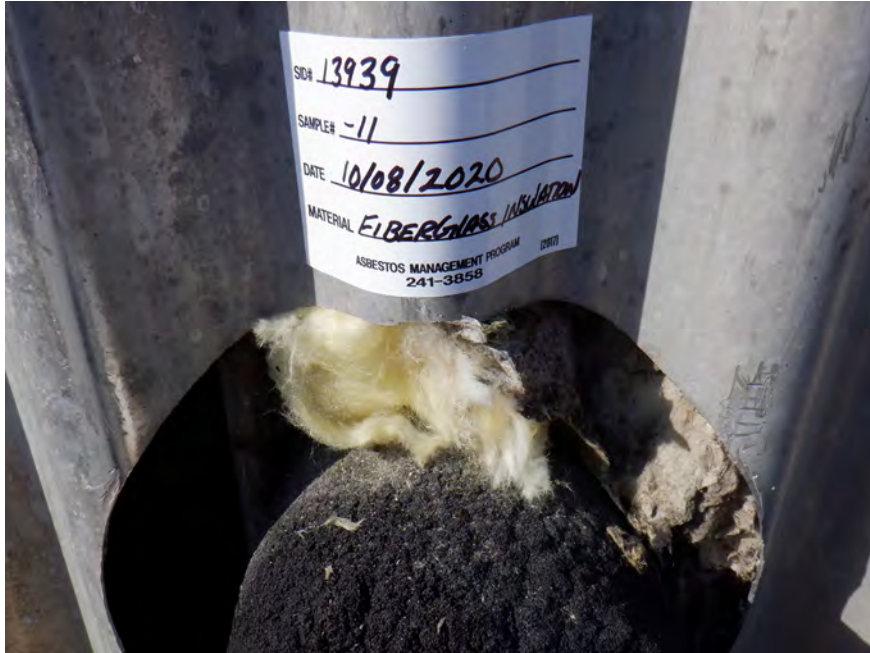
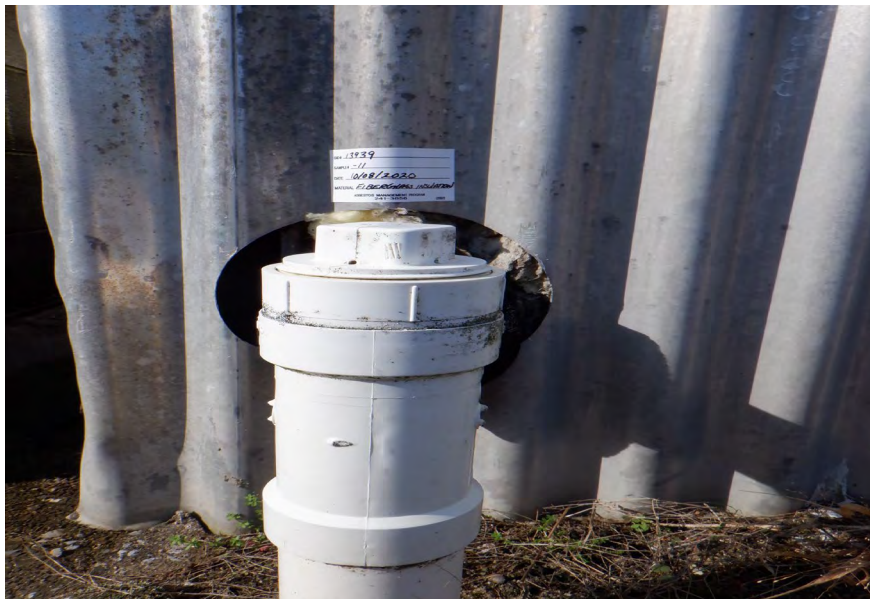
<b>HA Description</b>	Yellow fiberglass wall insulation
	<b>Sample #</b>	SID13939-11
	<b>Sample Location / Orientation</b>	SE exterior wall.
	<b>Sample/Inspection Results</b>	SID13939-11 – None Detected
	<b>Recommendation</b>	None

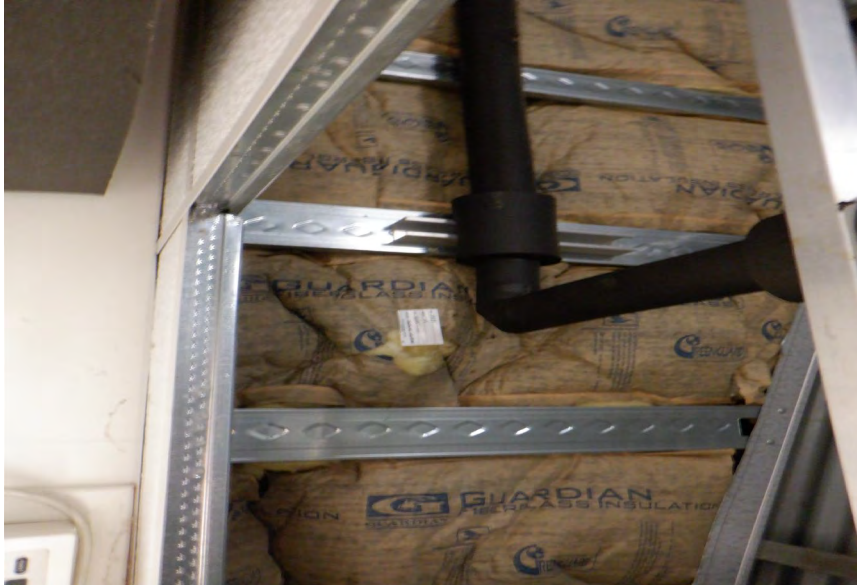
<b>HA Description</b>	<b>Yellow fiberglass wall insulation</b>
	<b>Sample #</b>	<b>SID13939-12</b>
	<b>Sample Location / Orientation</b>	<b>Above ceiling, center east wall.</b>
	<b>Sample/Inspection Results</b>	<b>SID13939-12 – None Detected</b>
	<b>Recommendation</b>	<b>None</b>

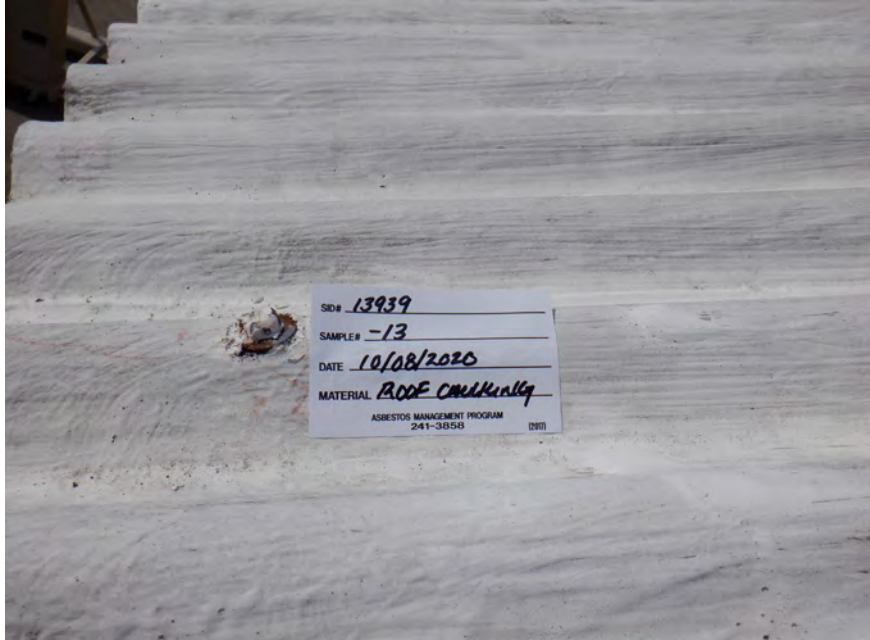
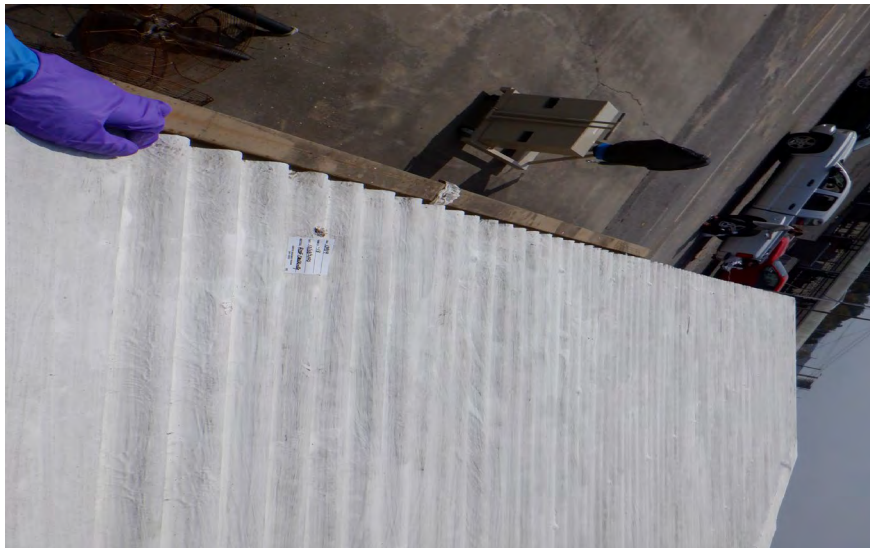
<b>HA Description</b>	<b>White/Gray corrugated metal roof caulking/coating material</b>
	<b>Sample #</b>	<b>SID13939-13</b>
	<b>Sample Location / Orientation</b>	<b>Eastside exterior roof.</b>
	<b>Sample/Inspection Results</b>	<b>SID13939-13 – None Detected</b>
	<b>Recommendation</b>	<b>None</b>

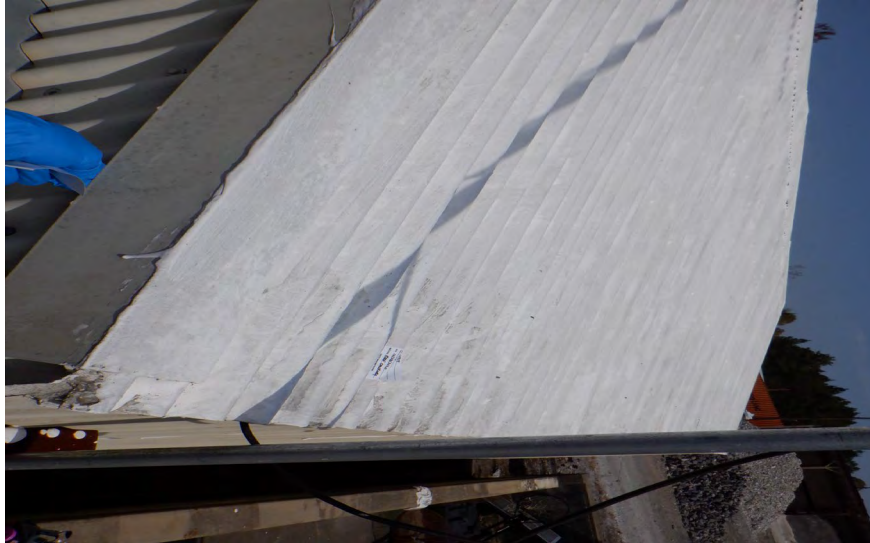
<b>HA Description</b>	White/Gray corrugated metal roof caulking/coating material
	<b>Sample #</b>	SID13939-14
	<b>Sample Location / Orientation</b>	West side exterior roof.
	<b>Sample/Inspection Results</b>	SID13939-14 – None Detected
	<b>Recommendation</b>	None

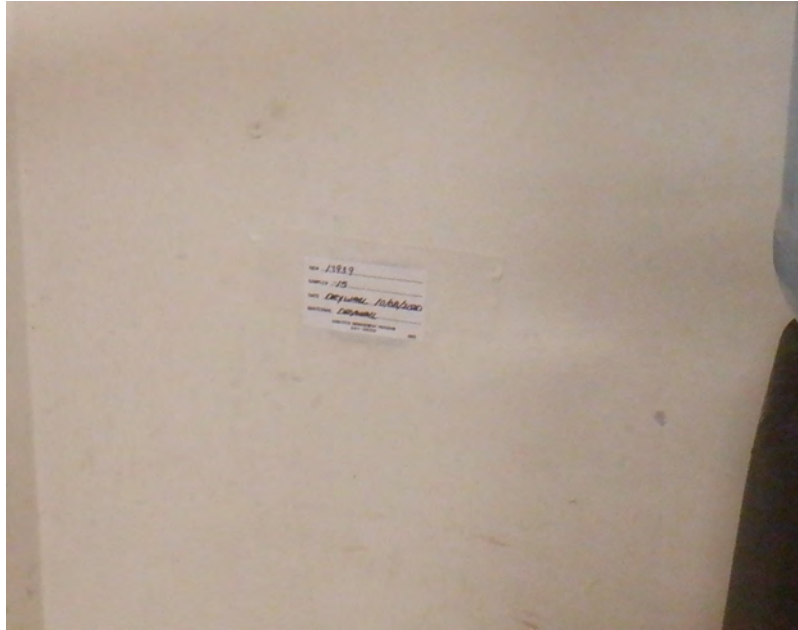
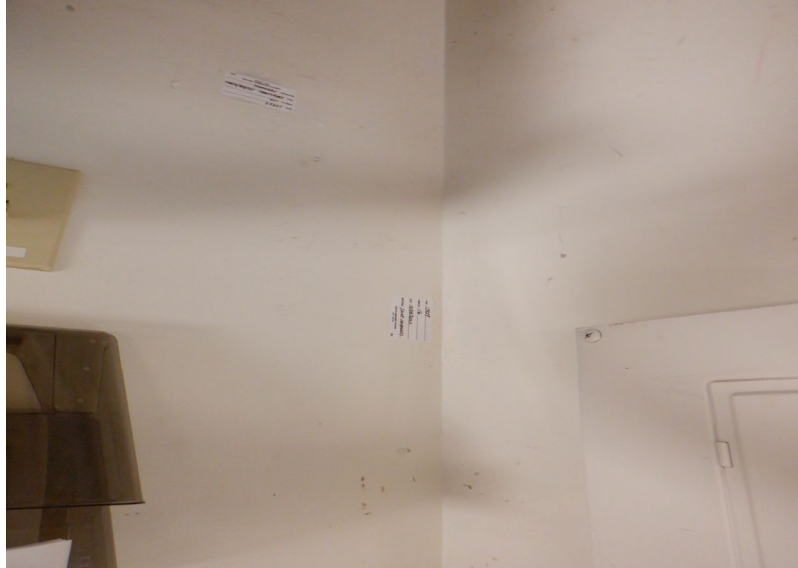
<b>HA Description</b>	<b>White drywall sheets</b>
	<b>Sample #</b>	<b>SID13939-15</b>
	<b>Sample Location / Orientation</b>	<b>North wall by door.</b>
	<b>Sample/Inspection Results</b>	<b>SID13939-15 – None Detected</b>
	<b>Recommendation</b>	<b>None</b>

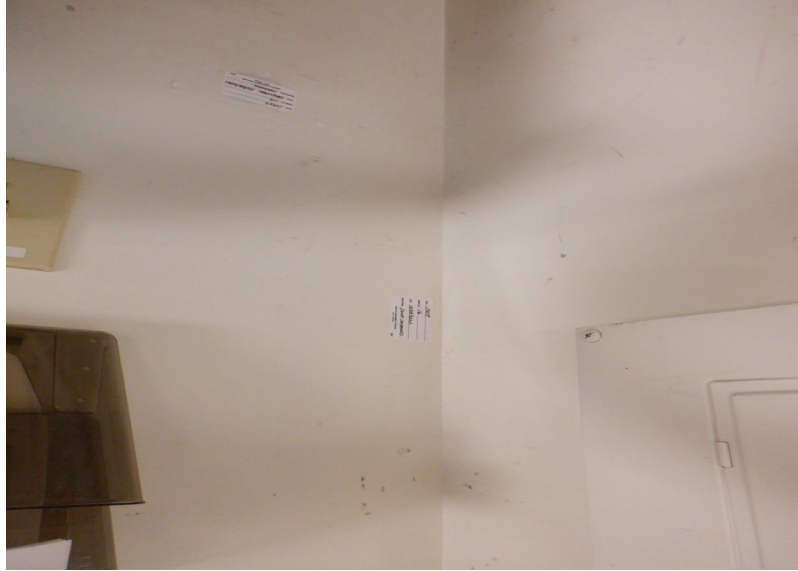
<b>HA Description</b>	Joint compound associated with sample 15.
	<b>Sample #</b>	SID13939-16
	<b>Sample Location / Orientation</b>	North wall by door.
	<b>Sample/Inspection Results</b>	SID13939-16 – None Detected
	<b>Recommendation</b>	None

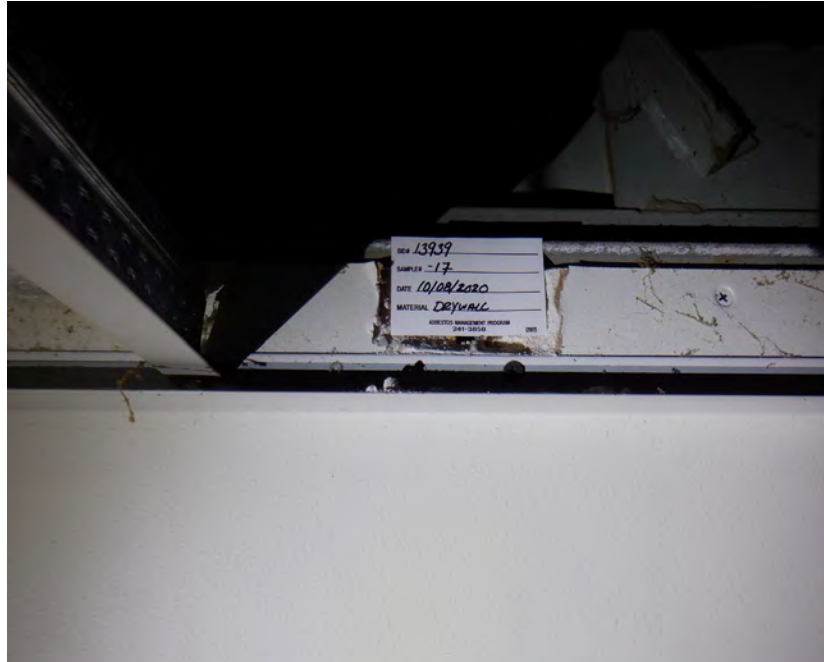
<b>HA Description</b>	<b>White drywall sheets</b>
	<b>Sample #</b>	<b>SID13939-17</b>
	<b>Sample Location / Orientation</b>	<b>West wall over door.</b>
	<b>Sample/Inspection Results</b>	SID13939-17 – None Detected
	<b>Recommendation</b>	None

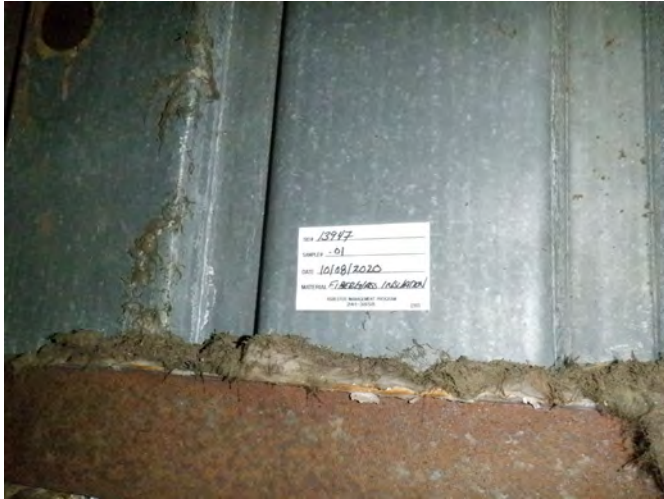
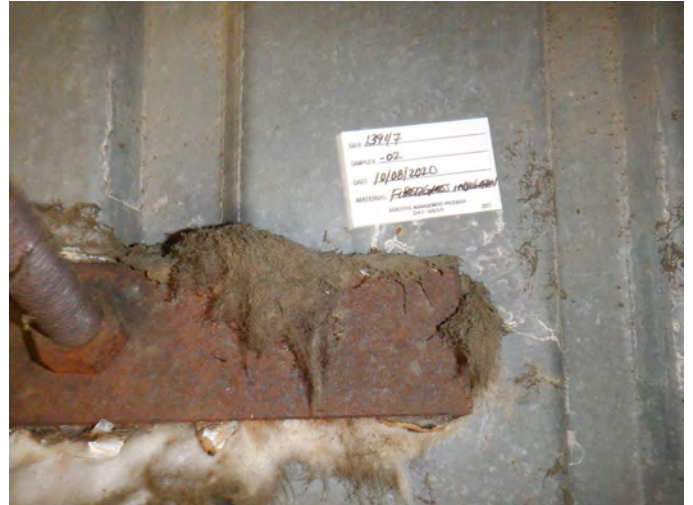
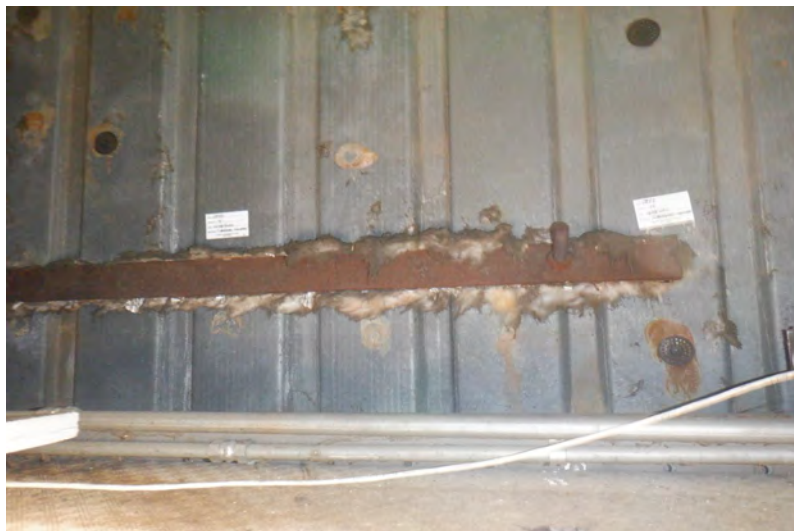
<b>HA Description</b>	WHITE/BROWN WALL INSULATION
	<b>Sample #</b>	<b>SID13947-01</b> <b>SID13947-02</b>
	<b>Sample Location / Orientation</b>	SID13947-01– West side above ceiling SID13947-02 – West side above ceiling
	<b>Sample/Inspection Results</b>	SID13947-01 – None Detected SID13947-02 – None Detected
	<b>Recommendation</b>	None

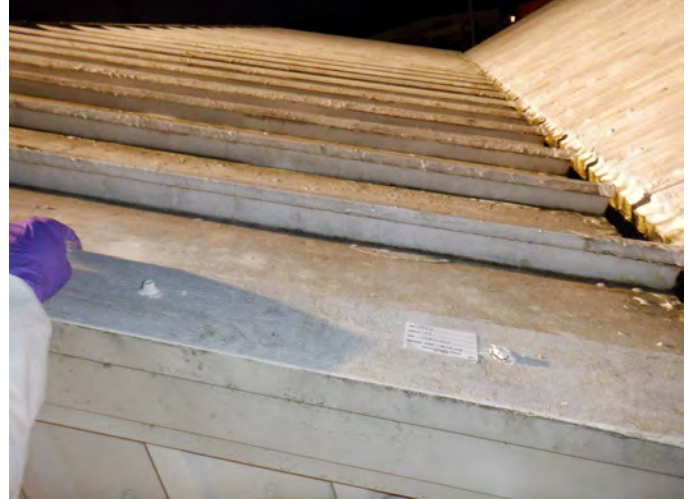
<b>HA Description</b>	WHITE ROOF CAULKING/Coating
	<b>Sample #</b>	<b>SID13947-03</b> <b>SID13947-04</b>
	<b>Sample Location / Orientation</b>	SID13947-03– Southwest corner of roof SID13947-04 – Southeast corner of roof.
	<b>Sample/Inspection Results</b>	SID13947-03 – None Detected SID13947-04 – None Detected
	<b>Recommendation</b>	None

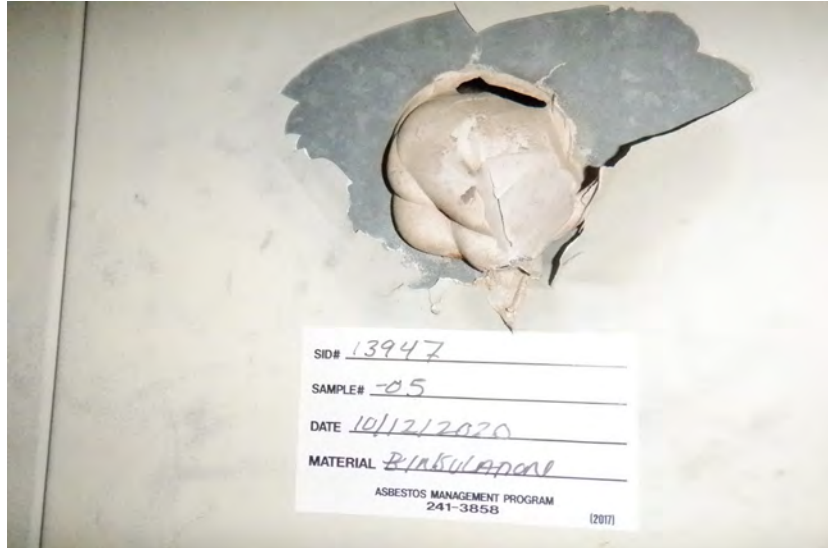
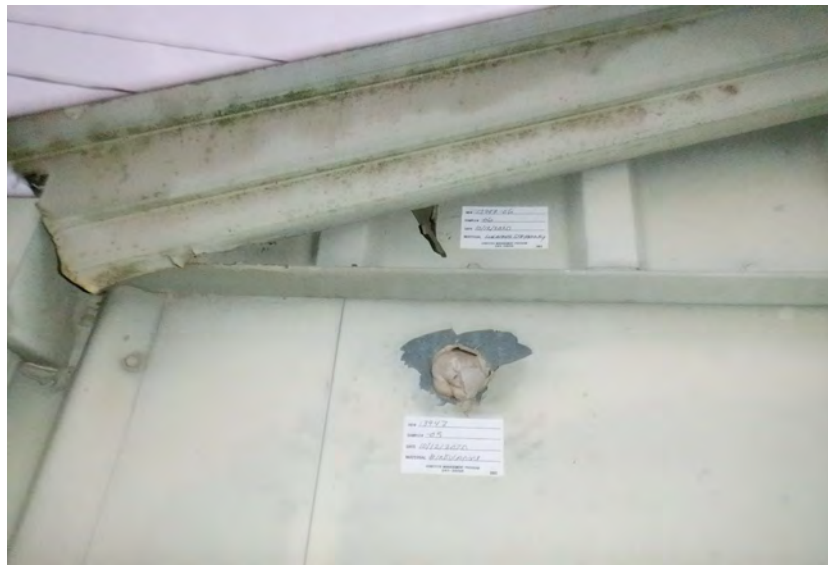
<b>HA Description</b>	TAN FOAM INSULATION
	<b>Sample #</b>	<b>SID13947-05</b>
	<b>Sample Location / Orientation</b>	SID13947-05– South side exterior of building
	<b>Sample/Inspection Results</b>	SID13947-05 – None Detected
	<b>Recommendation</b>	None

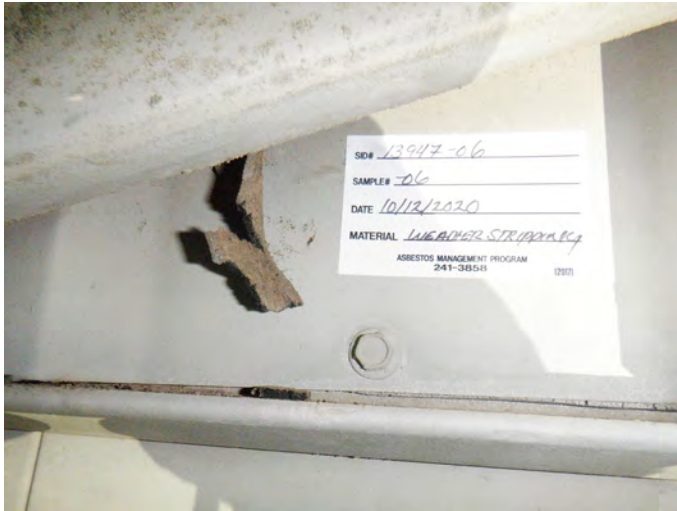
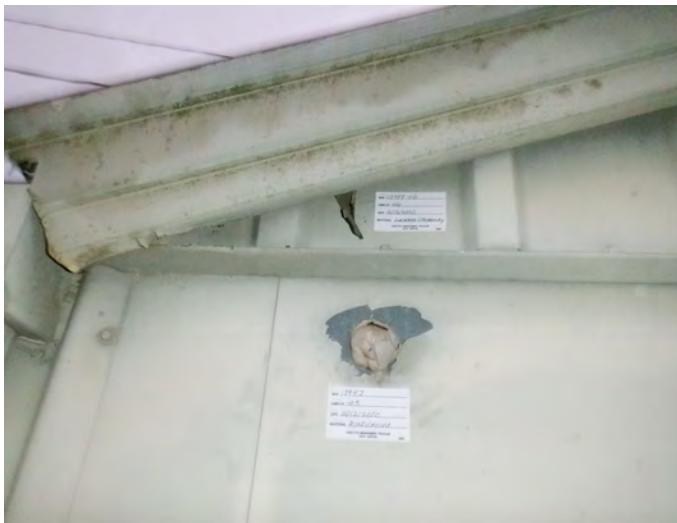
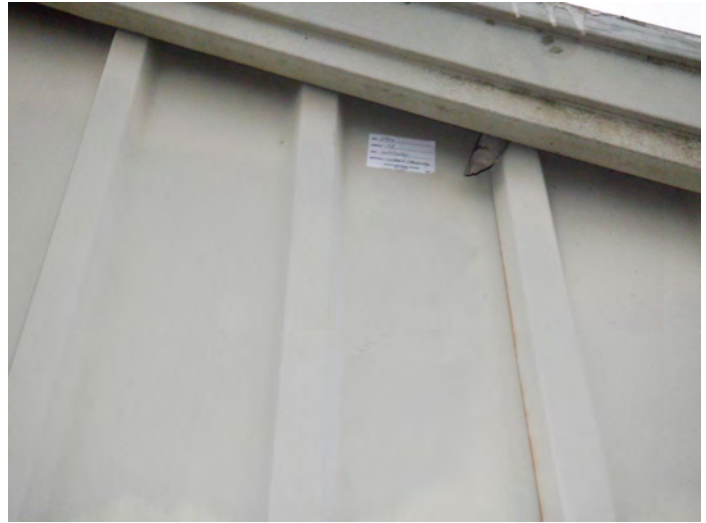
<b>HA Description</b>	BLACK WEATHER STRIPPING
	<b>Sample #</b>	<b>SID13947-06</b> <b>SID13947-07</b>
	<b>Sample Location / Orientation</b>	SID13947-05– Southeast corner, exterior SID13947-07– Northeast corner, exterior
	<b>Sample/Inspection Results</b>	SID13947-06 – None Detected SID13947-07– None Detected
	<b>Recommendation</b>	None

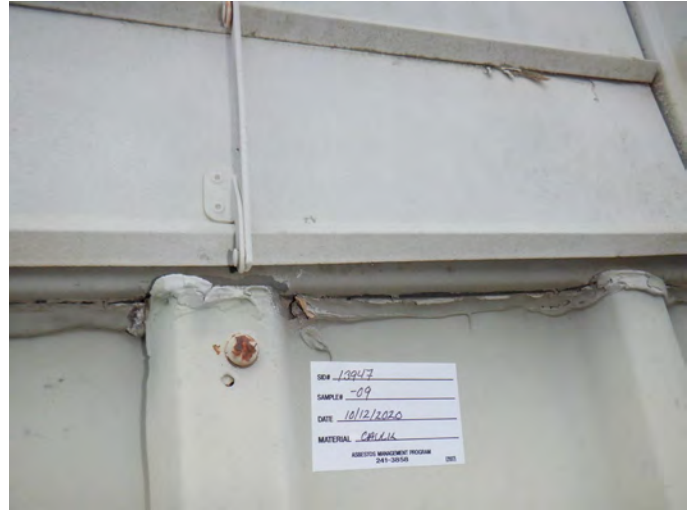
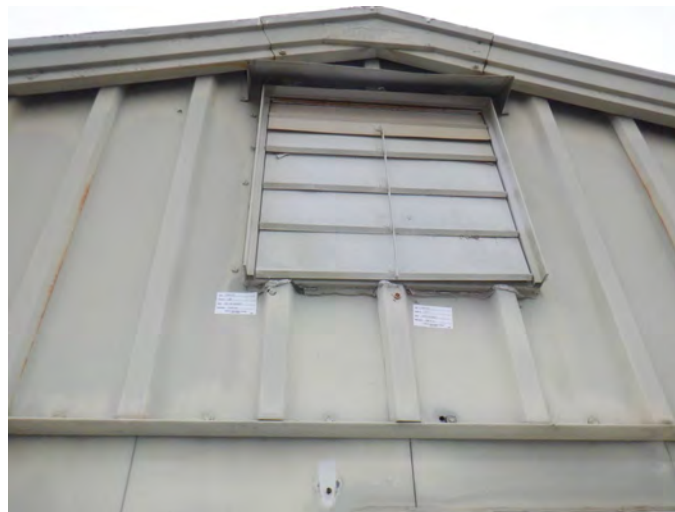
<b>HA Description</b>	GRAY CAULK
	<b>Sample #</b>	<b>SID13947-08</b> <b>SID13947-09</b>
	<b>Sample Location / Orientation</b>	SID13947-08– Southside exterior vent SID13947-09– Southside exterior vent
	<b>Sample/Inspection Results</b>	SID13947-08 – None Detected SID13947-09– None Detected
	<b>Recommendation</b>	None

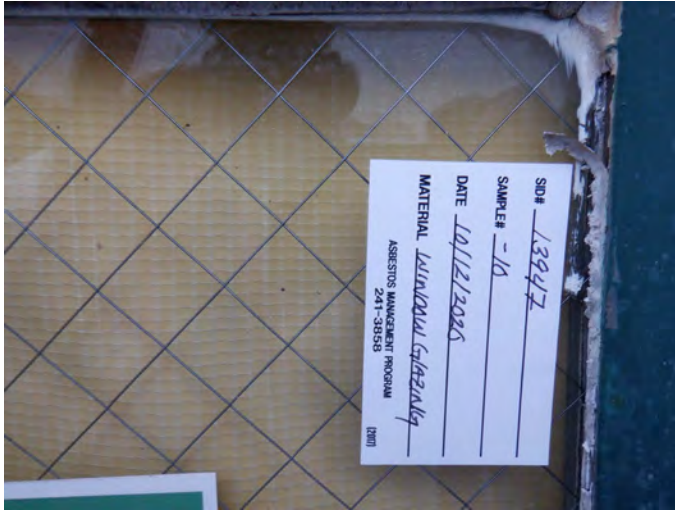
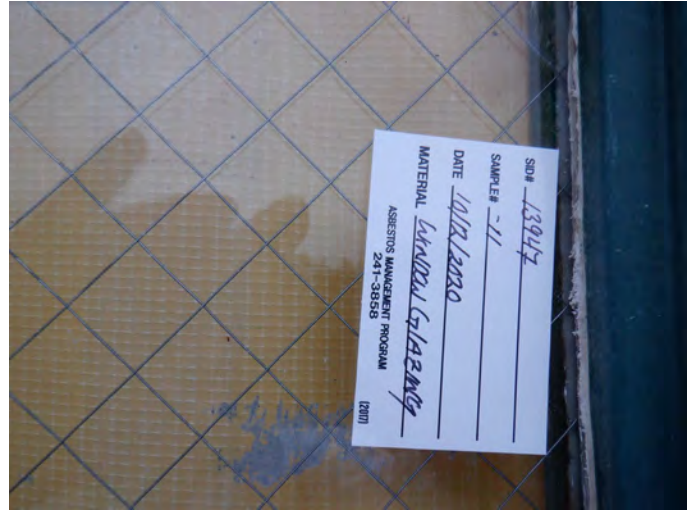
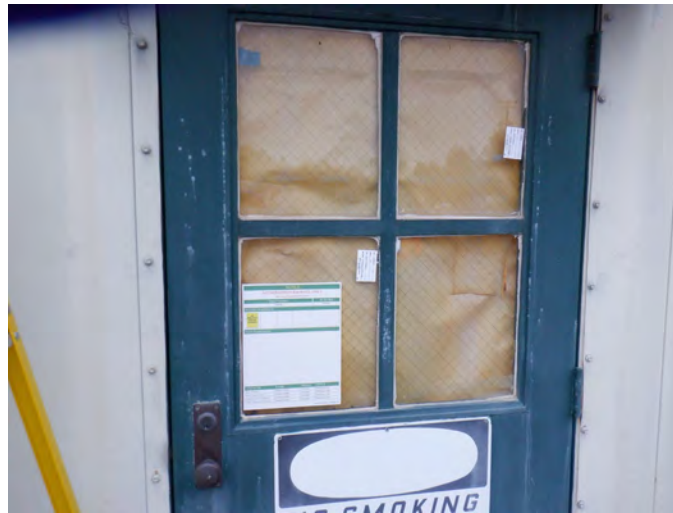
<b>HA Description</b>	WINDOW GLAZING
	<b>Sample #</b>	<b>SID13947-10</b> <b>SID13947-11</b>
	<b>Sample Location / Orientation</b>	SID13947-10– East side door, lower pane SID13947-11– East side door, upper pane
	<b>Sample/Inspection Results</b>	SID13947-10 – None Detected SID13947-11– None Detected
	<b>Recommendation</b>	None

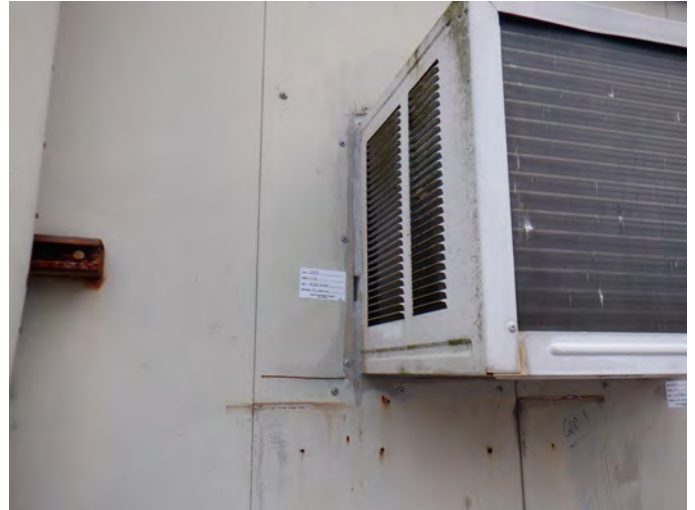
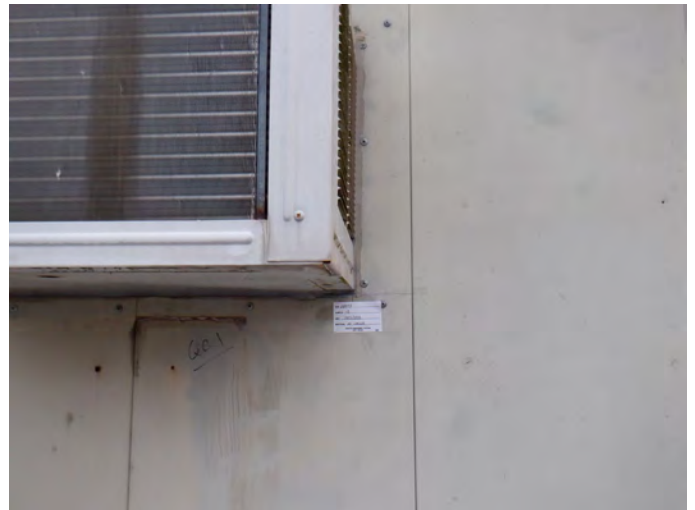
<b>HA Description</b>	CLEAR CAULK
	<b>Sample #</b>	<b>SID13947-12</b> <b>SID13947-13</b>
	<b>Sample Location / Orientation</b>	SID13947-12– AC unit, west side exterior SID13947-13– AC unite, west side exterior
	<b>Sample/Inspection Results</b>	SID13947-12 – None Detected SID13947-13– None Detected
	<b>Recommendation</b>	None

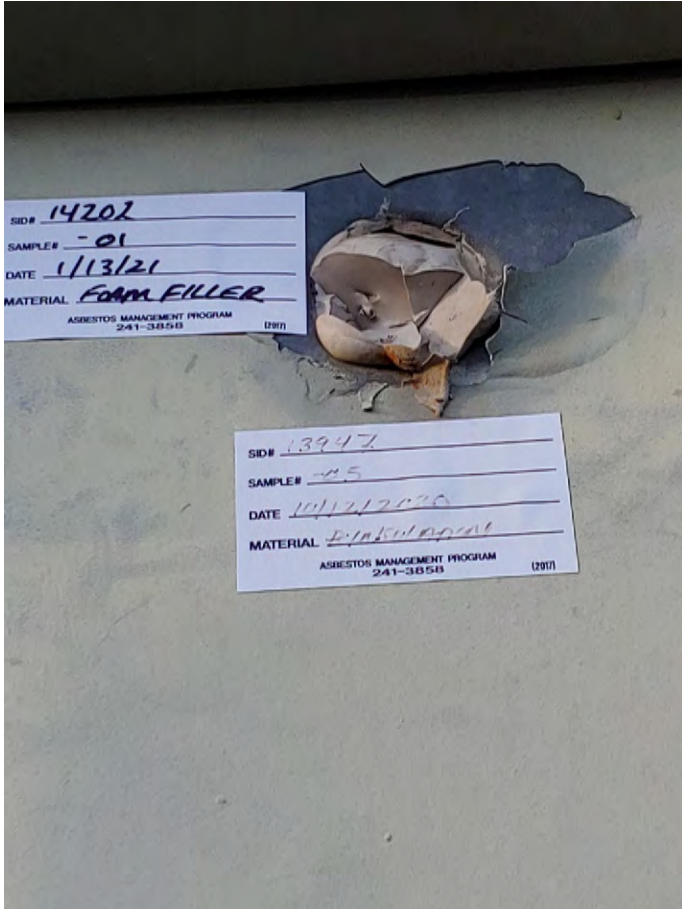
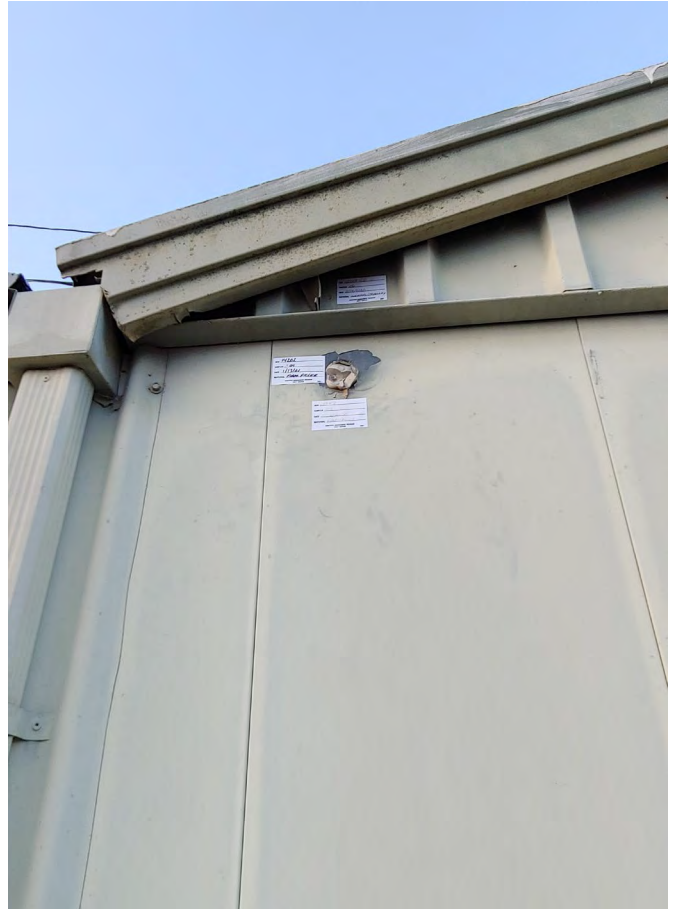
HA-7035E-003	<b>HA Description</b>	TAN FOAM FILLER
	<b>Sample #</b>	SID14202-01
	<b>Sample Location / Orientation</b>	SID14202-01– Southeast side of building exterior
	<b>Sample/Inspection Results</b>	SID14202-01 – None Detected
	<b>Recommendation</b>	None

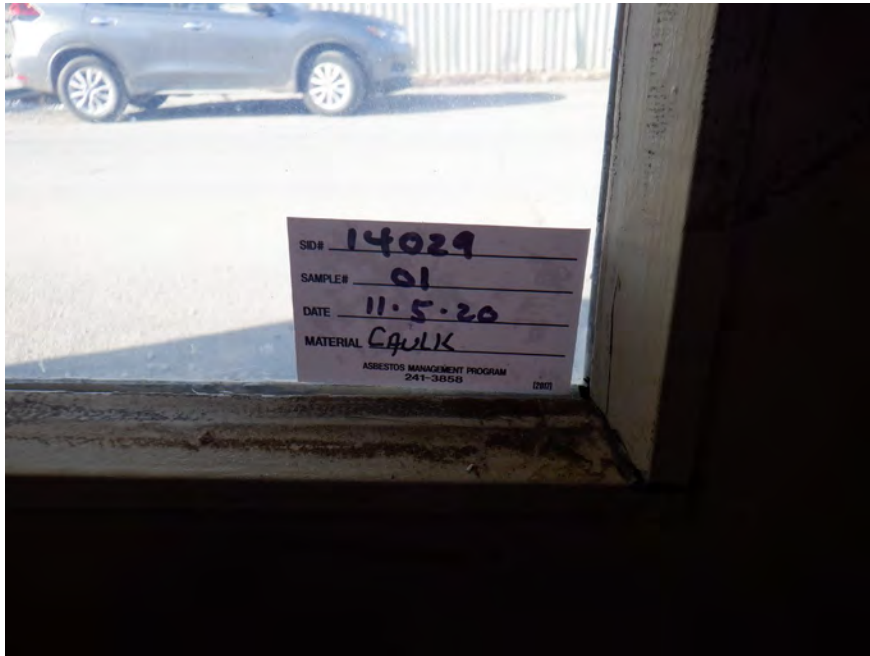
<b>HA Description</b>	<b>Black Window Caulk</b>
	<b>Sample #</b>	<b>SID14029-01</b>
	<b>Sample Location / Orientation</b>	<b>Interior door, west side</b>
	<b>Sample/Inspection Results</b>	<b>SID14029-01 – 3% Asbestos Chrysotile</b>
	<b>Recommendation</b>	<b>Wrap and dispose of door as non-friable asbestos waste.</b>

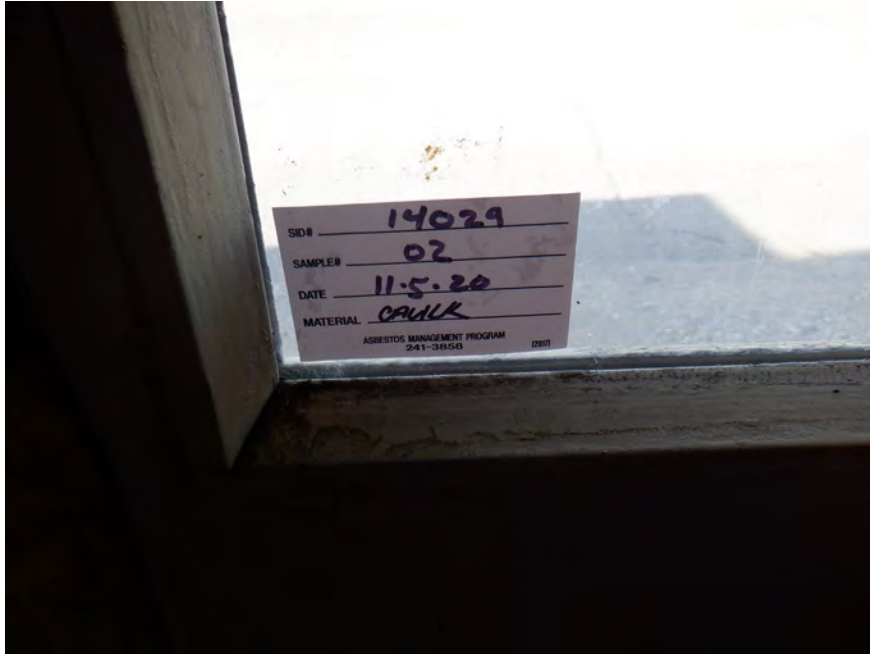
<b>HA Description</b>	Black Window Caulk
	<b>Sample #</b>	SID14029-02
	<b>Sample Location / Orientation</b>	Interior door, west side
	<b>Sample/Inspection Results</b>	SID14029-02 – 3% Asbestos Chrysotile
	<b>Recommendation</b>	Wrap and dispose of door as non-friable asbestos waste.

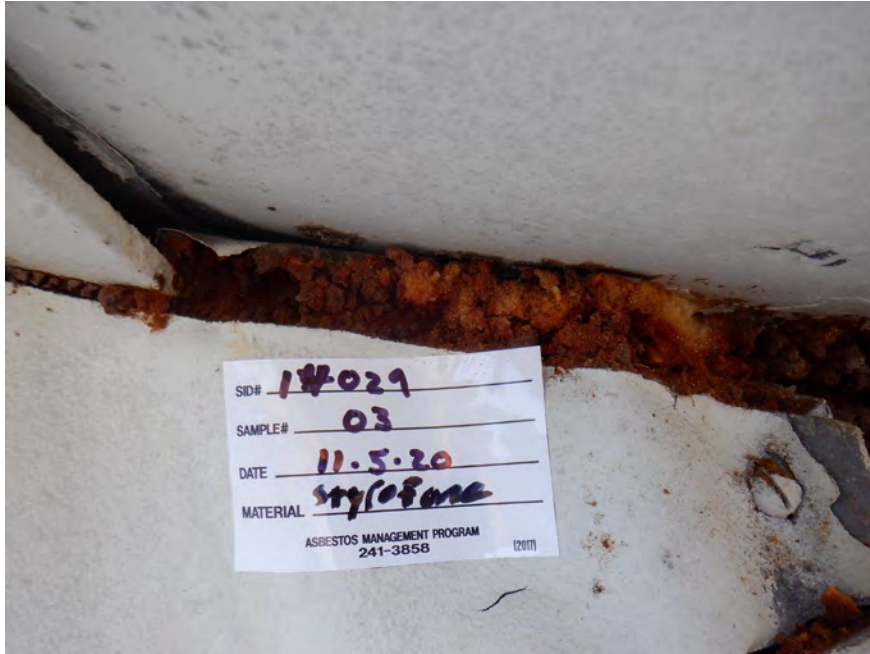
<b>HA Description</b>	<b>Yellow Foam Insulation / Filler, Walls</b>
	<b>Sample #</b>	<b>SID14029-03</b>
	<b>Sample Location / Orientation</b>	<b>NW exterior between wall and roof</b>
	<b>Sample/Inspection Results</b>	<b>SID14029-03 – None Detected</b>
	<b>Recommendation</b>	<b>None</b>

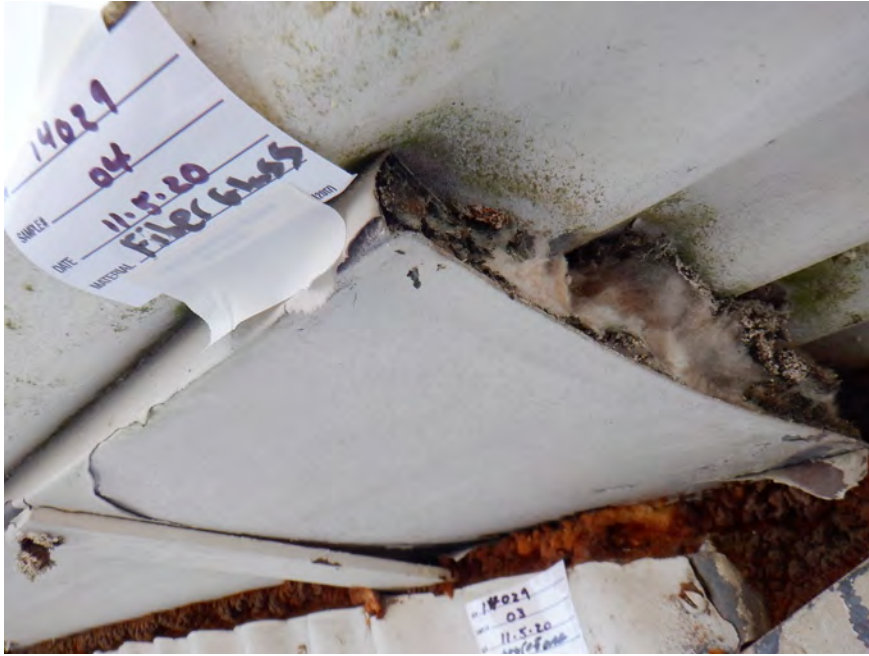
<b>HA Description</b>	<b>White Fiberglass Insulation</b>
	<b>Sample #</b>	<b>SID14029-04</b>
	<b>Sample Location / Orientation</b>	<b>NW exterior between layers of roof</b>
	<b>Sample/Inspection Results</b>	<b>SID14029-04 – None Detected</b>
	<b>Recommendation</b>	<b>None</b>

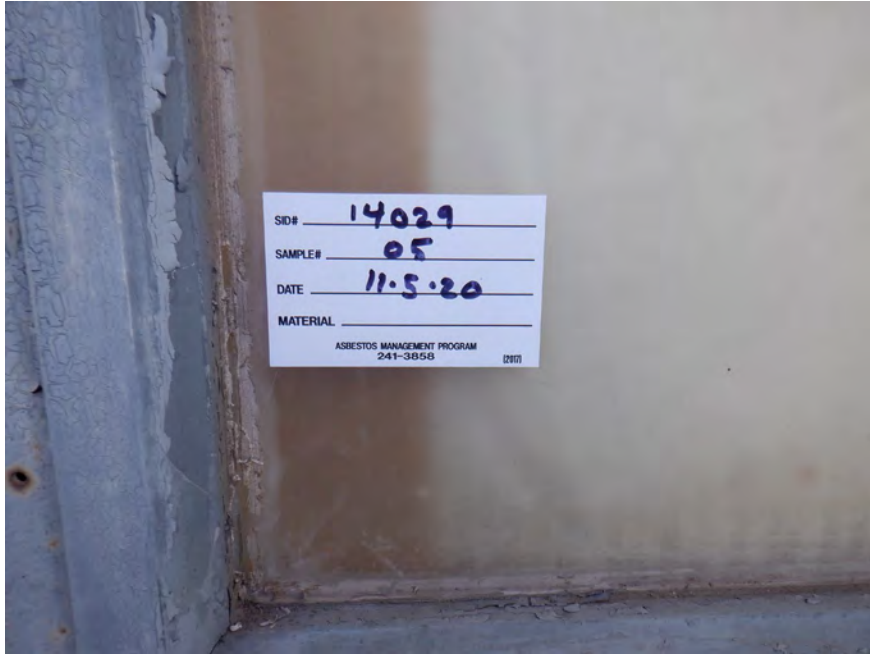
<b>HA Description</b>	White Caulk
	<b>Sample #</b>	SID14029-05
	<b>Sample Location / Orientation</b>	Exterior door, west side
	<b>Sample/Inspection Results</b>	SID14029-05 – None Detected
	<b>Recommendation</b>	None

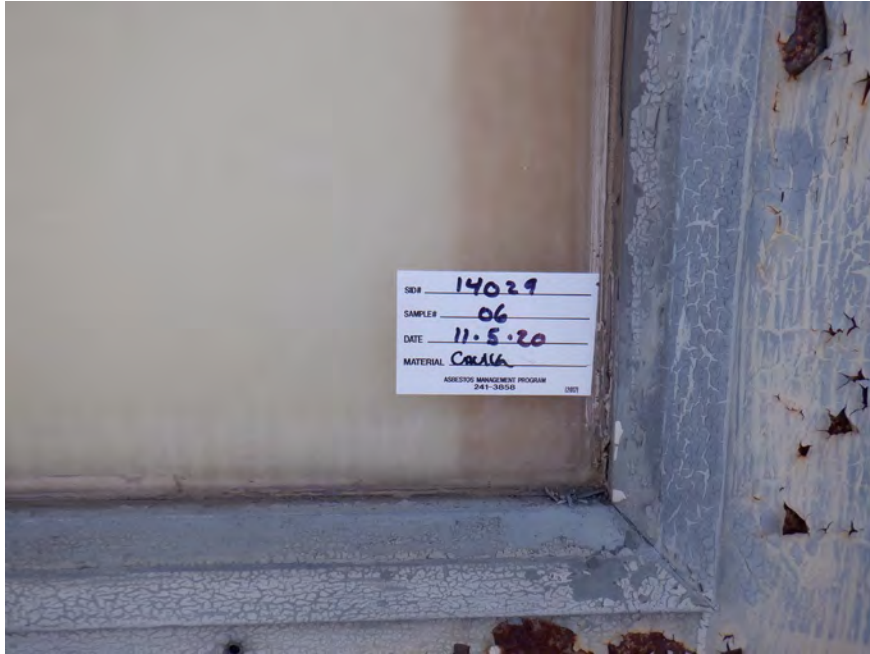
<b>HA Description</b>	White Caulk
	<b>Sample #</b>	SID14029-06
	<b>Sample Location / Orientation</b>	Exterior door, west side
	<b>Sample/Inspection Results</b>	SID14029-06 – None Detected
	<b>Recommendation</b>	None

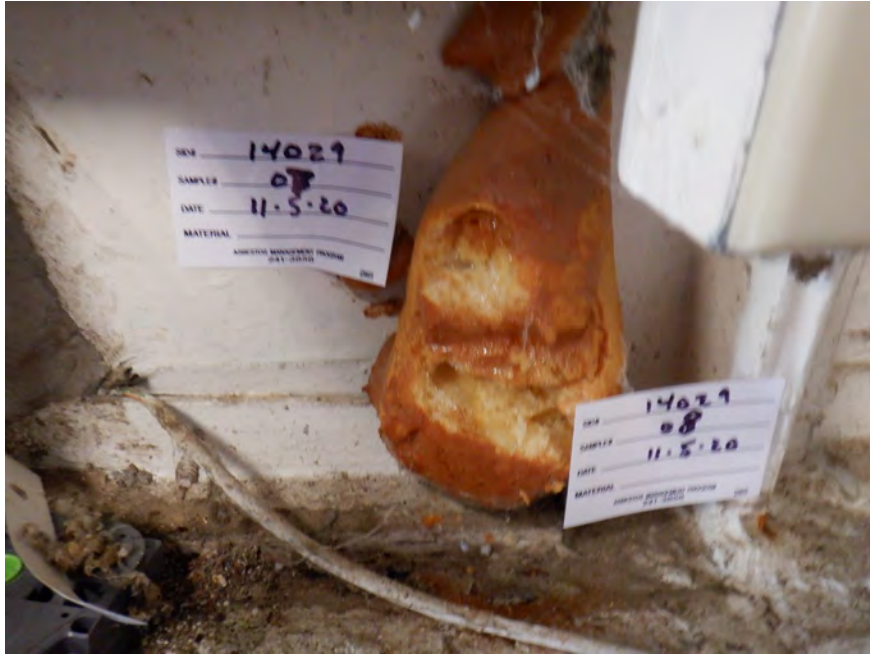
<b>HA Description</b>	<b>Yellow Foam Insulation / Filler Walls</b>
	<b>Sample #</b>	<b>SID14029-07</b>
	<b>Sample Location / Orientation</b>	<b>West wall</b>
	<b>Sample/Inspection Results</b>	<b>SID14029-07 – None Detected</b>
	<b>Recommendation</b>	<b>None</b>

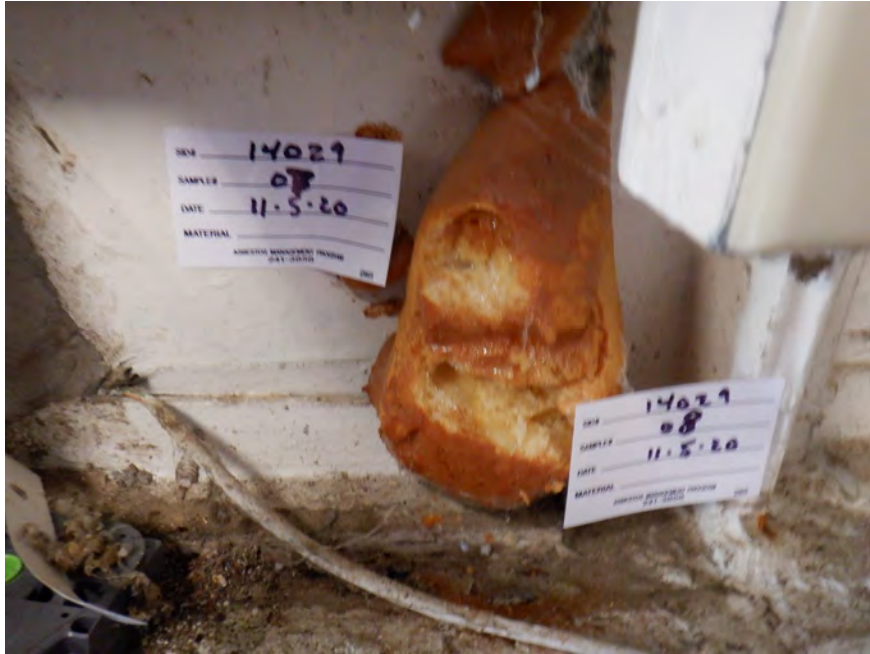
<b>HA Description</b>	<b>Yellow Foam Insulation / Filler Walls</b>
	<b>Sample #</b>	<b>SID14029-08</b>
	<b>Sample Location / Orientation</b>	<b>West wall</b>
	<b>Sample/Inspection Results</b>	<b>SID14029-08 – None Detected</b>
	<b>Recommendation</b>	<b>None</b>

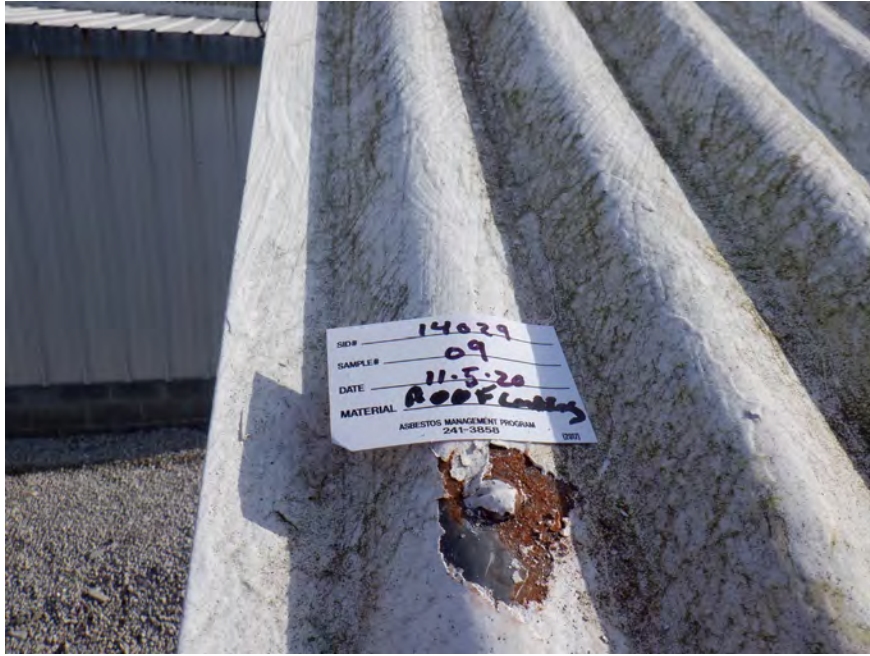
<b>HA Description</b>	White Roof Caulk/Coating
	<b>Sample #</b>	SID14029-09
	<b>Sample Location / Orientation</b>	NW side of roof
	<b>Sample/Inspection Results</b>	SID14029-09 – None Detected
	<b>Recommendation</b>	None
