**Scope of Work and Specifications**

**CRSF Building Demolition**

**OAK RIDGE NATIONAL LABORATORY**

**March 2021**

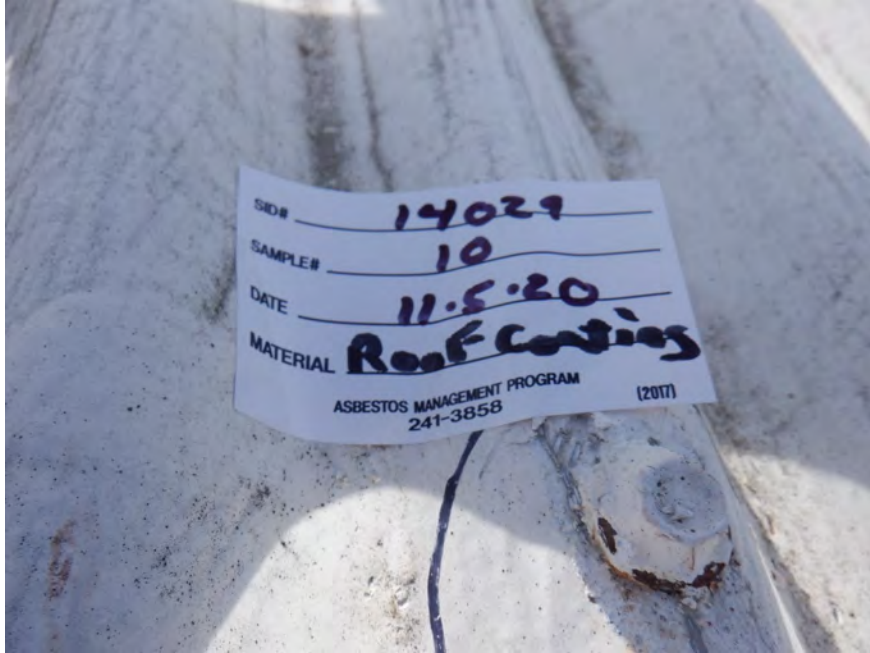
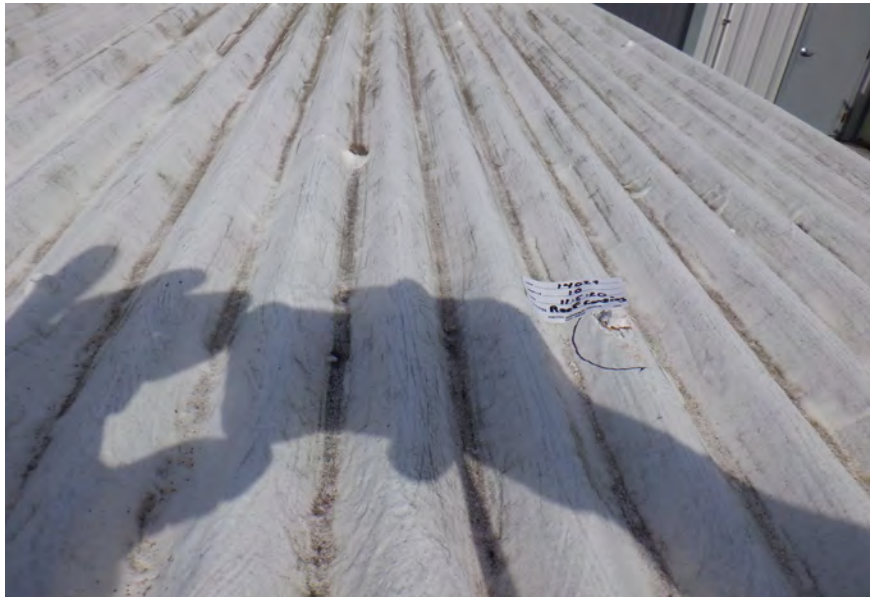
<b>HA Description</b>	White Roof Caulk/Coating
	<b>Sample #</b>	SID14029-10
	<b>Sample Location / Orientation</b>	SE side of roof
	<b>Sample/Inspection Results</b>	SID14029-10 – None Detected
	<b>Recommendation</b>	None

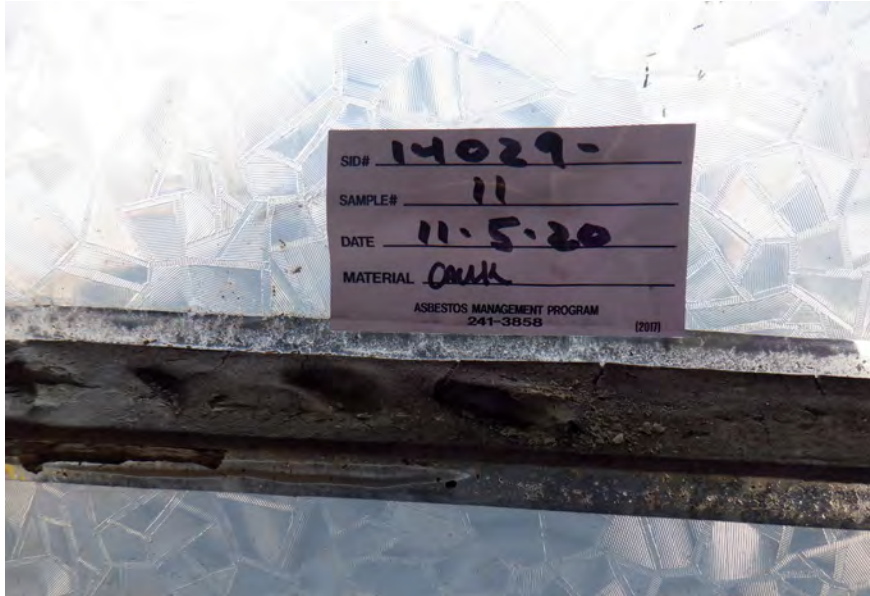
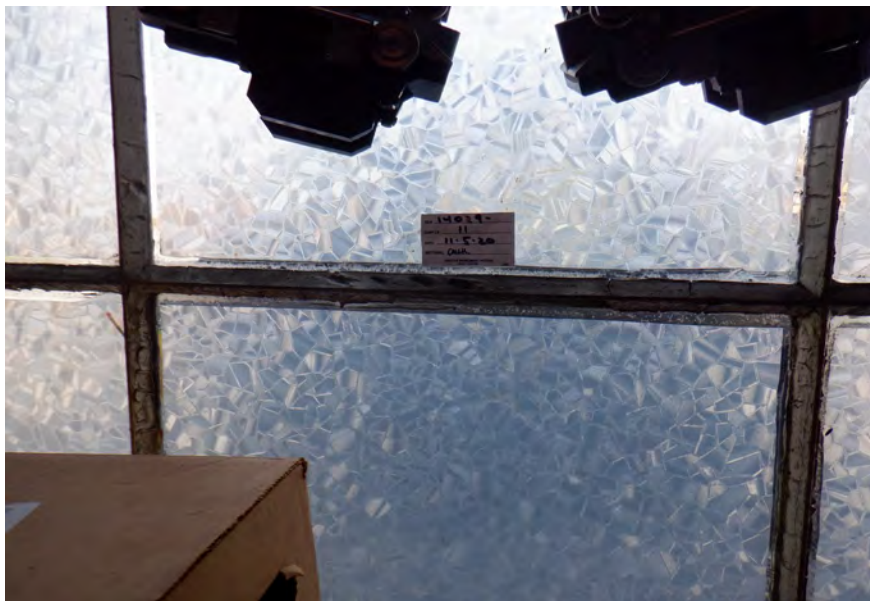
<b>HA Description</b>	Window Glazing
	<b>Sample #</b>	SID14029-11
	<b>Sample Location / Orientation</b>	North interior window
	<b>Sample/Inspection Results</b>	SID14029-11 – 3% Asbestos Chrysotile
	<b>Recommendation</b>	Wrap and Dispose of window as non-friable asbestos waste

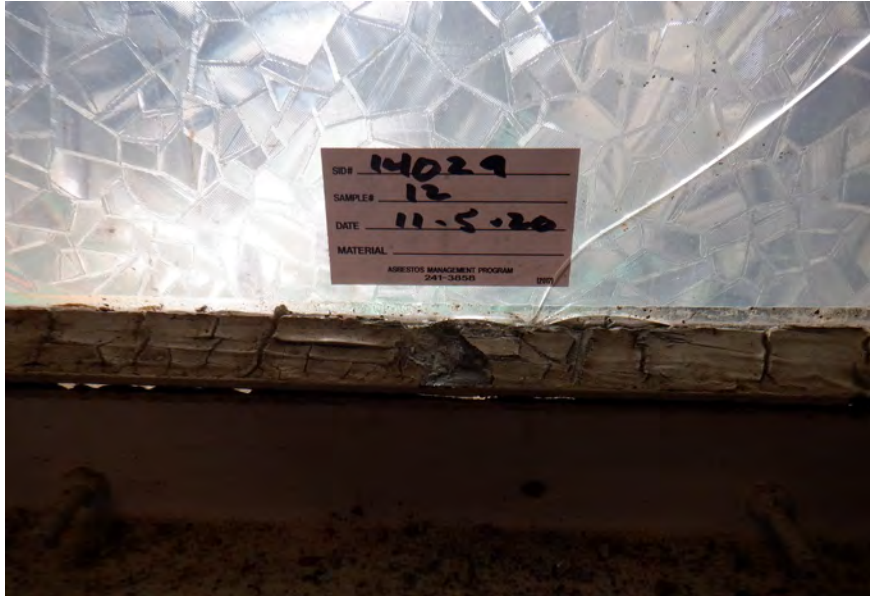
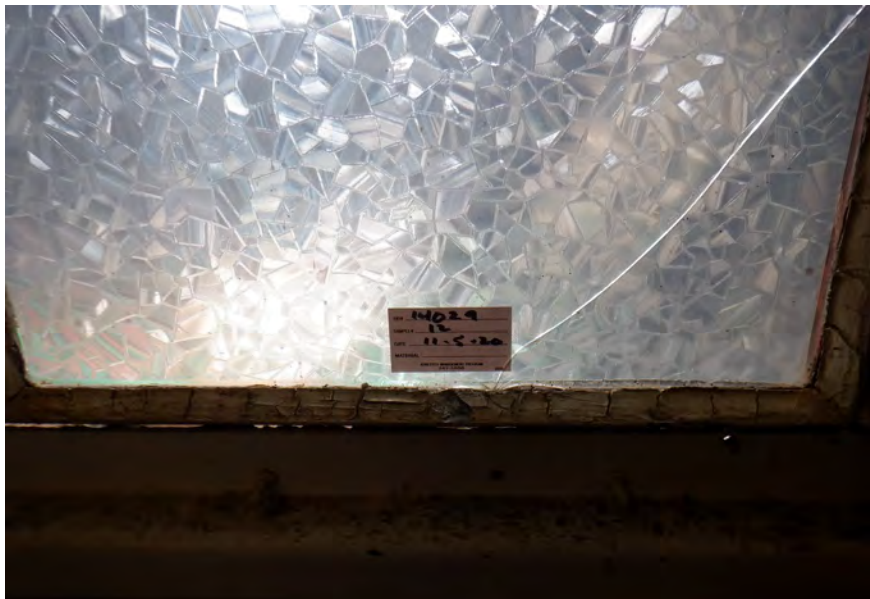
<b>HA Description</b>	<b>Window Glazing</b>
	<b>Sample #</b>	<b>SID14029-12</b>
	<b>Sample Location / Orientation</b>	<b>South interior window</b>
	<b>Sample/Inspection Results</b>	<b>SID14029-12 – 3% Asbestos Chrysotile</b>
	<b>Recommendation</b>	<b>Wrap and dispose of window as non-friable asbestos waste.</b>

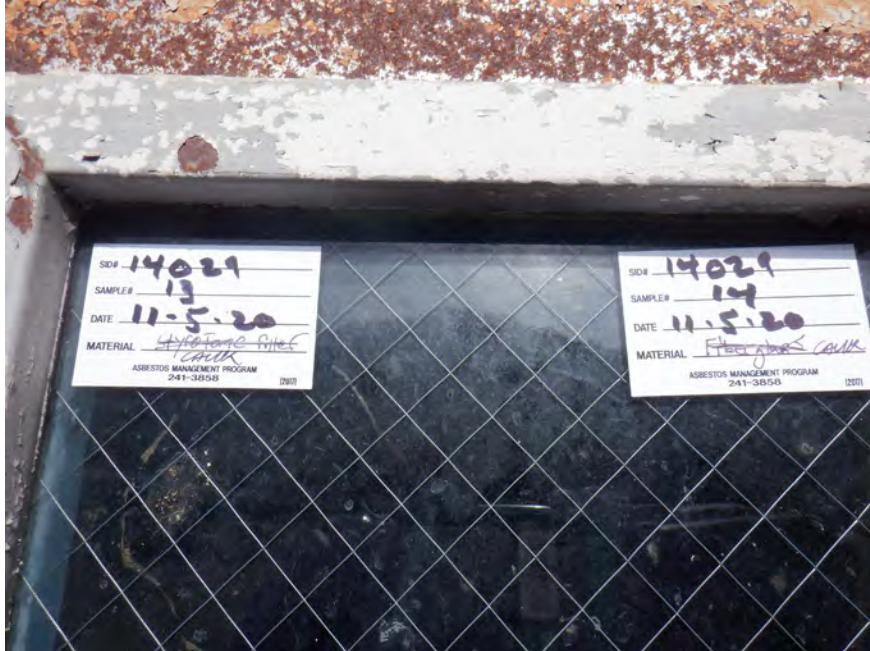
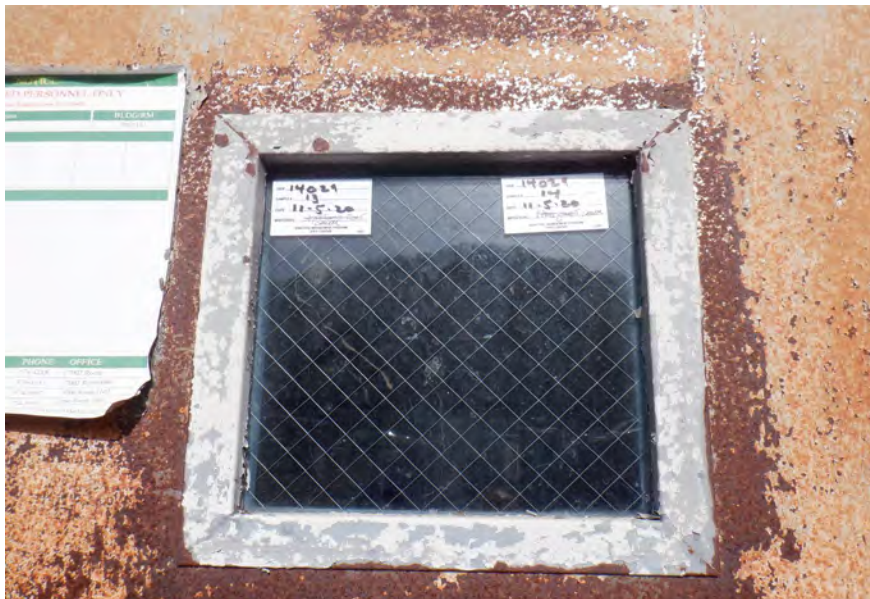
<b>HA Description</b>	White Caulk Painted Blue
	<b>Sample #</b>	SID14029-13
	<b>Sample Location / Orientation</b>	South facing exterior door window
	<b>Sample/Inspection Results</b>	SID14029-13 – None Detected
	<b>Recommendation</b>	None

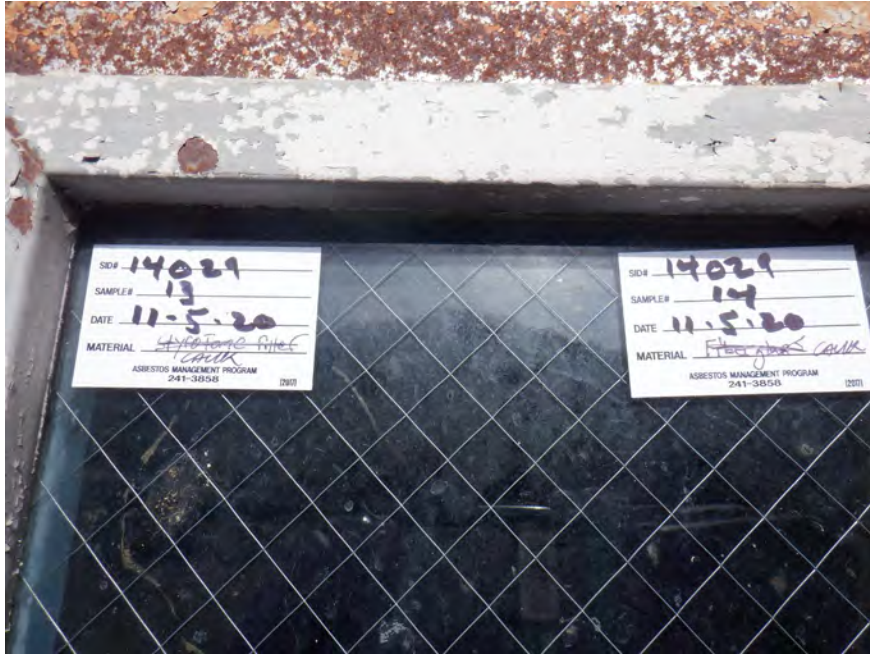
<b>HA Description</b>	White Caulk Painted Blue
	<b>Sample #</b>	SID14029-14
	<b>Sample Location / Orientation</b>	South facing exterior door window, room 101
	<b>Sample/Inspection Results</b>	SID14029-14 – None Detected
	<b>Recommendation</b>	None

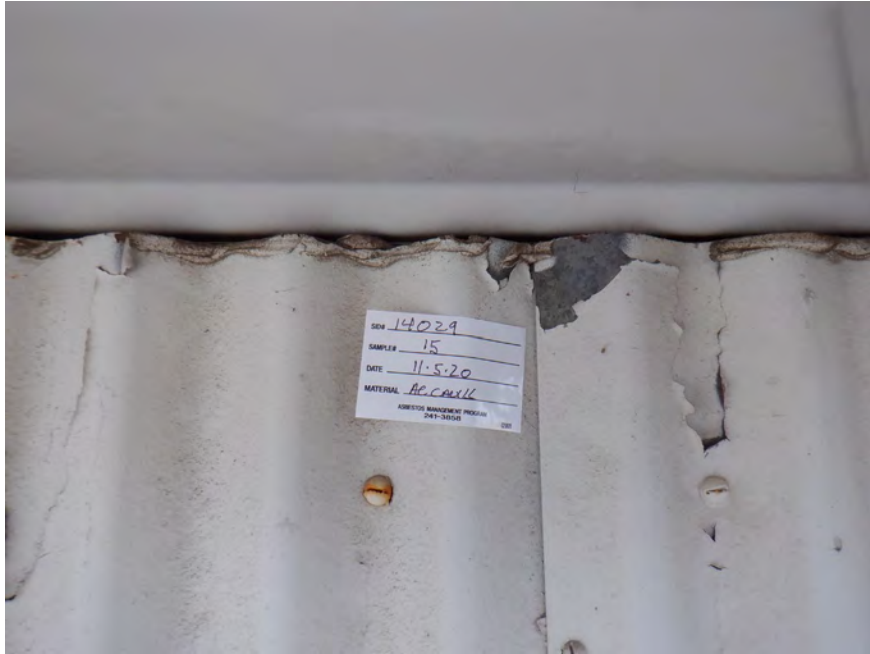
<b>HA Description</b>	<b>White Caulk</b>
	<b>Sample #</b>	<b>SID14029-15</b>
	<b>Sample Location / Orientation</b>	<b>North side exterior AC unit</b>
	<b>Sample/Inspection Results</b>	<b>SID14029-15 – None Detected</b>
	<b>Recommendation</b>	<b>None</b>

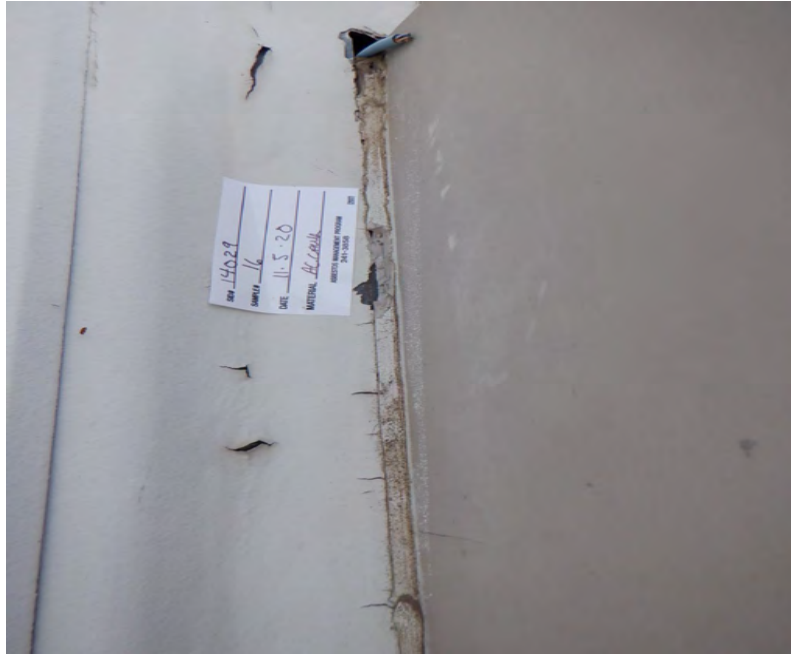
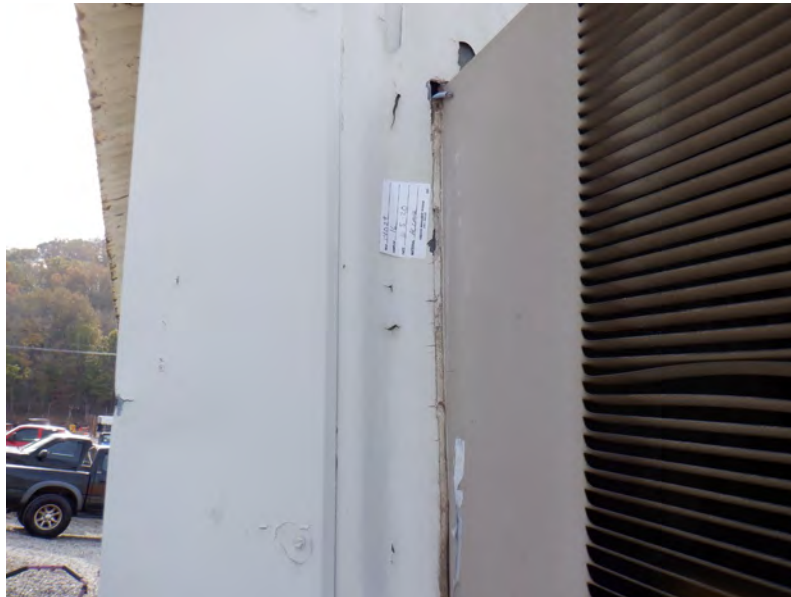
<b>HA Description</b>	White Caulk
	<b>Sample #</b>	SID14029-16
	<b>Sample Location / Orientation</b>	North side exterior AC unit
	<b>Sample/Inspection Results</b>	SID14029-16 – None Detected
	<b>Recommendation</b>	None

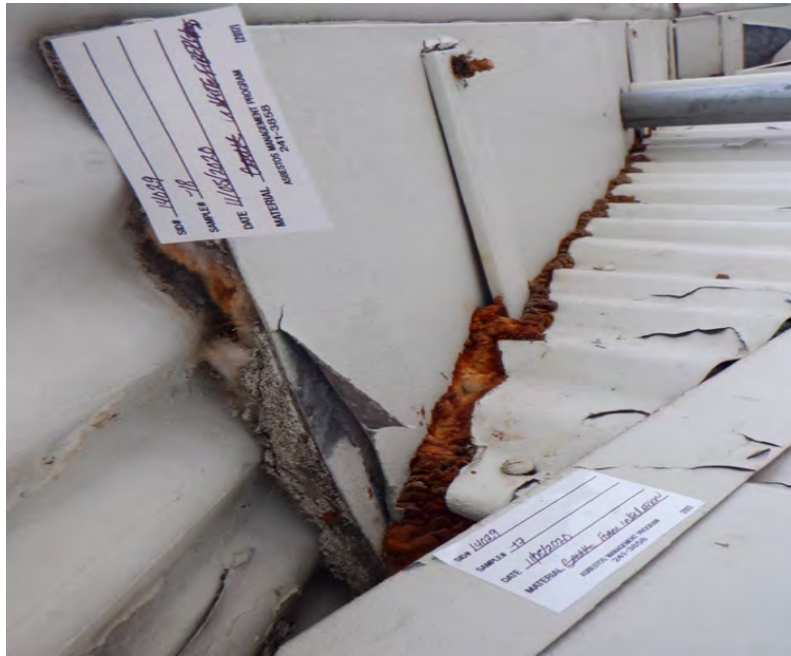
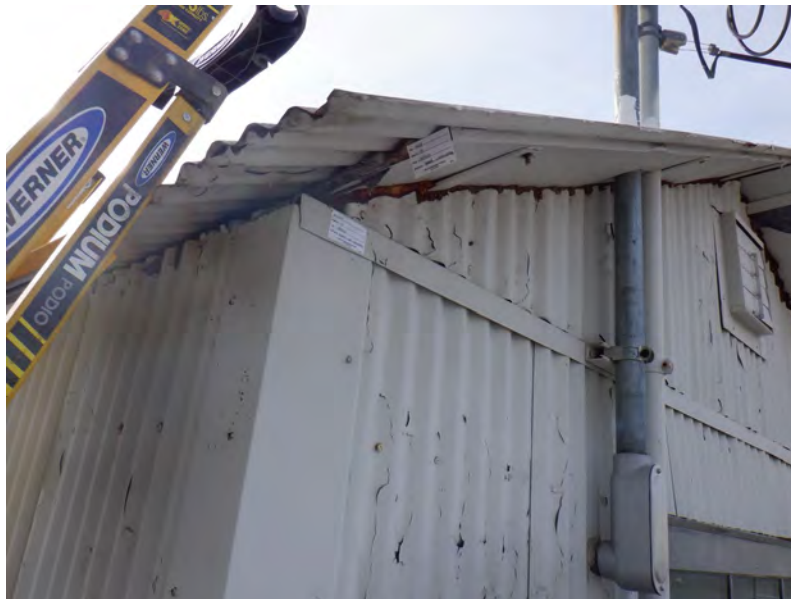
<b>HA Description</b>	<b>Yellow Foam Insulation</b>
	<b>Sample #</b>	<b>SID14029-17</b>
	<b>Sample Location / Orientation</b>	<b>NE corner of building between roof layers</b>
	<b>Sample/Inspection Results</b>	<b>SID14029-17 – None Detected</b>
	<b>Recommendation</b>	<b>None</b>

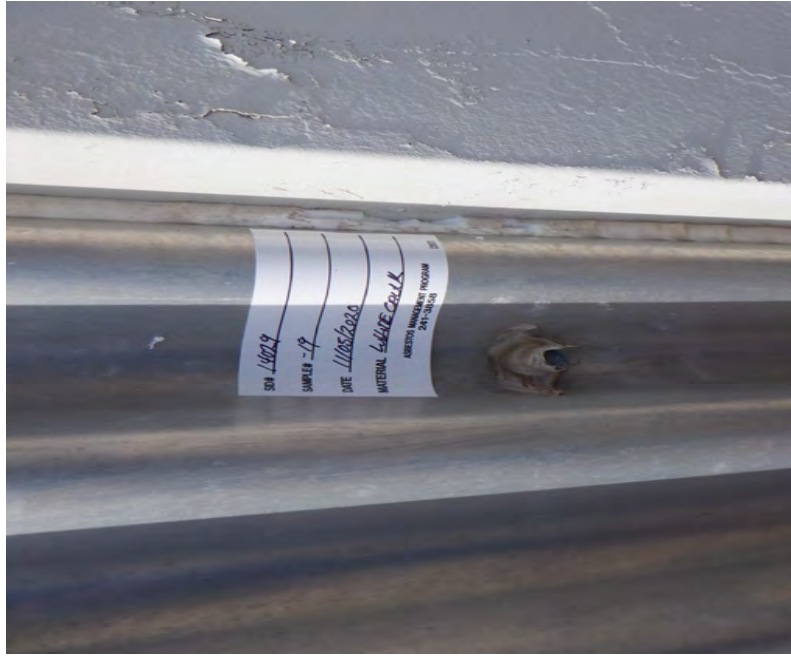
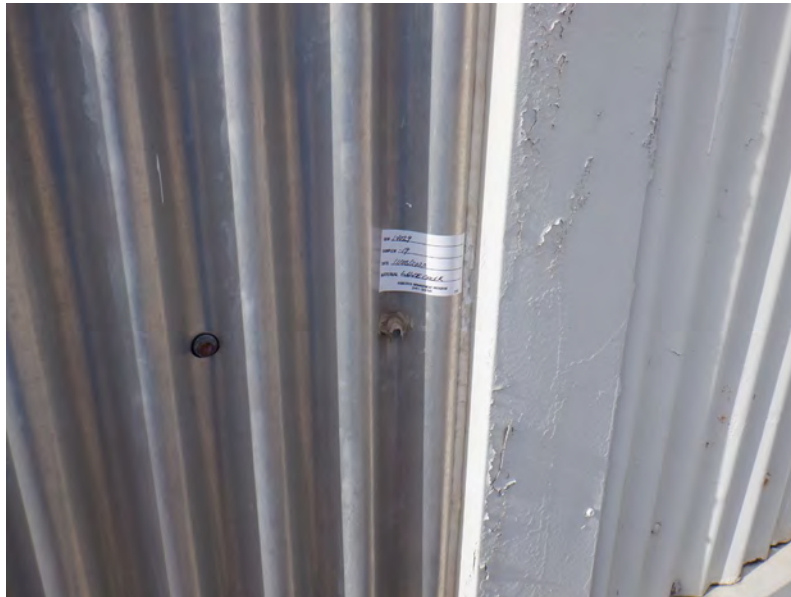
<b>HA Description</b>	<b>White Caulk</b>
	<b>Sample #</b>	<b>SID14029-19</b>
	<b>Sample Location / Orientation</b>	<b>SE Building exterior</b>
	<b>Sample/Inspection Results</b>	<b>SID14029-19 – None Detected</b>
	<b>Recommendation</b>	<b>None</b>

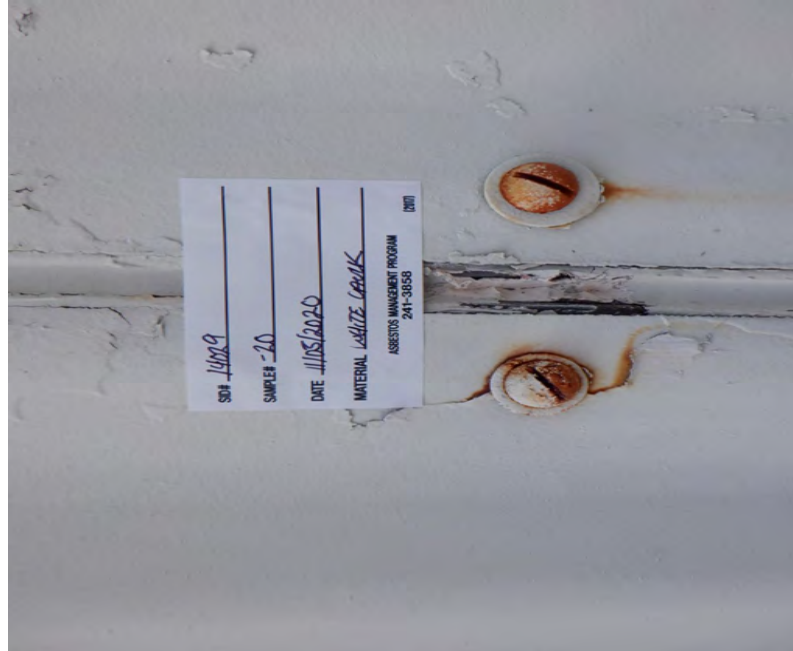
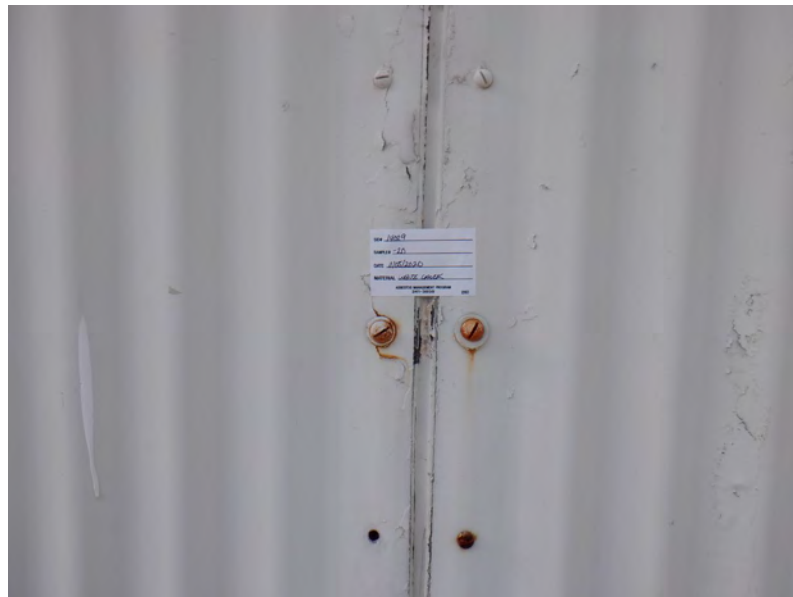
<b>HA Description</b>	White Caulk
	<b>Sample #</b>	SID14029-20
	<b>Sample Location / Orientation</b>	East Building exterior
	<b>Sample/Inspection Results</b>	SID14029-20 – None Detected
	<b>Recommendation</b>	None

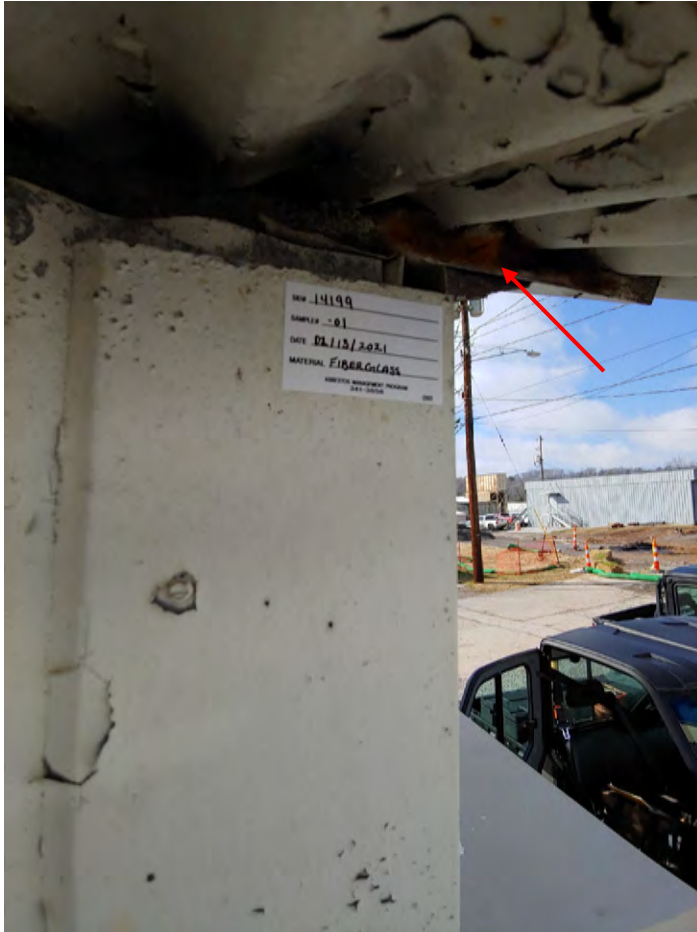
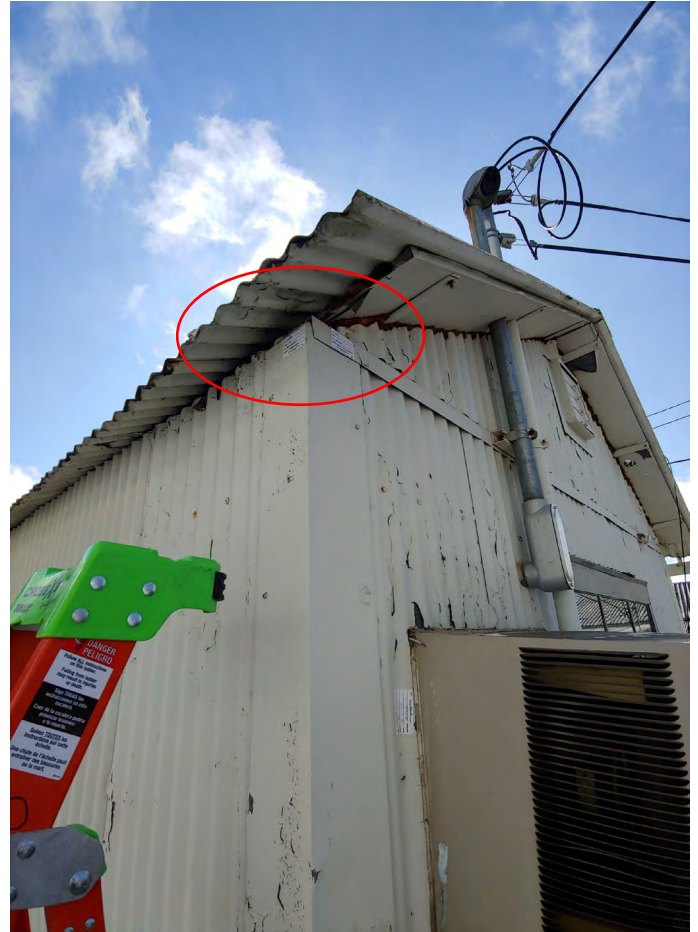
<b>HA Description</b>	WHITE FIBERGLASS INSULATION
	<b>Sample #</b>	SID14199-01
	<b>Sample Location / Orientation</b>	SID14199-01– Northeast corner of building exterior
	<b>Sample/Inspection Results</b>	SID14199-01- None Detected
	<b>Recommendation</b>	None

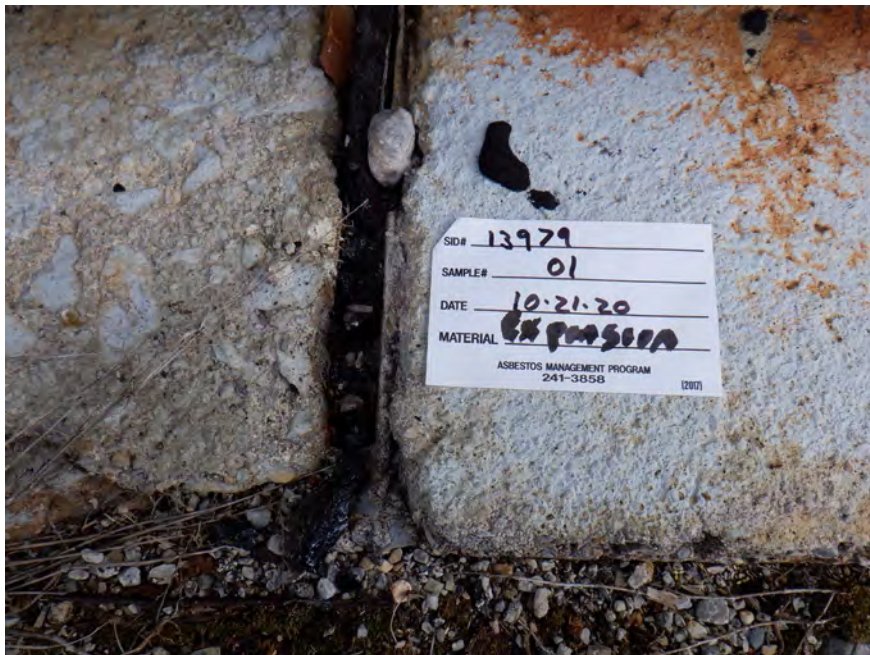
<b>HA Description</b>	<b>Black expansion joint</b>
	<b>Sample #</b>	<b>SID13979-01</b>
	<b>Sample Location / Orientation</b>	<b>East side of building below green gate.</b>
	<b>Sample/Inspection Results</b>	<b>SID13979-01 - None Detected</b>
	<b>Recommendation</b>	<b>None</b>

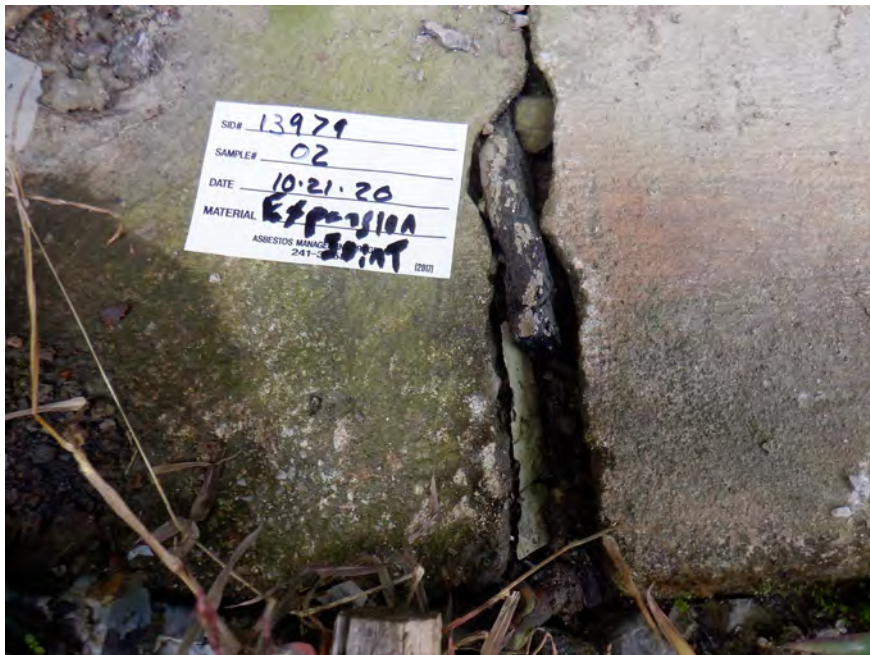
<b>HA Description</b>	<b>Black expansion joint</b>
	<b>Sample #</b>	<b>SID13979-02</b>
	<b>Sample Location / Orientation</b>	<b>West side of building below lumber storage gate.</b>
	<b>Sample/Inspection Results</b>	<b>SID13979-02 - None Detected</b>
	<b>Recommendation</b>	<b>None</b>

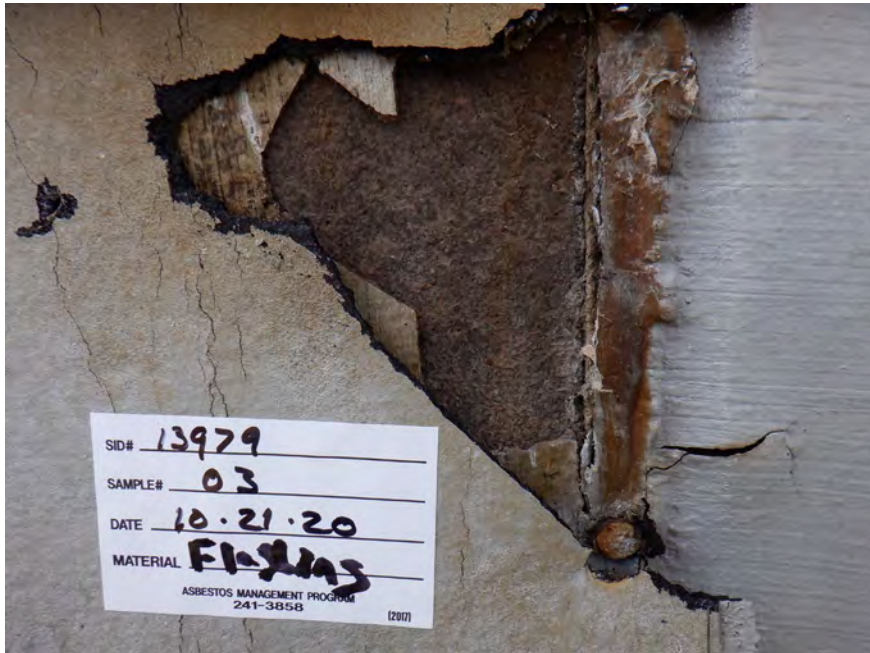
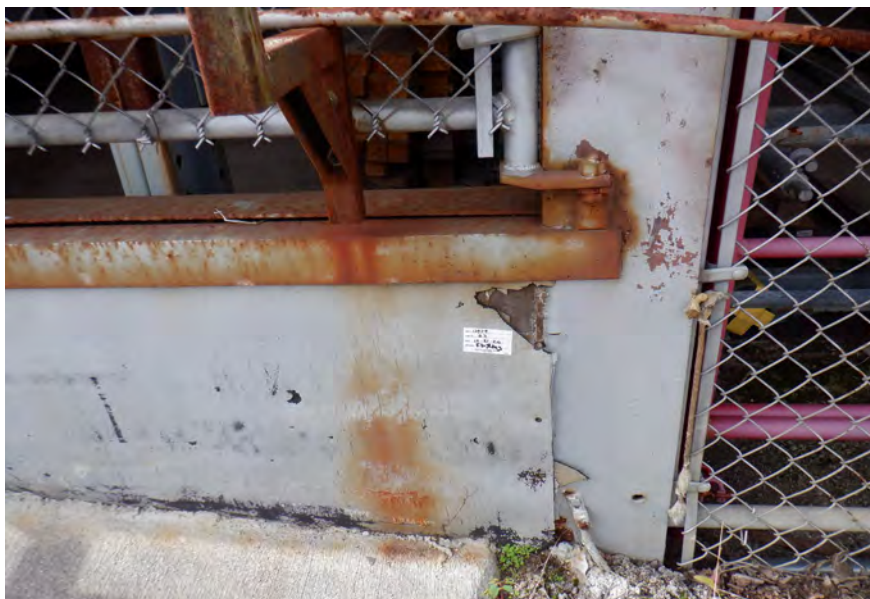
<b>HA Description</b>	<b>Black tar flashing w/white paper cover</b>
	<b>Sample #</b>	<b>SID13979-03</b>
	<b>Sample Location / Orientation</b>	<b>East side of building in front of lumber storage. North of sample 04.</b>
	<b>Sample/Inspection Results</b>	<b>SID13979-03 - 3% Asbestos Chrysotile – Silver Paint None Detected - Black Tar Felt</b>
	<b>Recommendation</b>	<b>Silver Paint Coating on Flashing is ACM.</b>

Bulk sample results revealed the silver paint layer of roof flashing material located at ground level on the east facing foundation of building was 3% asbestos chrysotile and the black roof tar material located on the roof screws as <1% asbestos chrysotile. This black tar on the roof screws was all over entire roof. The roof flashing on the foundation has concrete block behind it. This is 18 feet long and ranges from 5 inches to 2 feet in height. All other sampled material results such as expansion joints, suspended ceiling tiles, roof coating and miscellaneous caulking at ground level were None Detected; therefore, no asbestos was seen during analysis of those materials. See expansion joint sample map for sample locations of roof flashing.

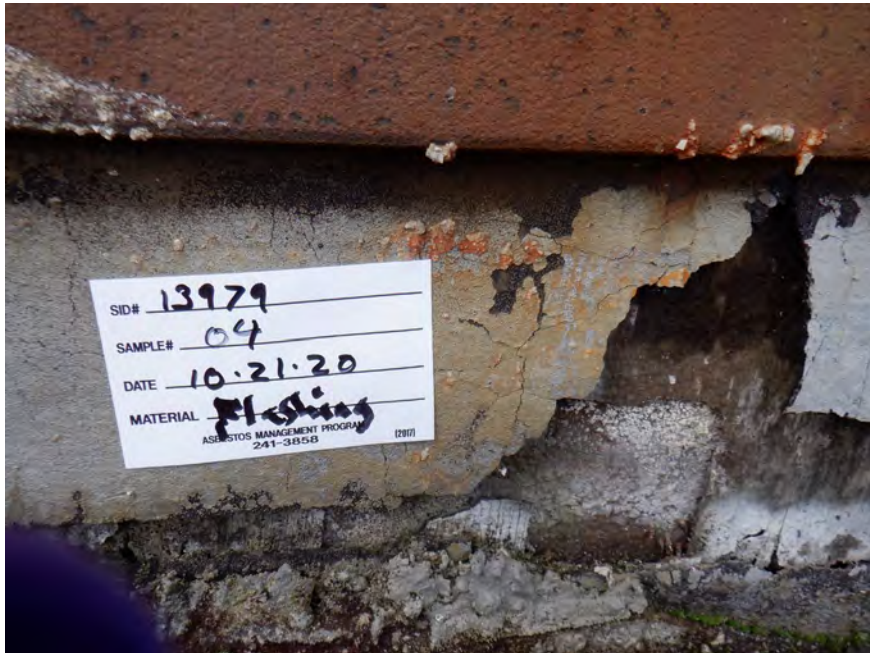
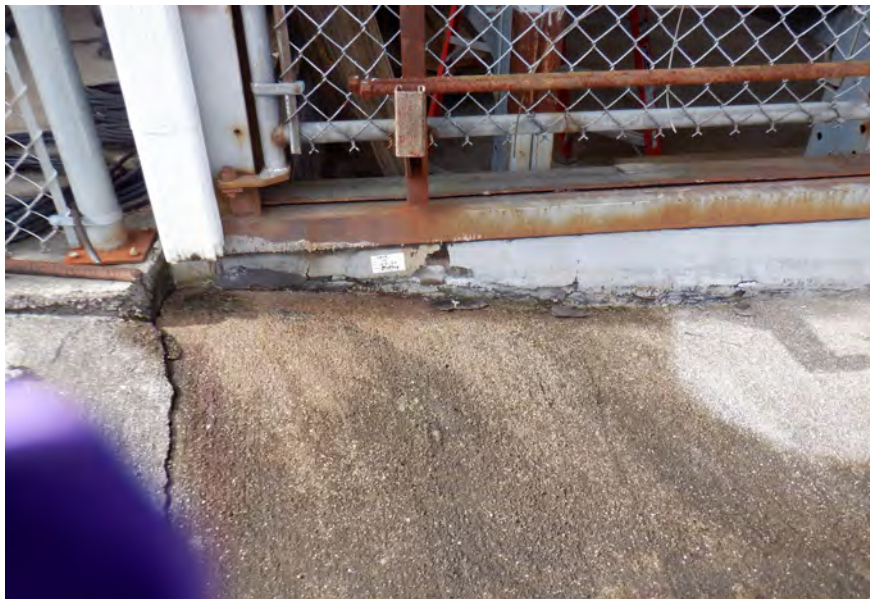
<b>HA Description</b>	Black tar flashing w/white paper cover
	<b>Sample #</b>	SID13979-04
	<b>Sample Location / Orientation</b>	East side of building in front of lumber storage. South of sample 03.
	<b>Sample/Inspection Results</b>	SID13979-04 - 3% Asbestos Chrysotile – Silver Paint None Detected - Black Tar Felt
	<b>Recommendation</b>	Silver Paint Coating on Flashing is ACM.

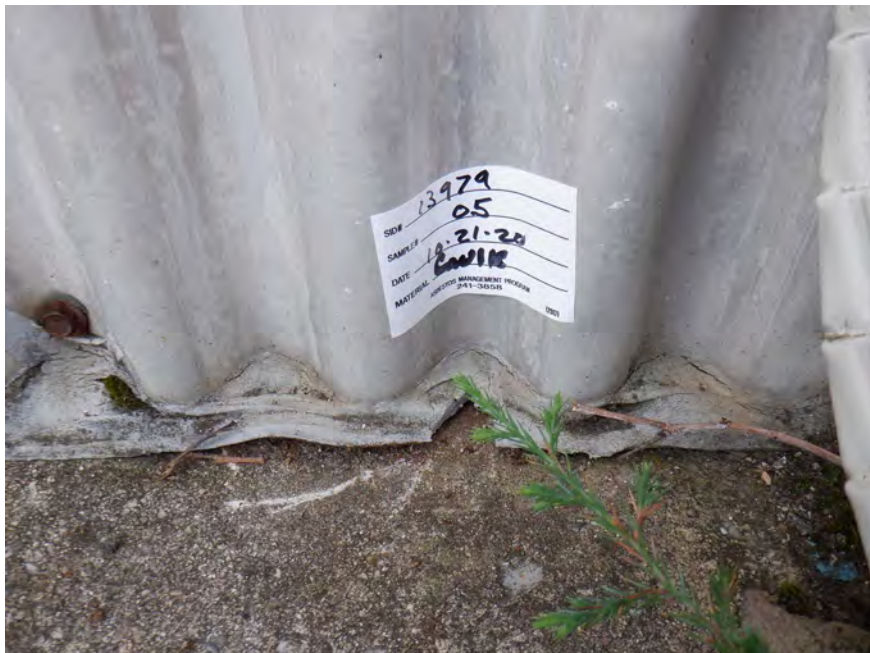
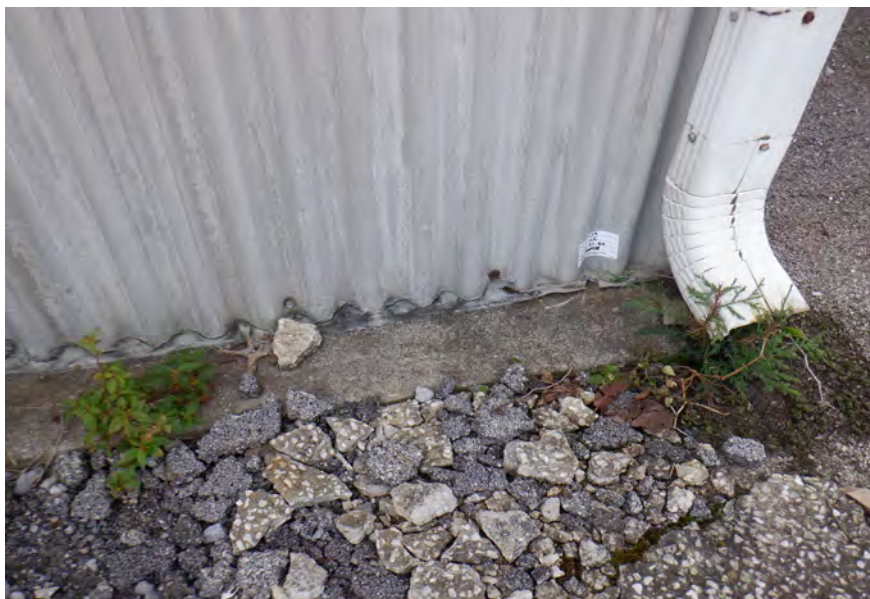
<b>HA Description</b>	Gray caulk
<b>Sample #</b>	SID13979-05
<b>Sample Location / Orientation</b>	Outside NE corner of building on east side. Between corrugated metal wall and concrete floor. North of sample 06.
<b>Sample/Inspection Results</b>	SID13979-05 -None Detected
<b>Recommendation</b>	None

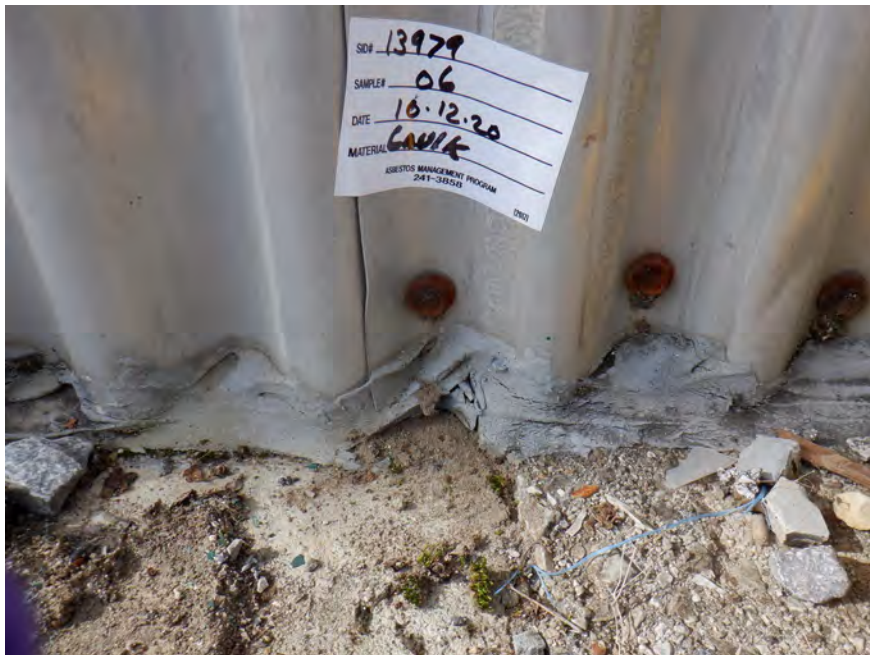
<b>HA Description</b>	Gray caulk
	<b>Sample #</b>	SID13979-06
	<b>Sample Location / Orientation</b>	Outside east side of building. Between corrugated metal wall and concrete floor. South of sample 05.
	<b>Sample/Inspection Results</b>	SID13979-06 - None Detected
	<b>Recommendation</b>	None

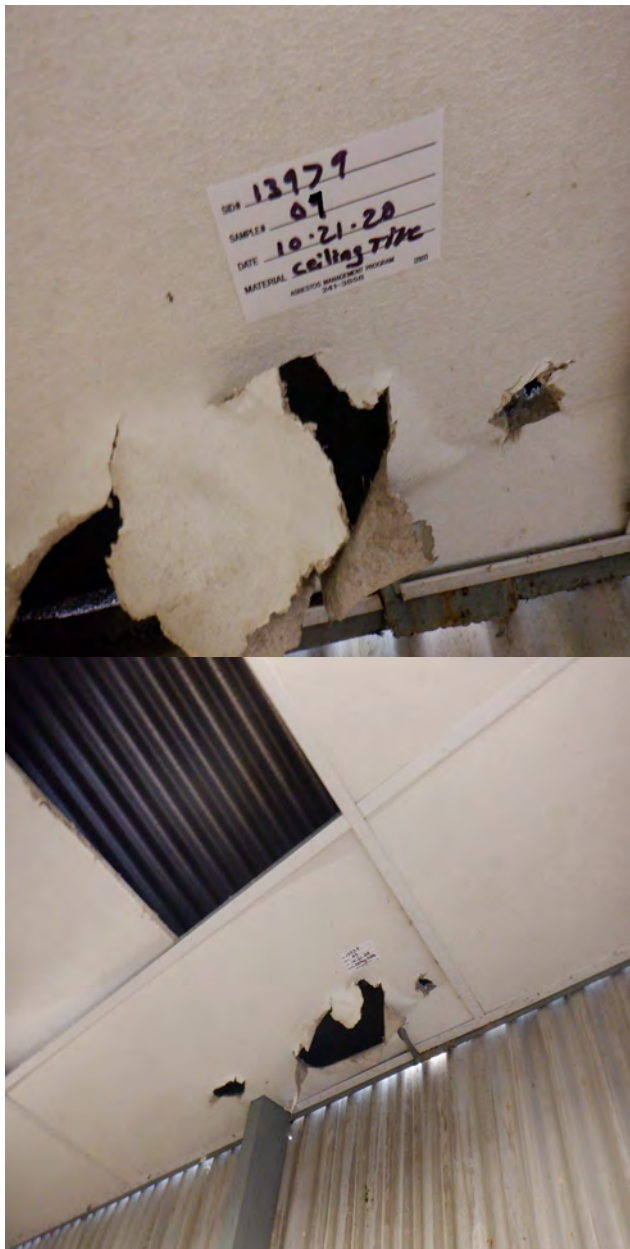
<b>HA Description</b>	Cellulose ceiling tile (2X4)
	<b>Sample #</b>	SID13979-07
	<b>Sample Location / Orientation</b>	East side of compactor room (room 03).
	<b>Sample/Inspection Results</b>	SID13979-07 - None Detected
	<b>Recommendation</b>	None

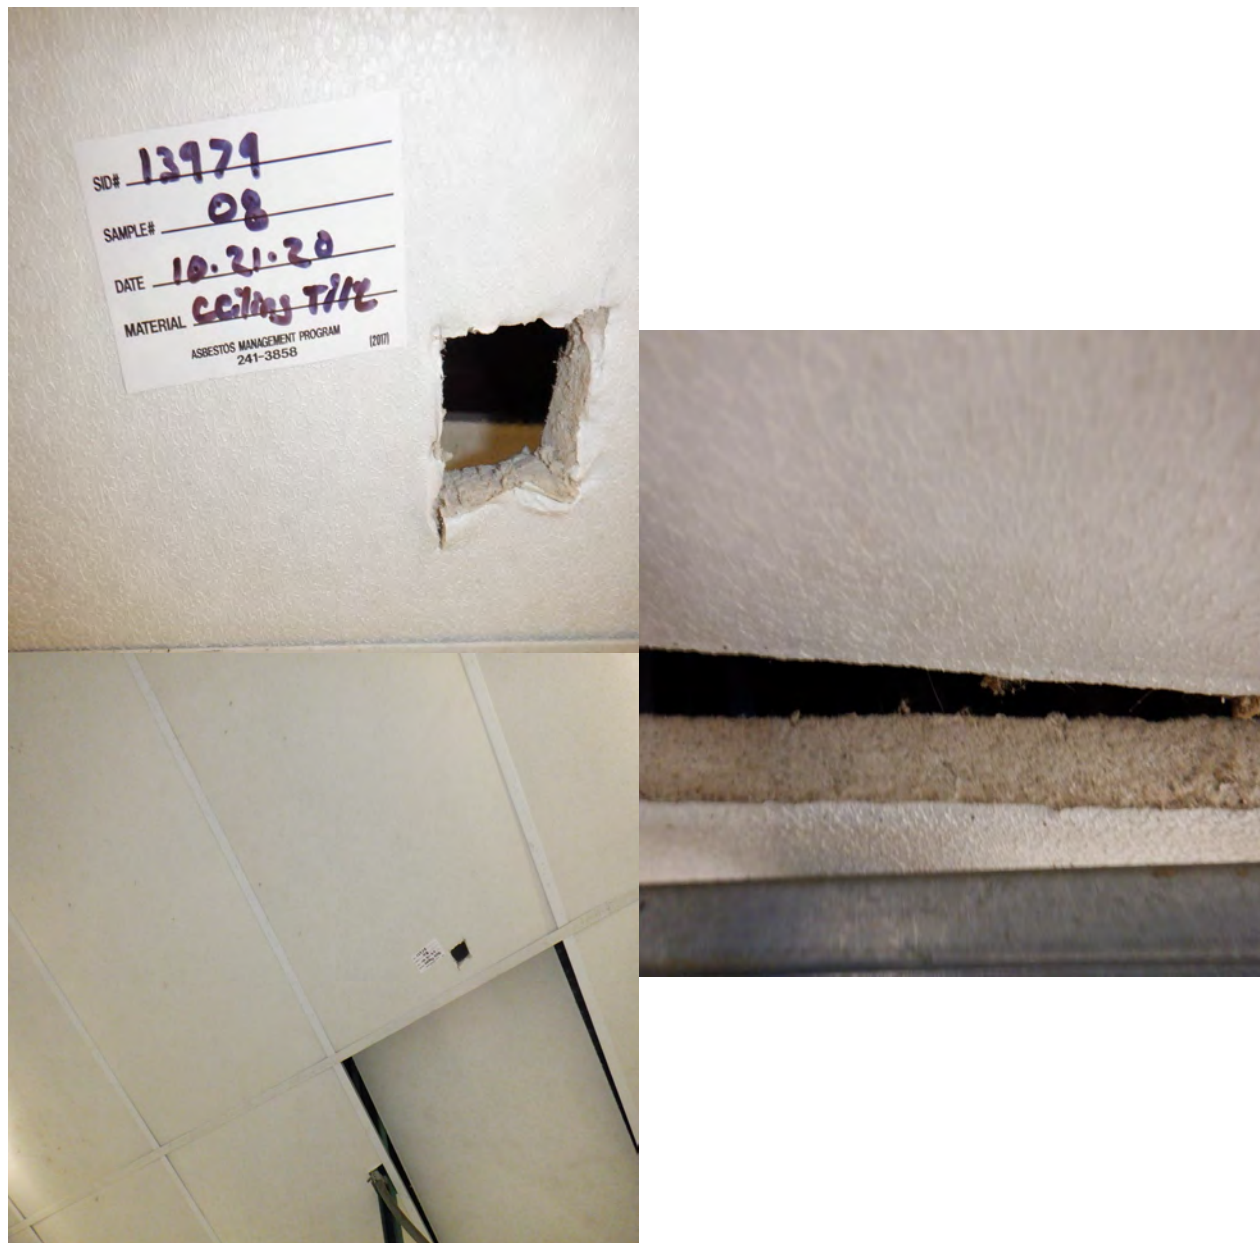
<b>HA Description</b>	Cellulose ceiling tile (2X4)
	<b>Sample #</b>	SID13979-08
	<b>Sample Location / Orientation</b>	Center of compactor room (room 03).
	<b>Sample/Inspection Results</b>	SID13979-08 - None Detected
	<b>Recommendation</b>	None

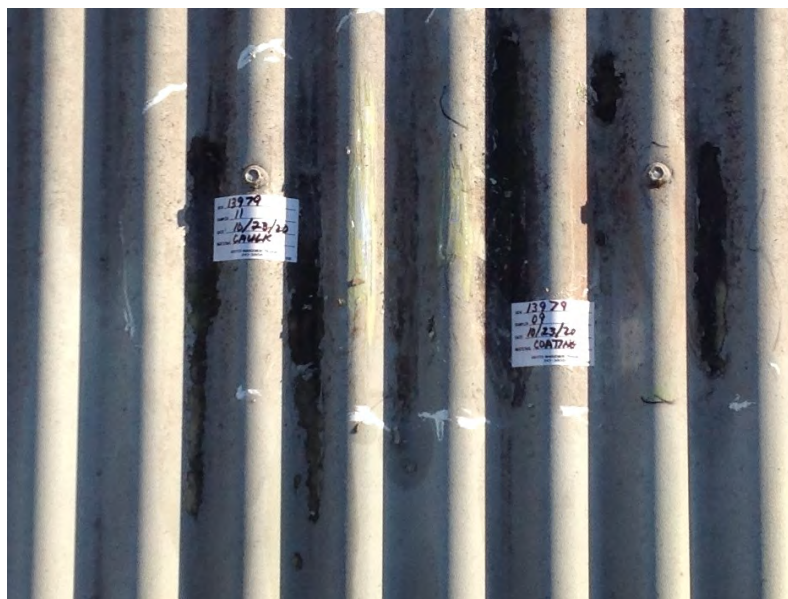
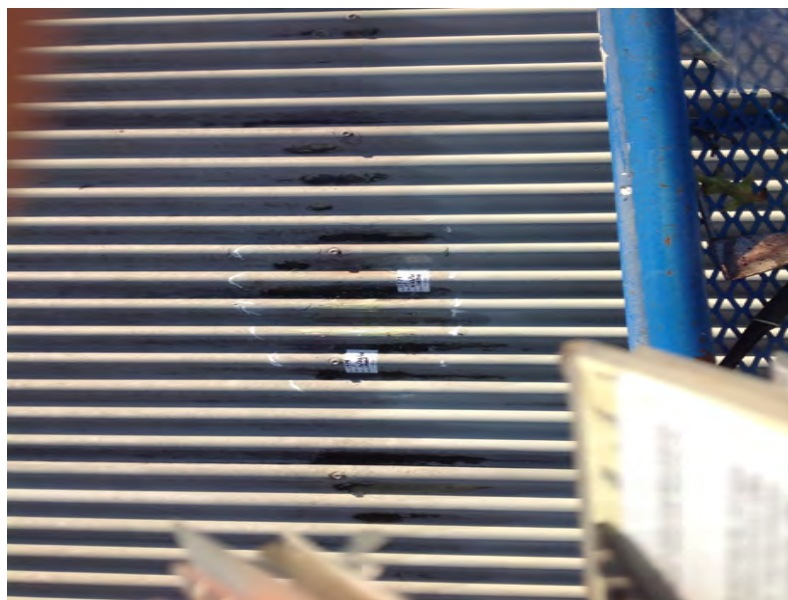
<b>HA Description</b>	Green roof coating
	<b>Sample #</b>	SID13979-09
	<b>Sample Location / Orientation</b>	West side middle.
	<b>Sample/Inspection Results</b>	SID13979-09 - None Detected
	<b>Recommendation</b>	None

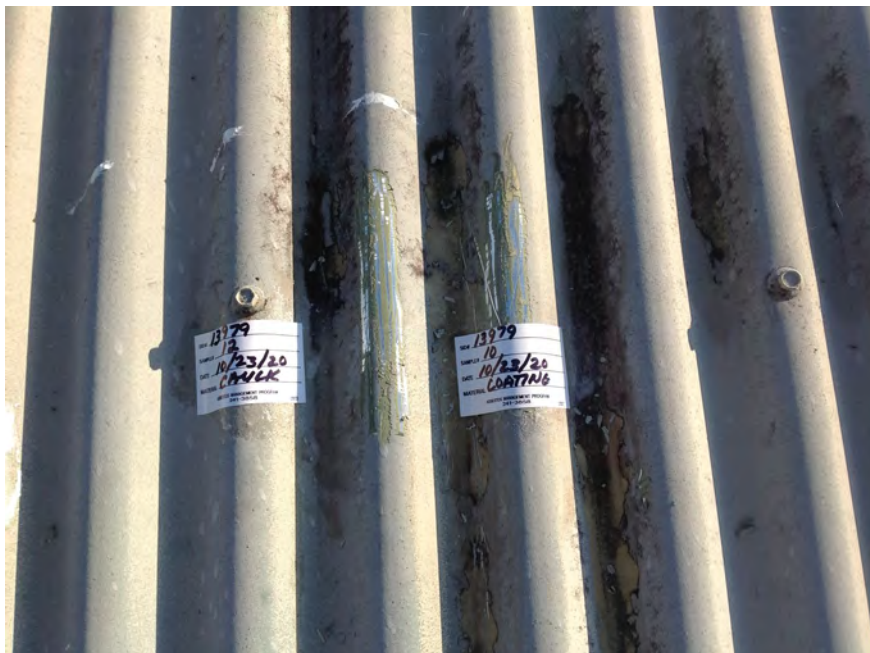
<b>HA Description</b>	<b>Green roof coating</b>
	<b>Sample #</b>	<b>SID13979-10</b>
	<b>Sample Location / Orientation</b>	<b>West side around screws.</b>
	<b>Sample/Inspection Results</b>	<b>SID13979-10 - None Detected</b>
	<b>Recommendation</b>	<b>None</b>

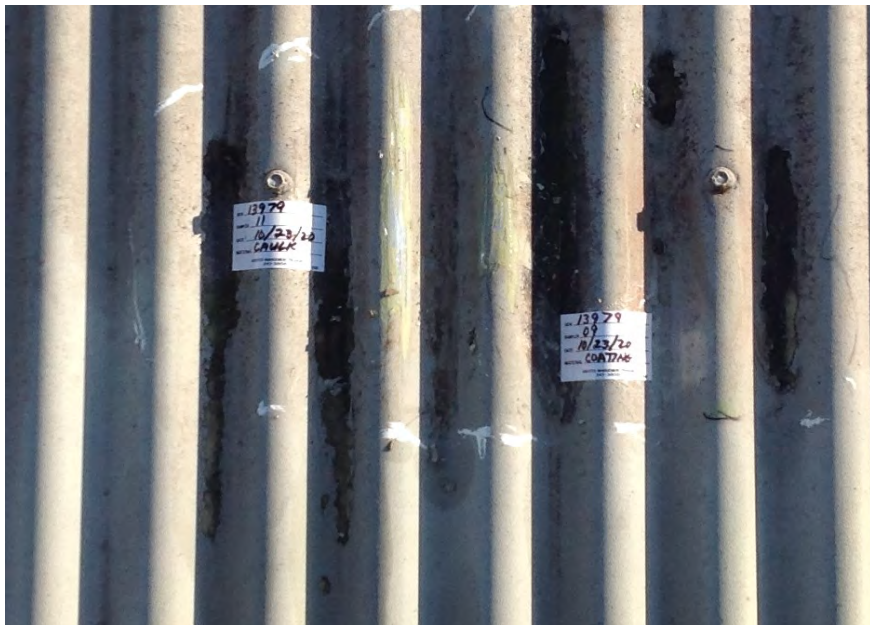
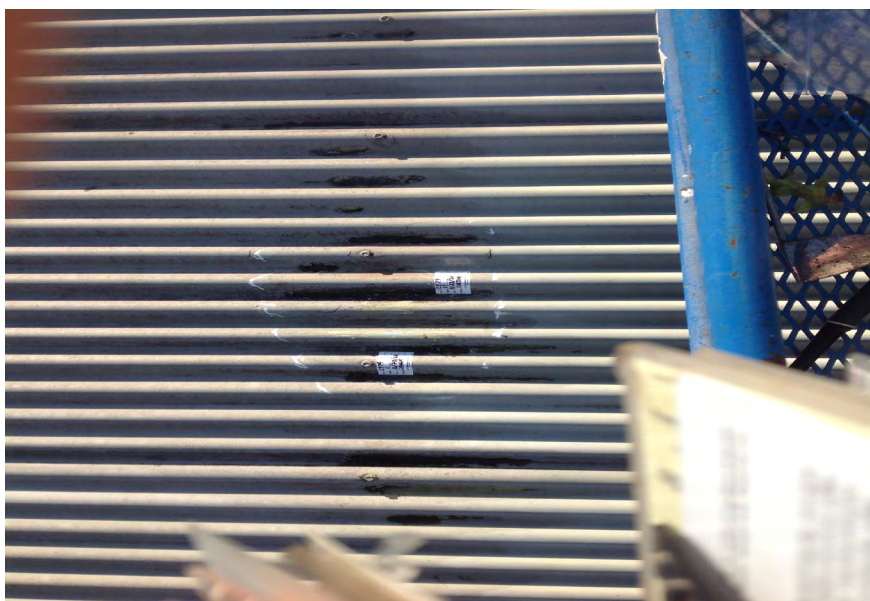
<b>HA Description</b>	Black roof tar
	<b>Sample #</b>	SID13979-11
	<b>Sample Location / Orientation</b>	West side middle.
	<b>Sample/Inspection Results</b>	SID13979-11 - None Detected
	<b>Recommendation</b>	None

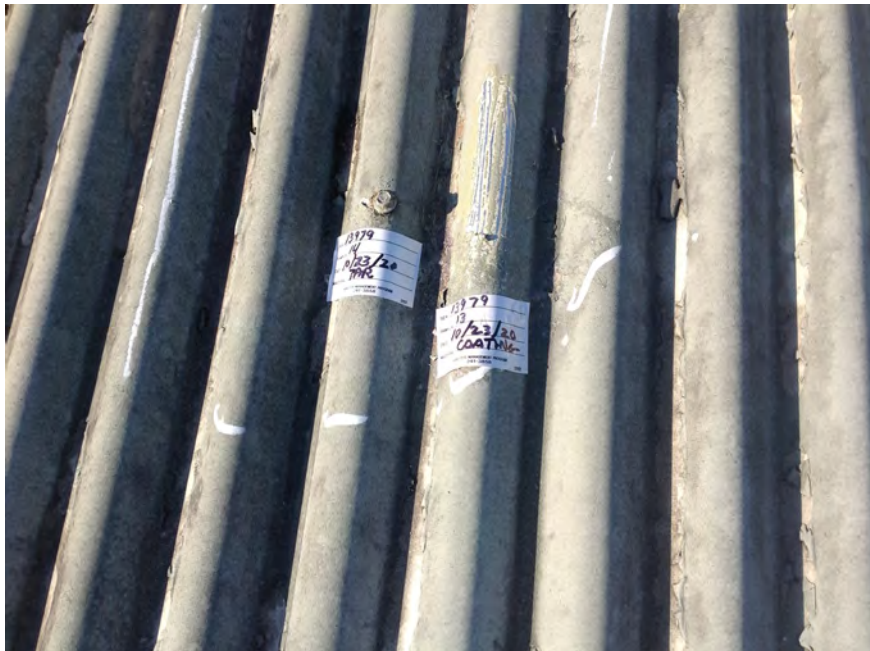
<b>HA Description</b>	Black roof coating
	<b>Sample #</b>	SID13979-13
	<b>Sample Location / Orientation</b>	South east roof
	<b>Sample/Inspection Results</b>	SID13979-13 - None Detected
	<b>Recommendation</b>	None
