**Scope of Work and Specifications**

**CRSF Building Demolition**

**OAK RIDGE NATIONAL LABORATORY**

**March 2021**

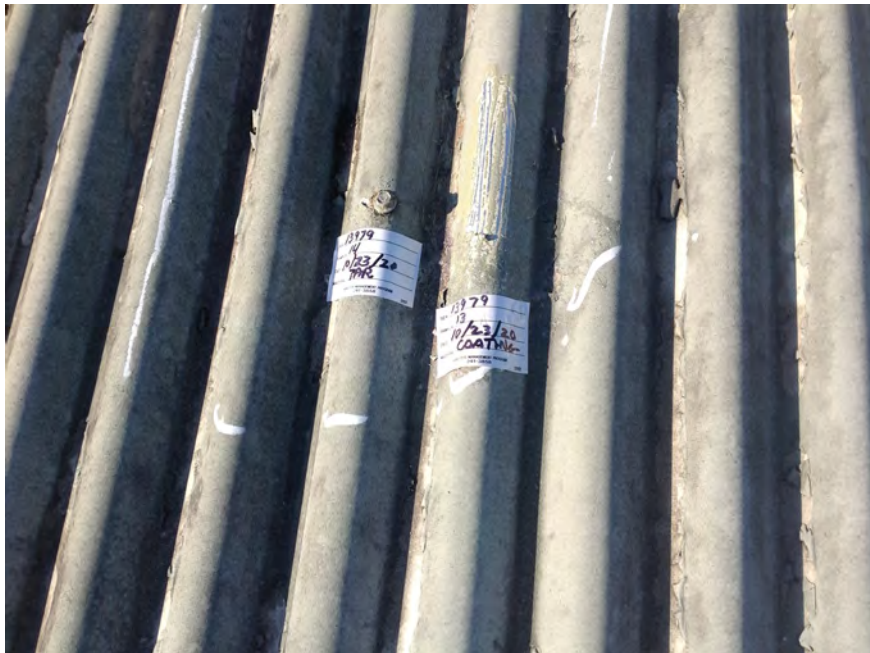
<b>HA Description</b>	Black roof tar
	<b>Sample #</b>	SID13979-14
	<b>Sample Location / Orientation</b>	West side around screws.
	<b>Sample/Inspection Results</b>	SID13979-14 - None Detected
	<b>Recommendation</b>	None

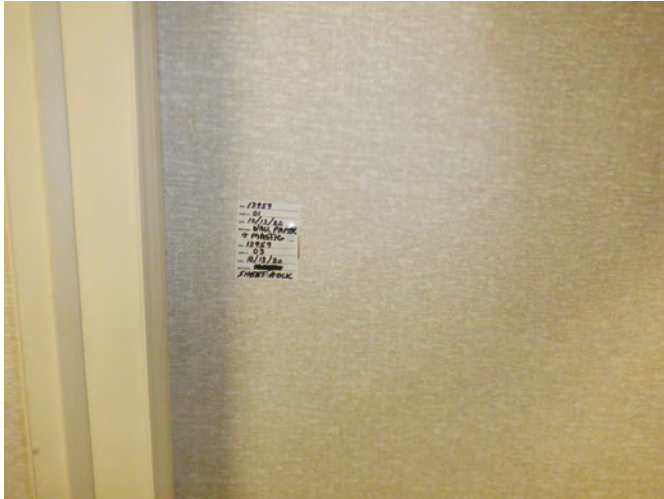
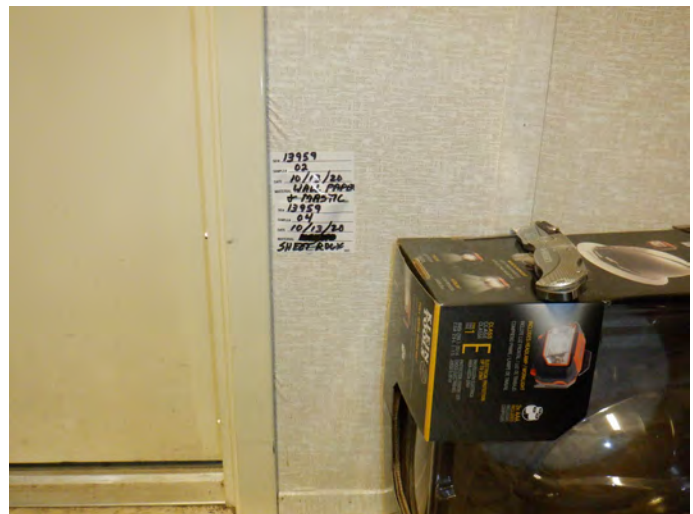
<b>HA Description</b>	TAN AND WHITE WALLPAPER W/ ASSOCIATED MASTIC
	<b>Sample #</b>	SID13959-01 SID13959-02
	<b>Sample Location / Orientation</b>	SID13959-01– Southwest corner SID13959-02 – Northwest corner
	<b>Sample/Inspection Results</b>	SID13959-01 – None Detected SID13959-02 – None Detected
	<b>Recommendation</b>	None

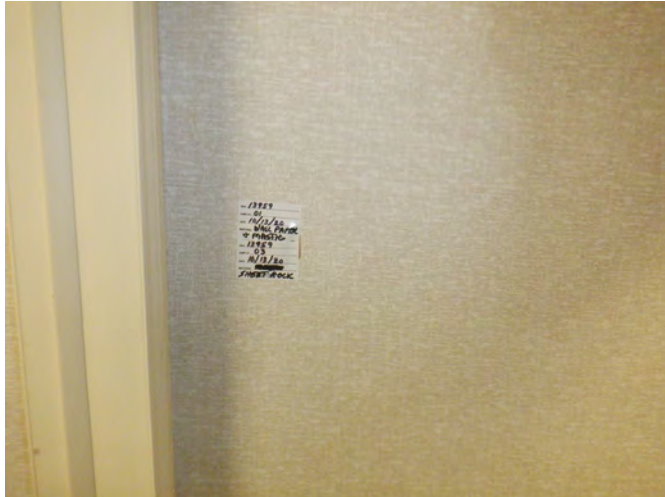
<b>HA Description</b>	DRYWALL (SHEETROCK)
	<b>Sample #</b>	SID13959-03 SID13959-04
	<b>Sample Location / Orientation</b>	SID13959-03 – Southwest corner, behind wallpaper SID13959-04 – Northwest corner, behind wallpaper
	<b>Sample/Inspection Results</b>	SID13959-03 – None Detected SID13959-04 – None Detected
	<b>Recommendation</b>	None

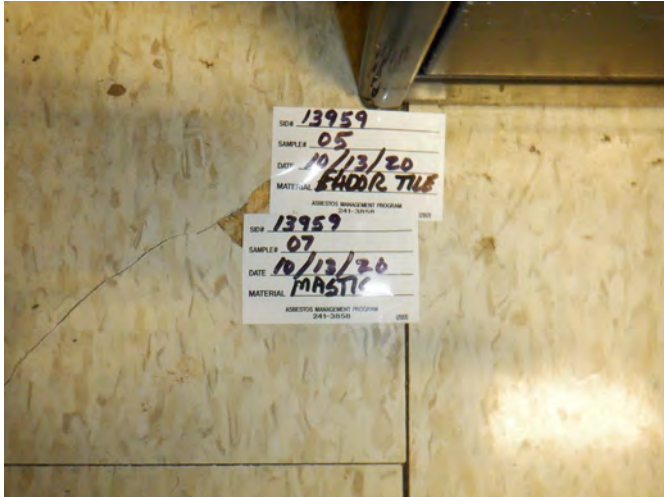
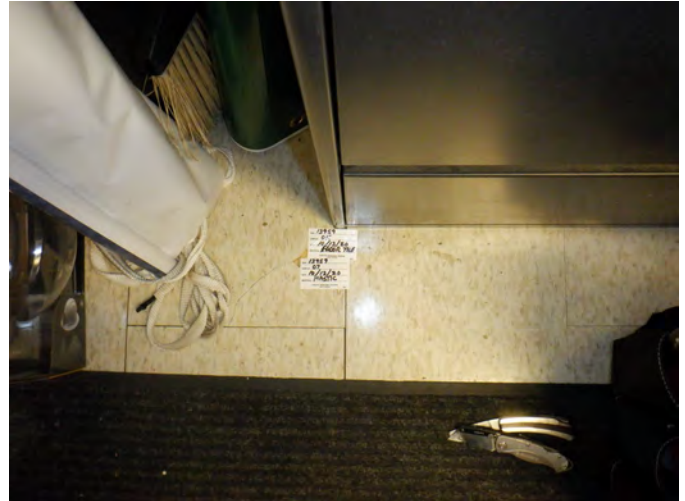
<b>HA Description</b>	12X12 BEIGE WITH BROWN AND TAN MARBLED TILE
	<b>Sample #</b>	SID13959-05 SID13959-06
	<b>Sample Location / Orientation</b>	SID13959-05– Northwest corner SID13959-06 – North side of room
	<b>Sample/Inspection Results</b>	SID13959-05 – None Detected SID13959-06 – None Detected
	<b>Recommendation</b>	None

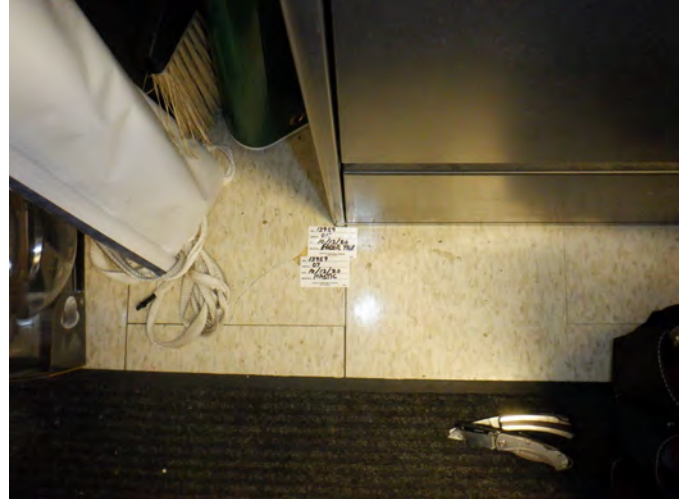
<b>HA Description</b>	YELLOW MASTIC ASSOCIATED W/ 12X12 BEIGE WITH BROWN AND TAN MARBLED TILE
	<b>Sample #</b>	<b>SID13959-07</b> <b>SID13959-08</b>
	<b>Sample Location / Orientation</b>	SID13959-07– Northwest corner SID13959-08 – North side of room
	<b>Sample/Inspection Results</b>	SID13959-07 – None Detected SID13959-08 – None Detected
	<b>Recommendation</b>	None

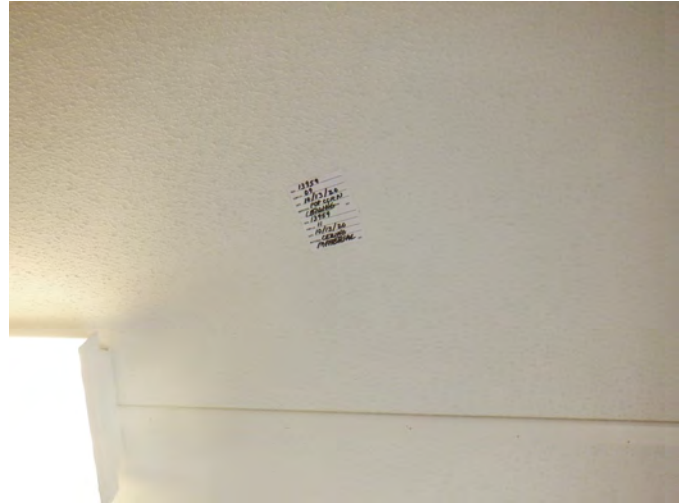
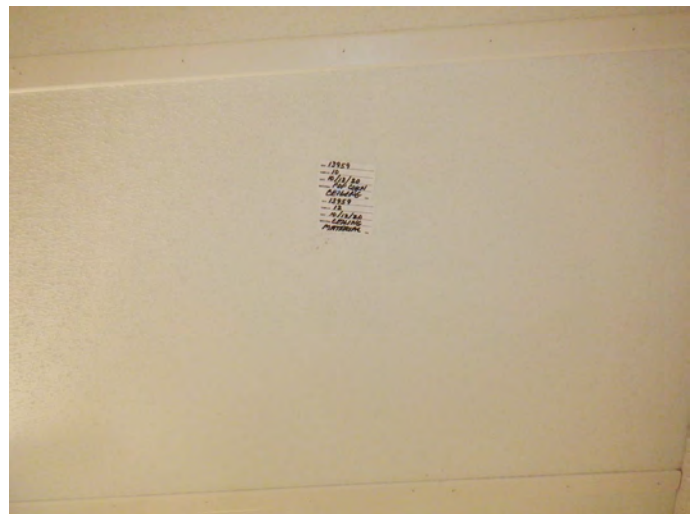
<b>HA Description</b>	TEXTURED, POPCORN CEILING (Spray-Applied Coating) MATERIAL
	<b>Sample #</b>	SID13959-09 SID13959-10
	<b>Sample Location / Orientation</b>	SID13959-09 – North side of building SID13959-10 – Center of the building
	<b>Sample/Inspection Results</b>	SID13959-09 – None Detected SID13959-10 – None Detected
	<b>Recommendation</b>	None

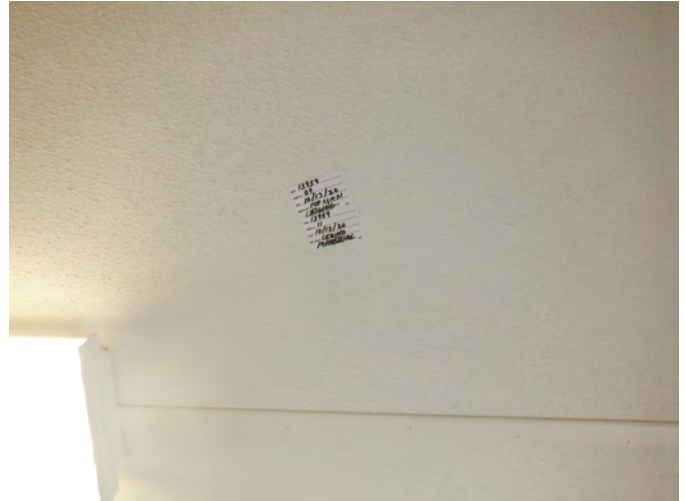
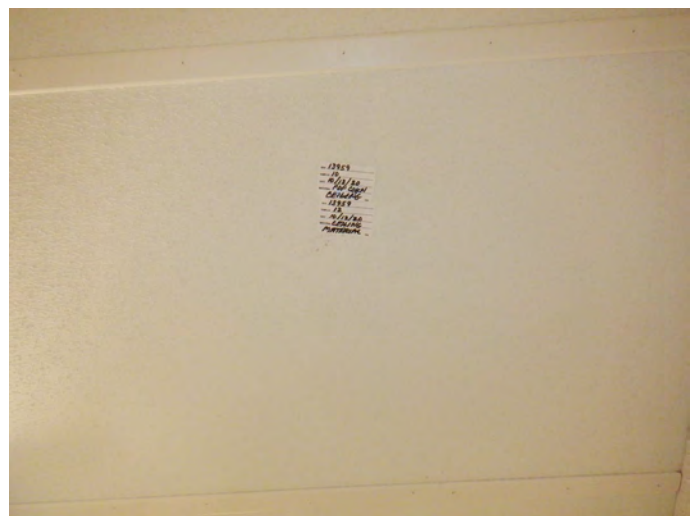
<b>HA Description</b>	CEILING MATERIAL (Drywall)
	<b>Sample #</b>	SID13959-11 SID13959-12
	<b>Sample Location / Orientation</b>	SID13959-11 – North side of building SID13959-12 – Center of the building
	<b>Sample/Inspection Results</b>	SID13959-11 – None Detected SID13959-12 – None Detected
	<b>Recommendation</b>	None

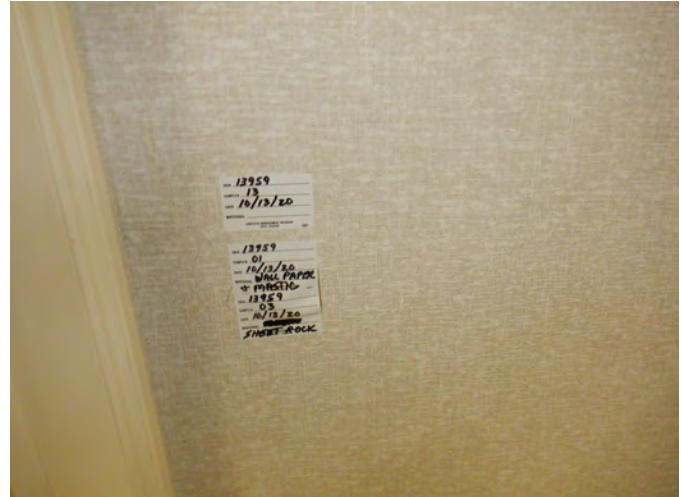
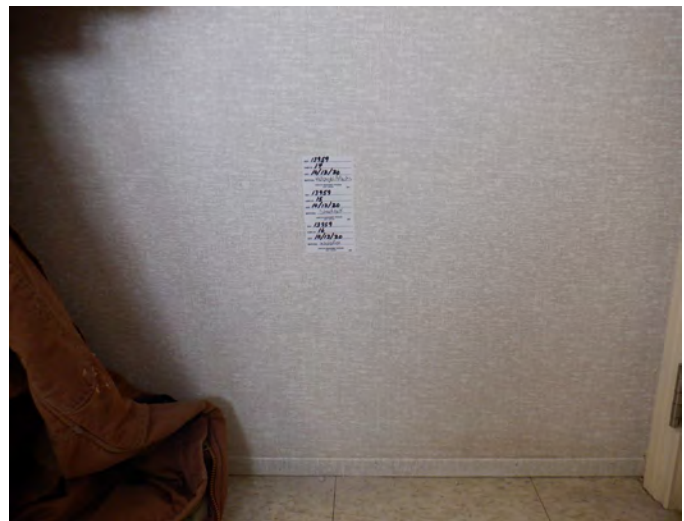
<b>HA Description</b>	WHITE FIBERGLASS INSULATION
	<b>Sample #</b>	SID13959-13 SID13959-16
	<b>Sample Location / Orientation</b>	SID13959-13 – Southwest corner SID13959-16 – Southwest wall
	<b>Sample/Inspection Results</b>	SID13959-13 –None Detected SID13959-16 – None Detected
	<b>Recommendation</b>	None

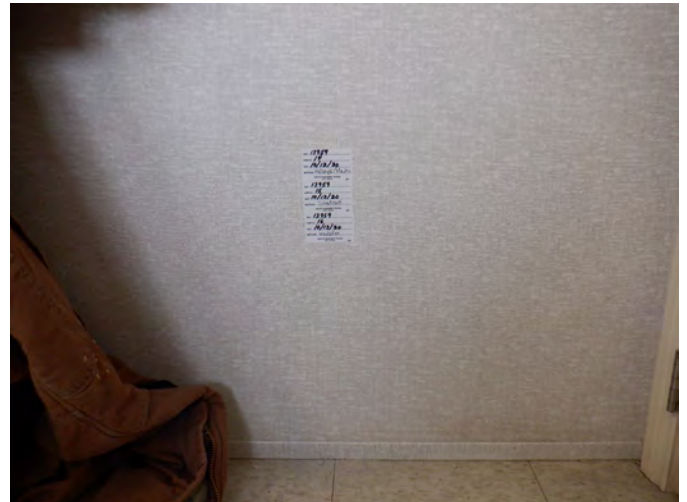
<b>HA Description</b>	WALLPAPER AND ASSOCIATED MASTIC
	<b>Sample #</b>	SID13959-14
	<b>Sample Location / Orientation</b>	SID13959-14 – Southwest corner
	<b>Sample/Inspection Results</b>	SID13959-14 – None Detected
	<b>Recommendation</b>	None

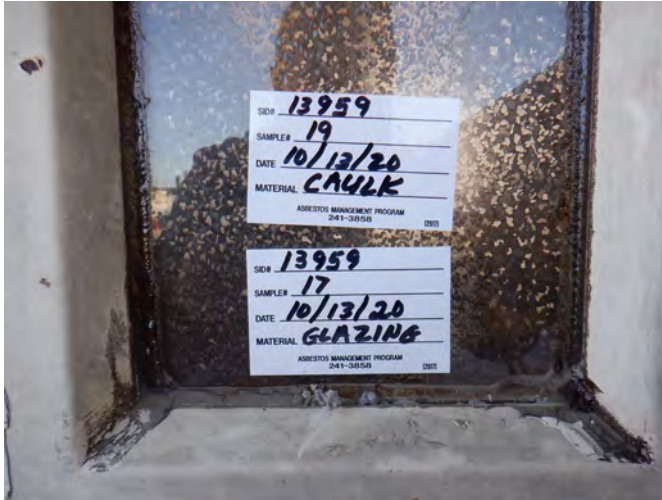
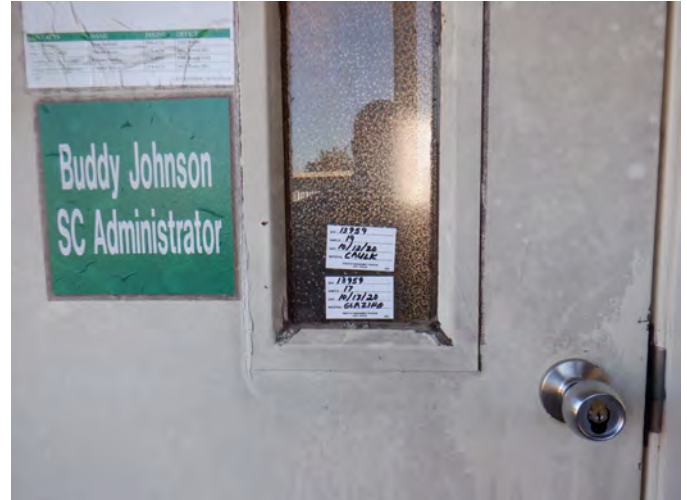
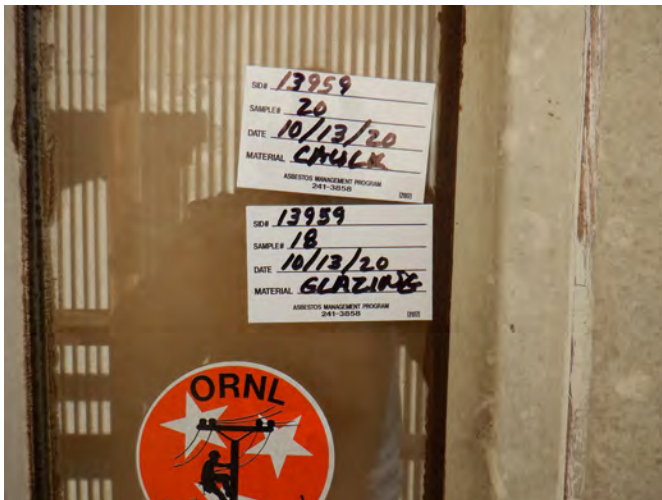
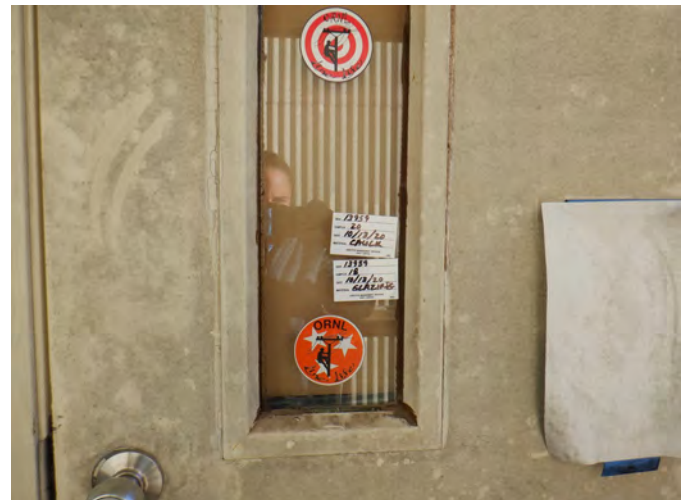
<b>HA Description</b>	BLACK WINDOW GLAZING
	<b>Sample #</b>	SID13959-17 SID13959-18
	<b>Sample Location / Orientation</b>	SID13959-17 – Northwest door (exterior) SID13959-18 – Southwest door (exterior)
	<b>Sample/Inspection Results</b>	SID13959-17 – None Detected SID13959-18 – None Detected
	<b>Recommendation</b>	None

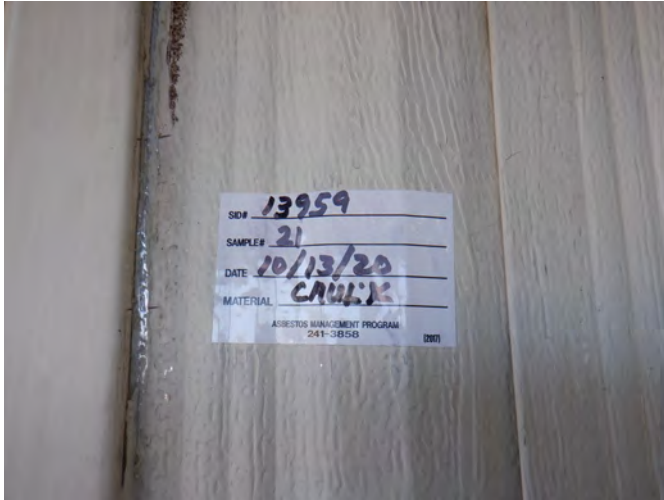
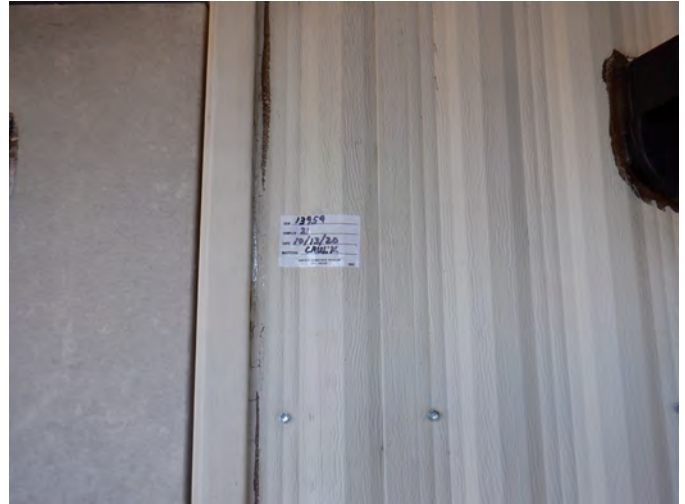
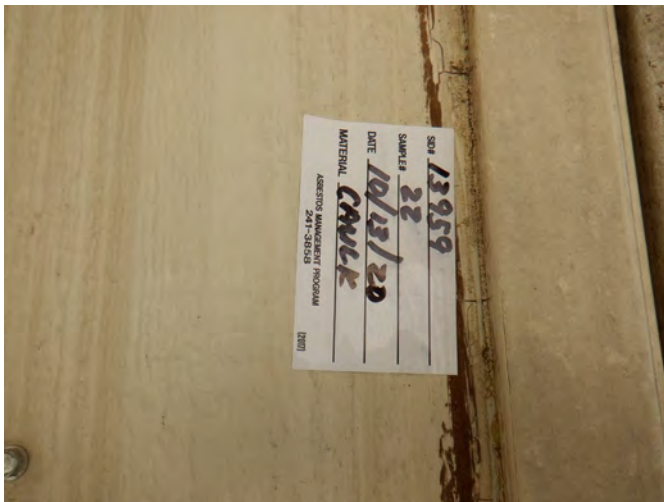
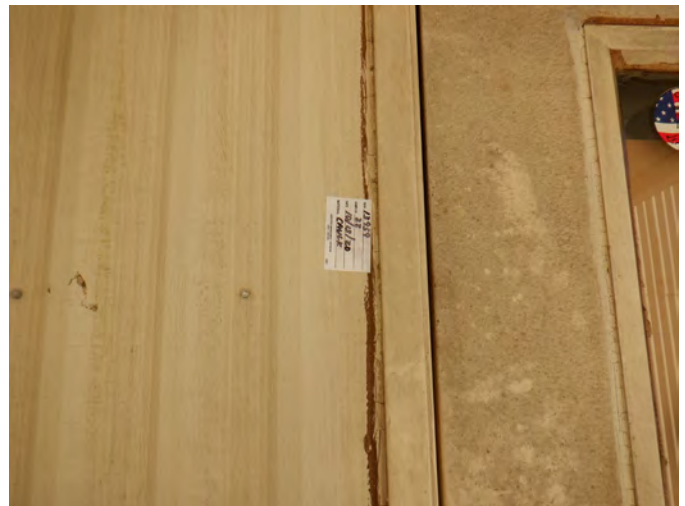
<b>HA Description</b>	WHITE CAULK PAINTED CREAM
	<b>Sample #</b>	SID13959-21 SID13959-22
	<b>Sample Location / Orientation</b>	SID13959-21 – Northwest door SID13959-22 – Southwest door
	<b>Sample/Inspection Results</b>	SID13959-21 – None Detected SID13959-22 – None Detected
	<b>Recommendation</b>	None

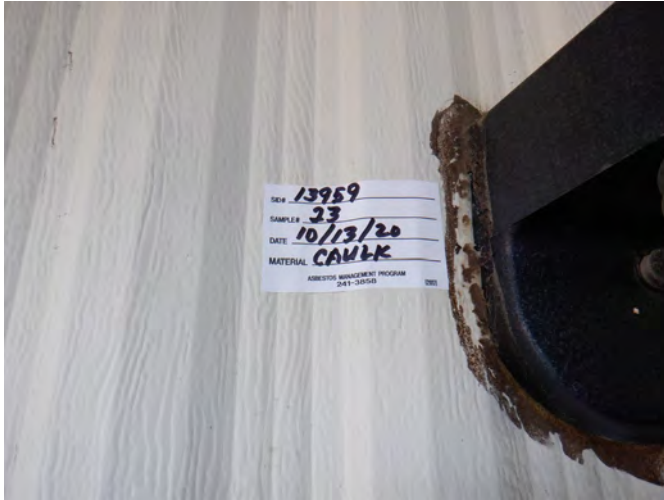
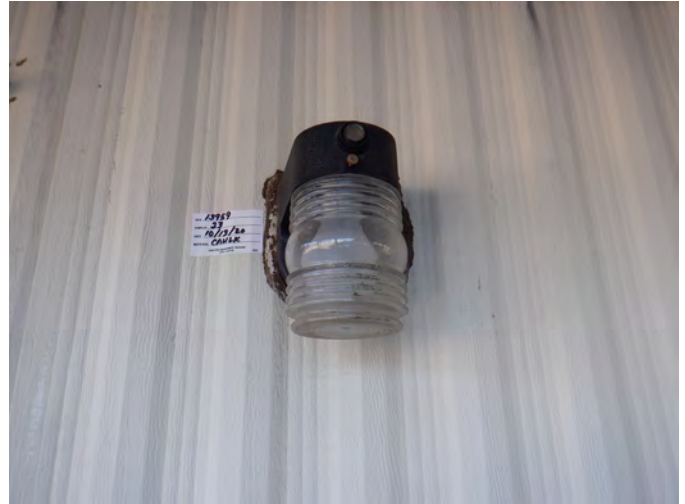
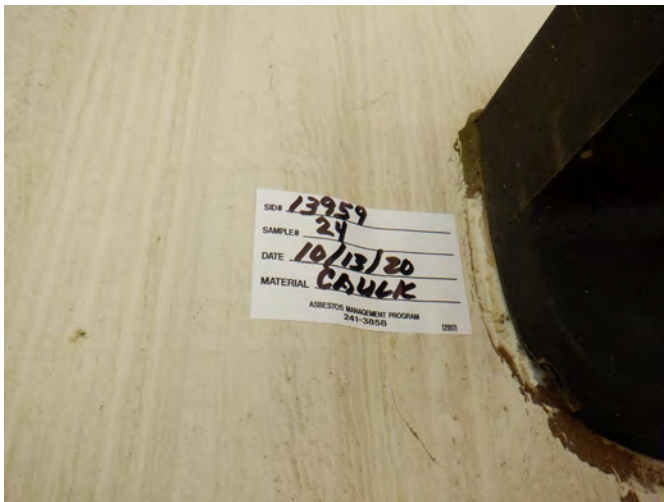
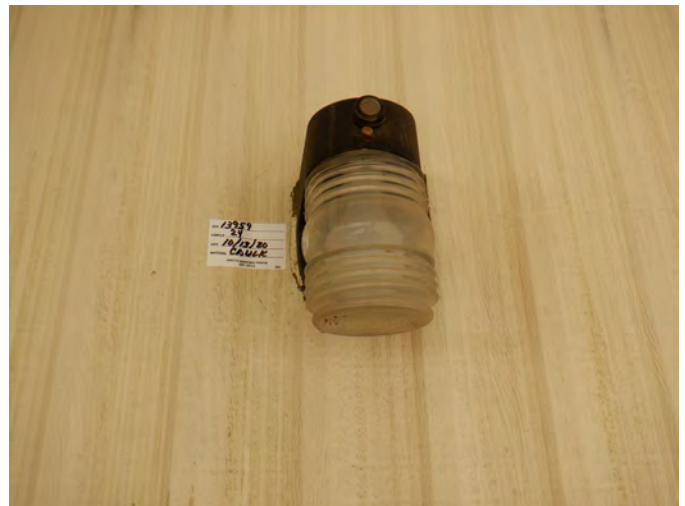
<b>HA Description</b>	CLEAR CAULK
	<b>Sample #</b>	<b>SID13959-23</b> <b>SID13959-24</b>
	<b>Sample Location / Orientation</b>	SID13959-23 – Northwest outside light SID13959-24 – Southwest outside light
	<b>Sample/Inspection Results</b>	SID13959-23 – None Detected SID13959-24 – None Detected
	<b>Recommendation</b>	None

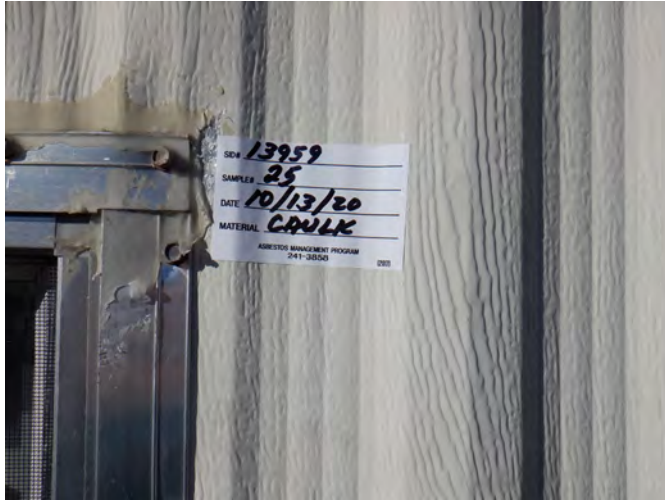
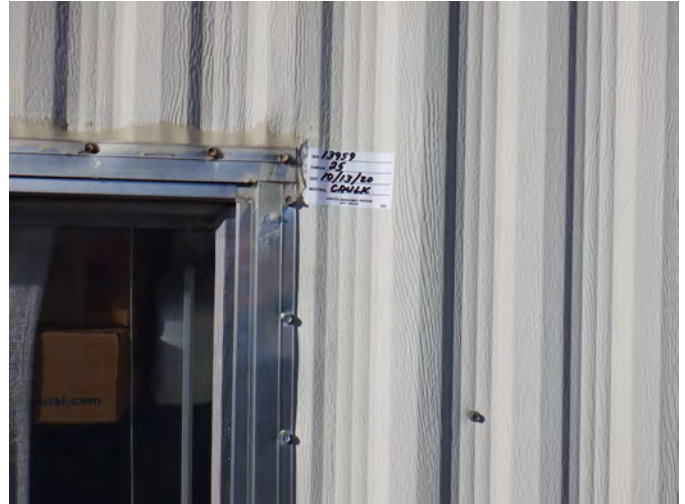
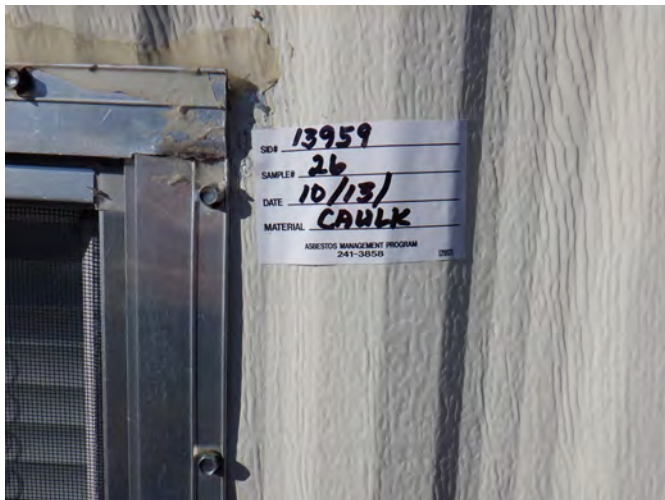
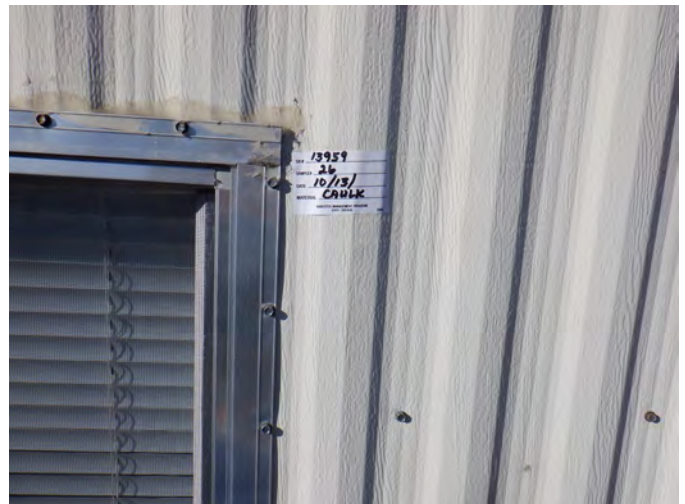
<b>HA Description</b>	CLEAR WINDOW CAULK
	<b>Sample #</b>	SID13959-25 SID13959-26
	<b>Sample Location / Orientation</b>	SID13959-25 – Northeast Window (exterior) SID13959-26 – Southeast Window (exterior)
	<b>Sample/Inspection Results</b>	SID13959-25 – None Detected SID13959-26 – None Detected
	<b>Recommendation</b>	None

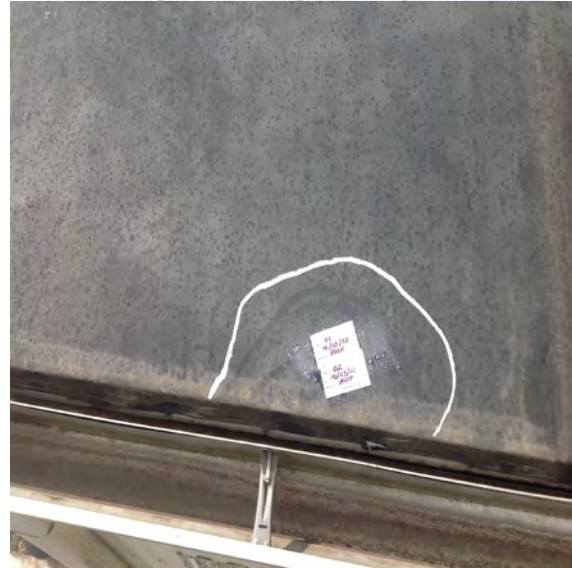
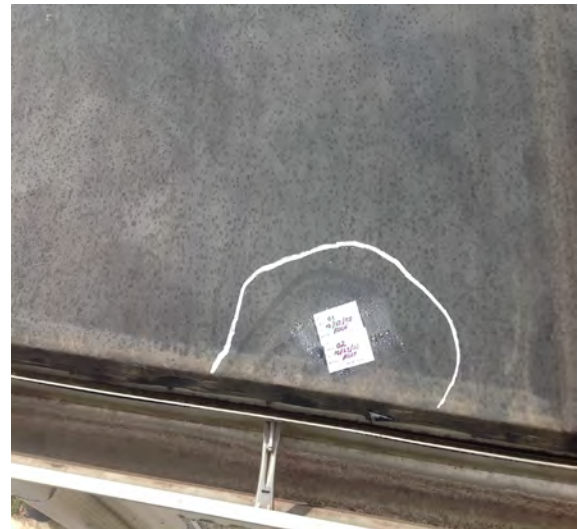
<b>HA Description</b>	Rubber roof and adhesive
<b>Sample #</b>	SID13962-01 SID13962-02
<b>Sample Location / Orientation</b>	SID13962-01 – Roof - Southeast end of roof. - Rubber roof SID13962-02 – Roof - Southeast end of roof. - Adhesive under the Rubber roof
<b>Sample/Inspection Results</b>	SID13962-01 - None Detected SID13962-02 - None Detected
<b>Recommendation</b>	None

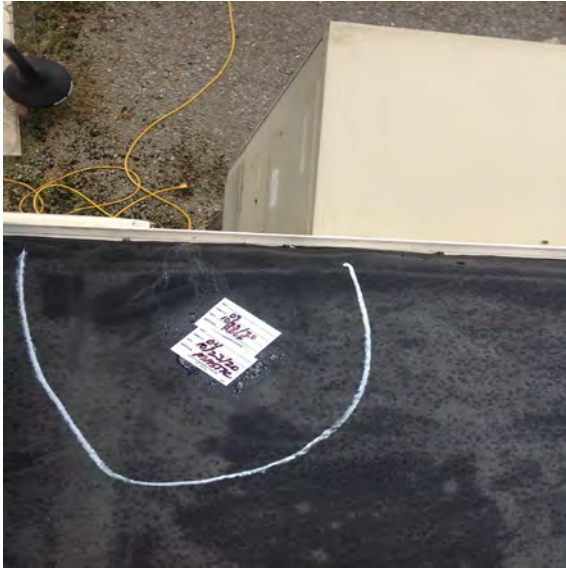
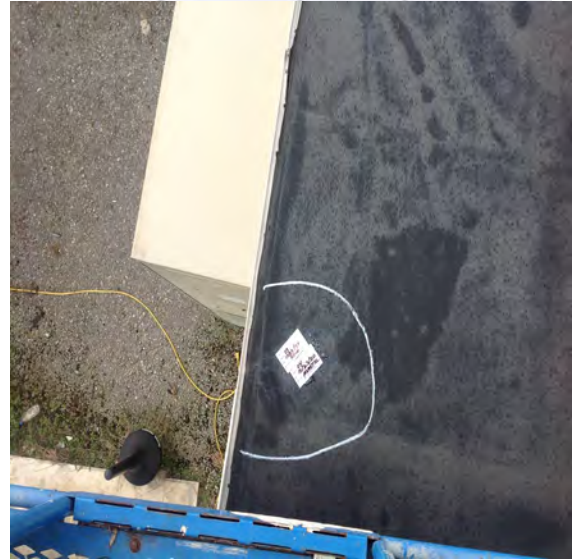
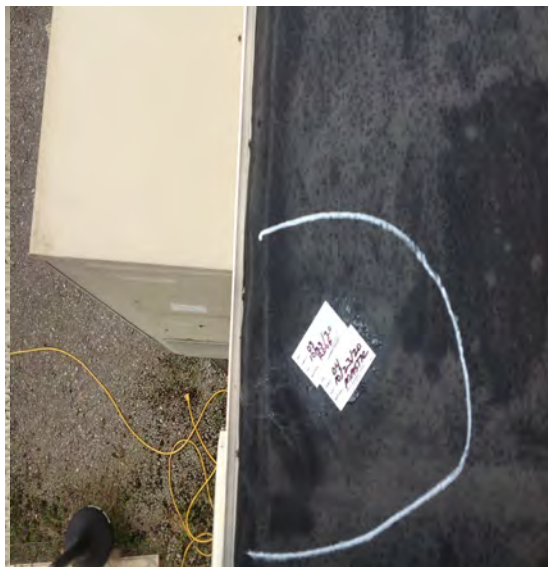
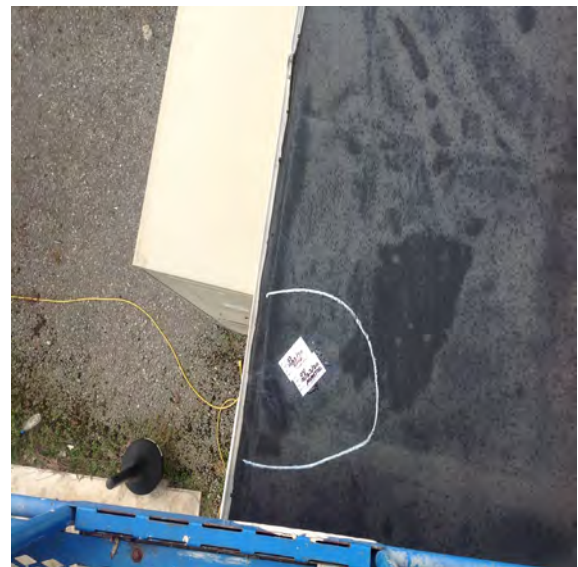
<b>HA Description</b>	Rubber roof and adhesive
<b>Sample #</b>	<b>SID13962-03</b> <b>SID13962-04</b>
<b>Sample Location / Orientation</b>	SID13962-03 – Roof - South end of roof. - Rubber roof SID13962-04 – Roof - South end of roof. - Adhesive under the Rubber roof
<b>Sample/Inspection Results</b>	SID13962-03 - None Detected SID13962-04 - None Detected
<b>Recommendation</b>	None

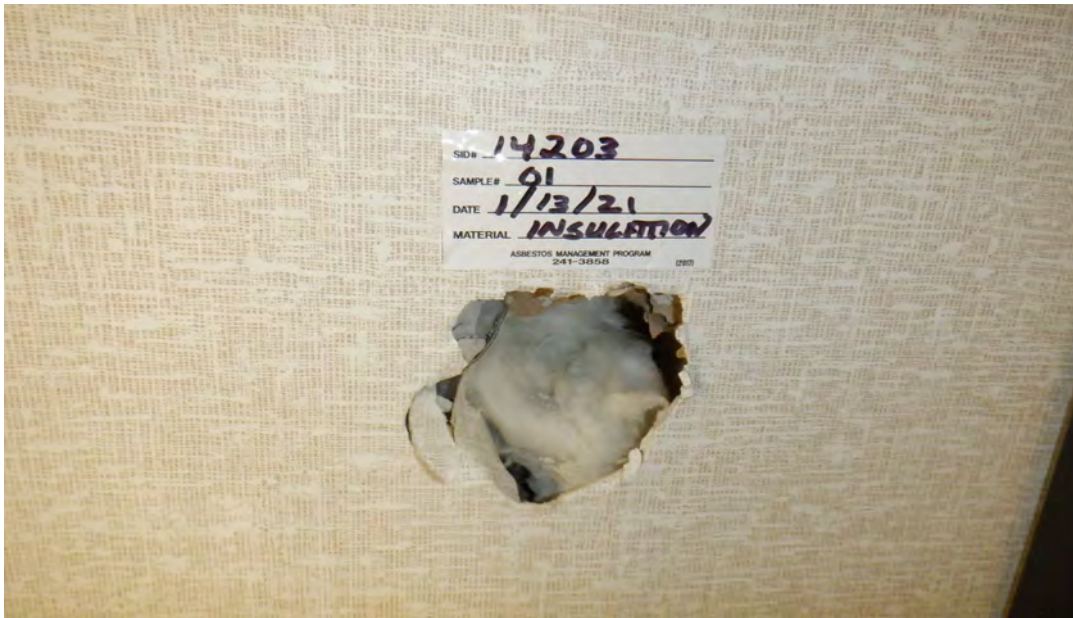
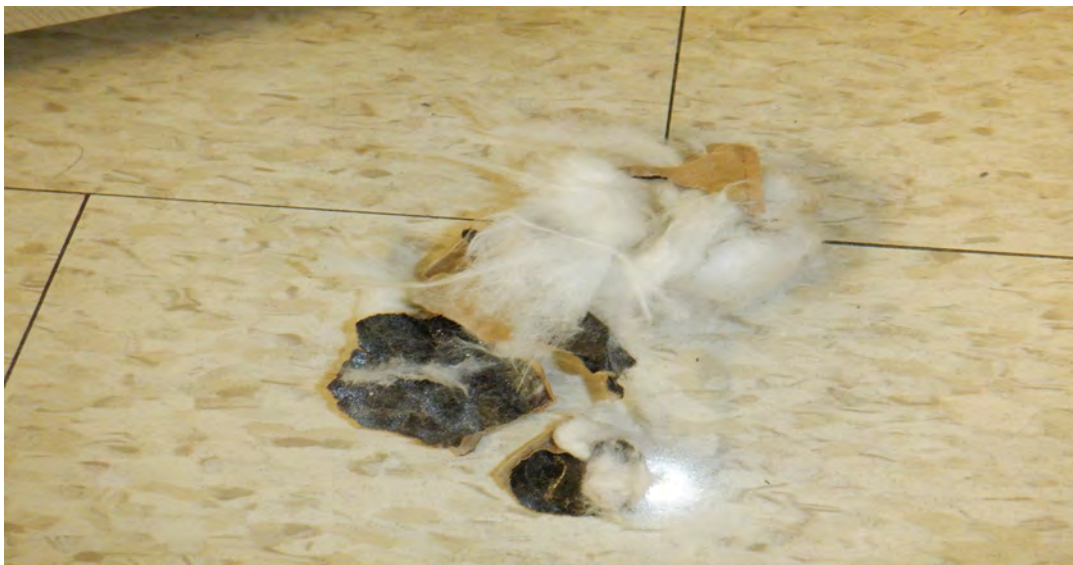
<b>HA Description</b>	White batt Insulation
<b>Sample #</b>	<b>SID14203-01</b>
<b>Sample Location / Orientation</b>	SID14203-01 – Room 2 - white batt insulation with brown paper and black on paper in East wall.
<b>Sample/Inspection Results</b>	SID14203-01 - None Detected
<b>Recommendation</b>	None

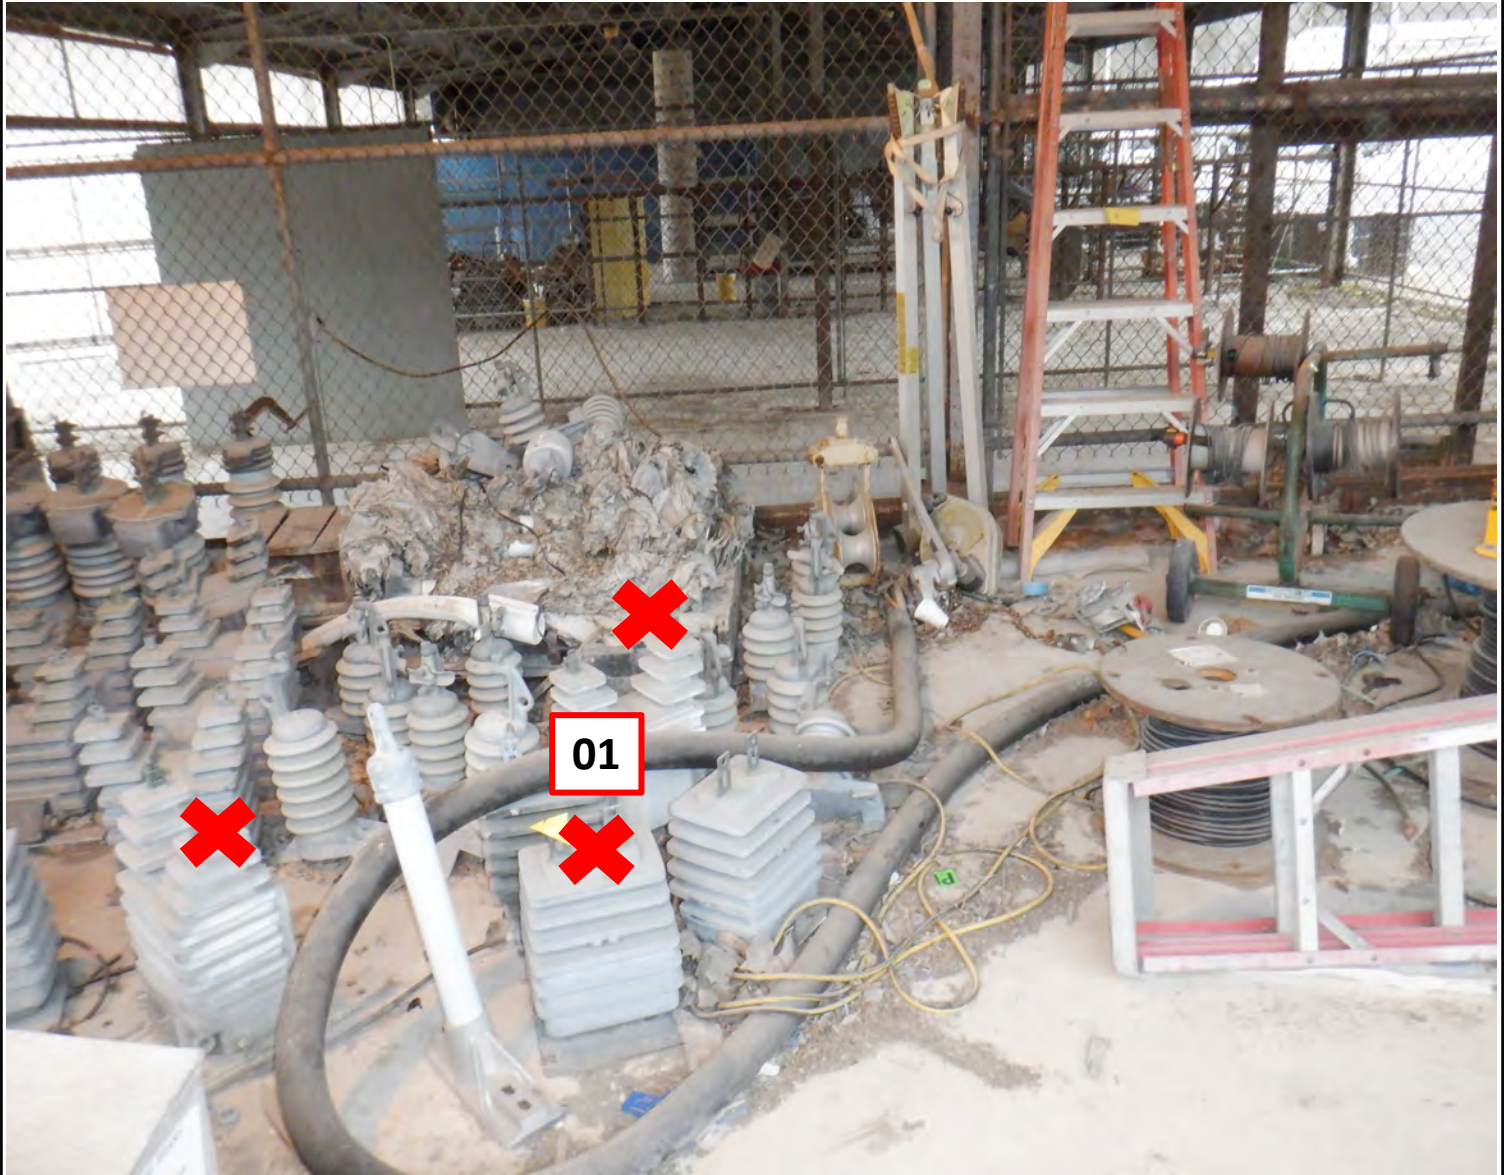
<b>Sample #</b>	<b>SID14332-01</b>
	<b>Sample Location / Orientation</b>	Electrical equipment

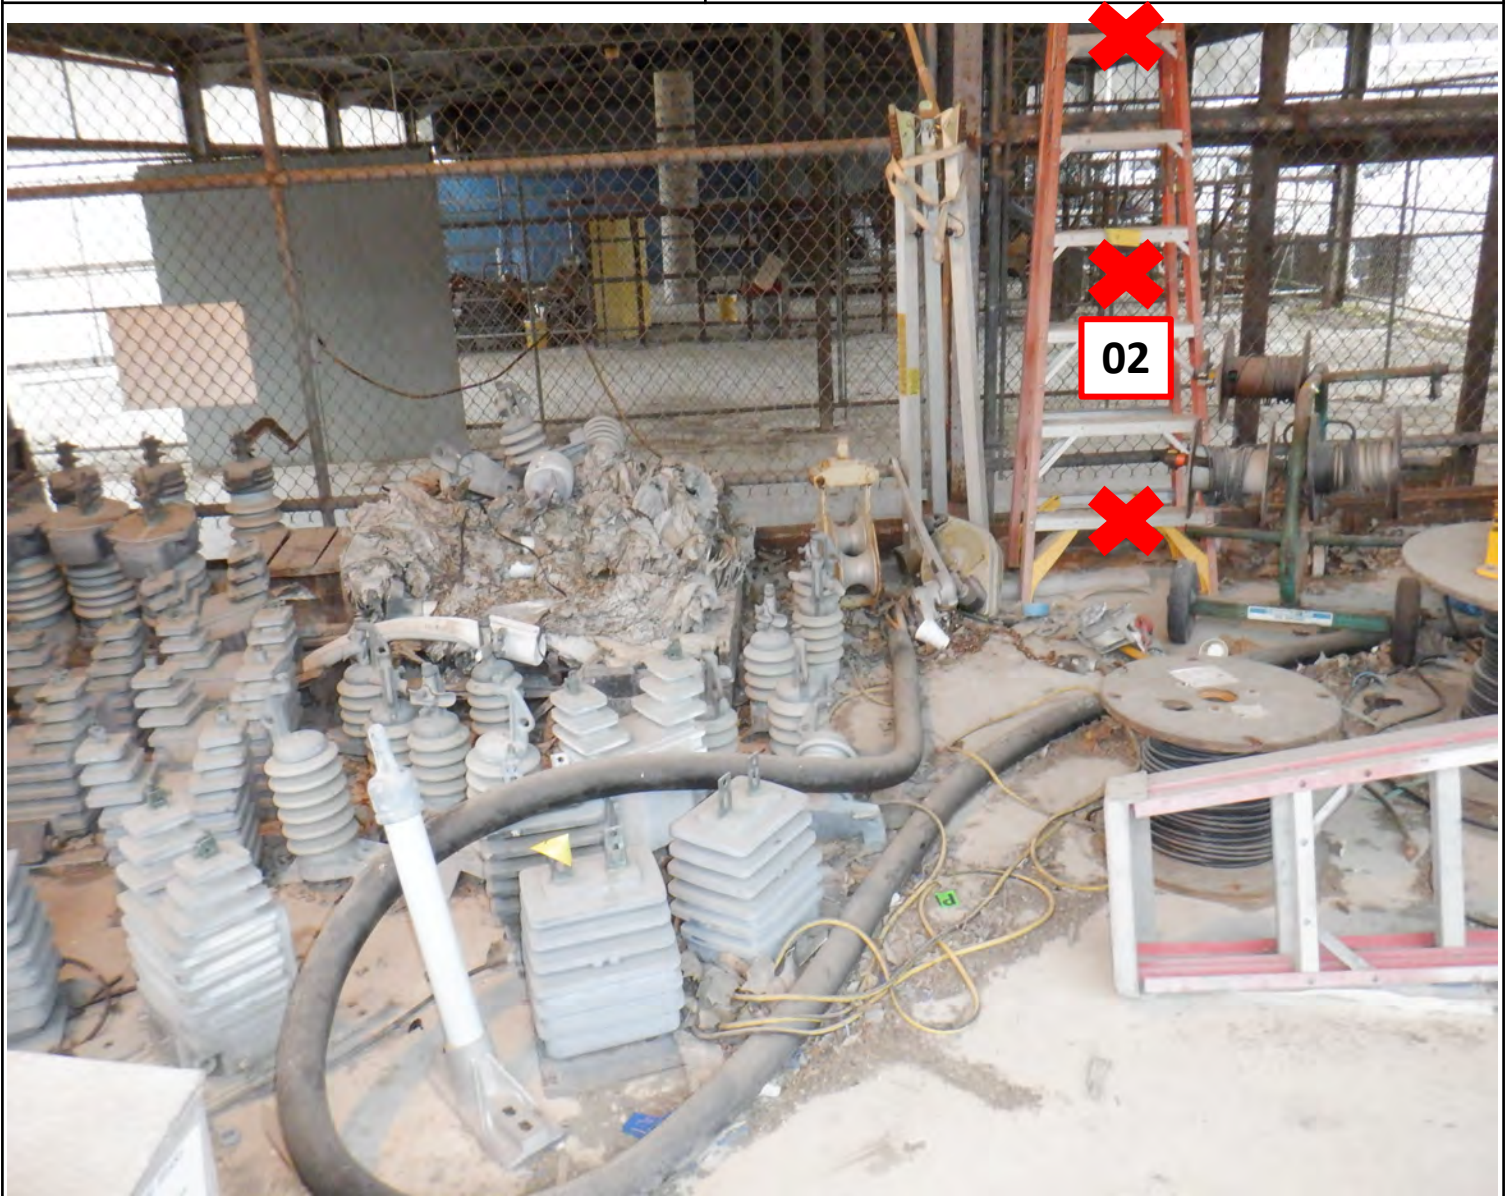
<b>Sample #</b>	<b>SID14332-02</b>
	<b>Sample Location / Orientation</b>	Orange Ladder

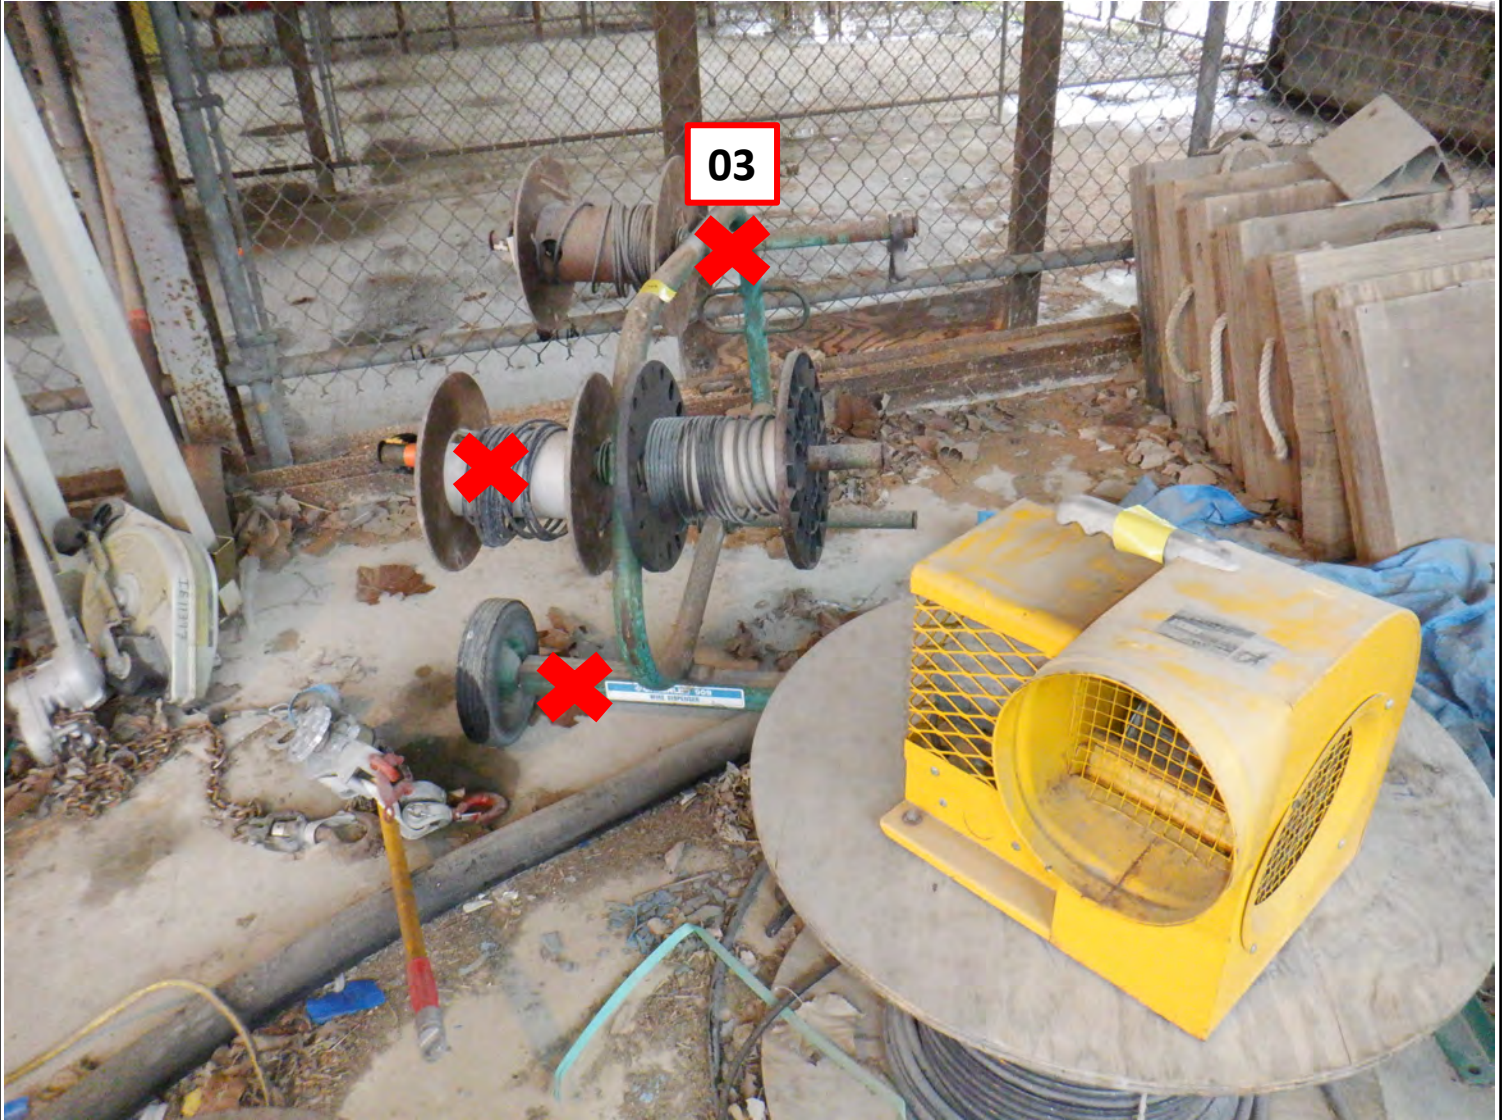
<b>Sample #</b>	<b>SID14332-03</b>
	<b>Sample Location / Orientation</b>	Reel Caddy For Wire Spools

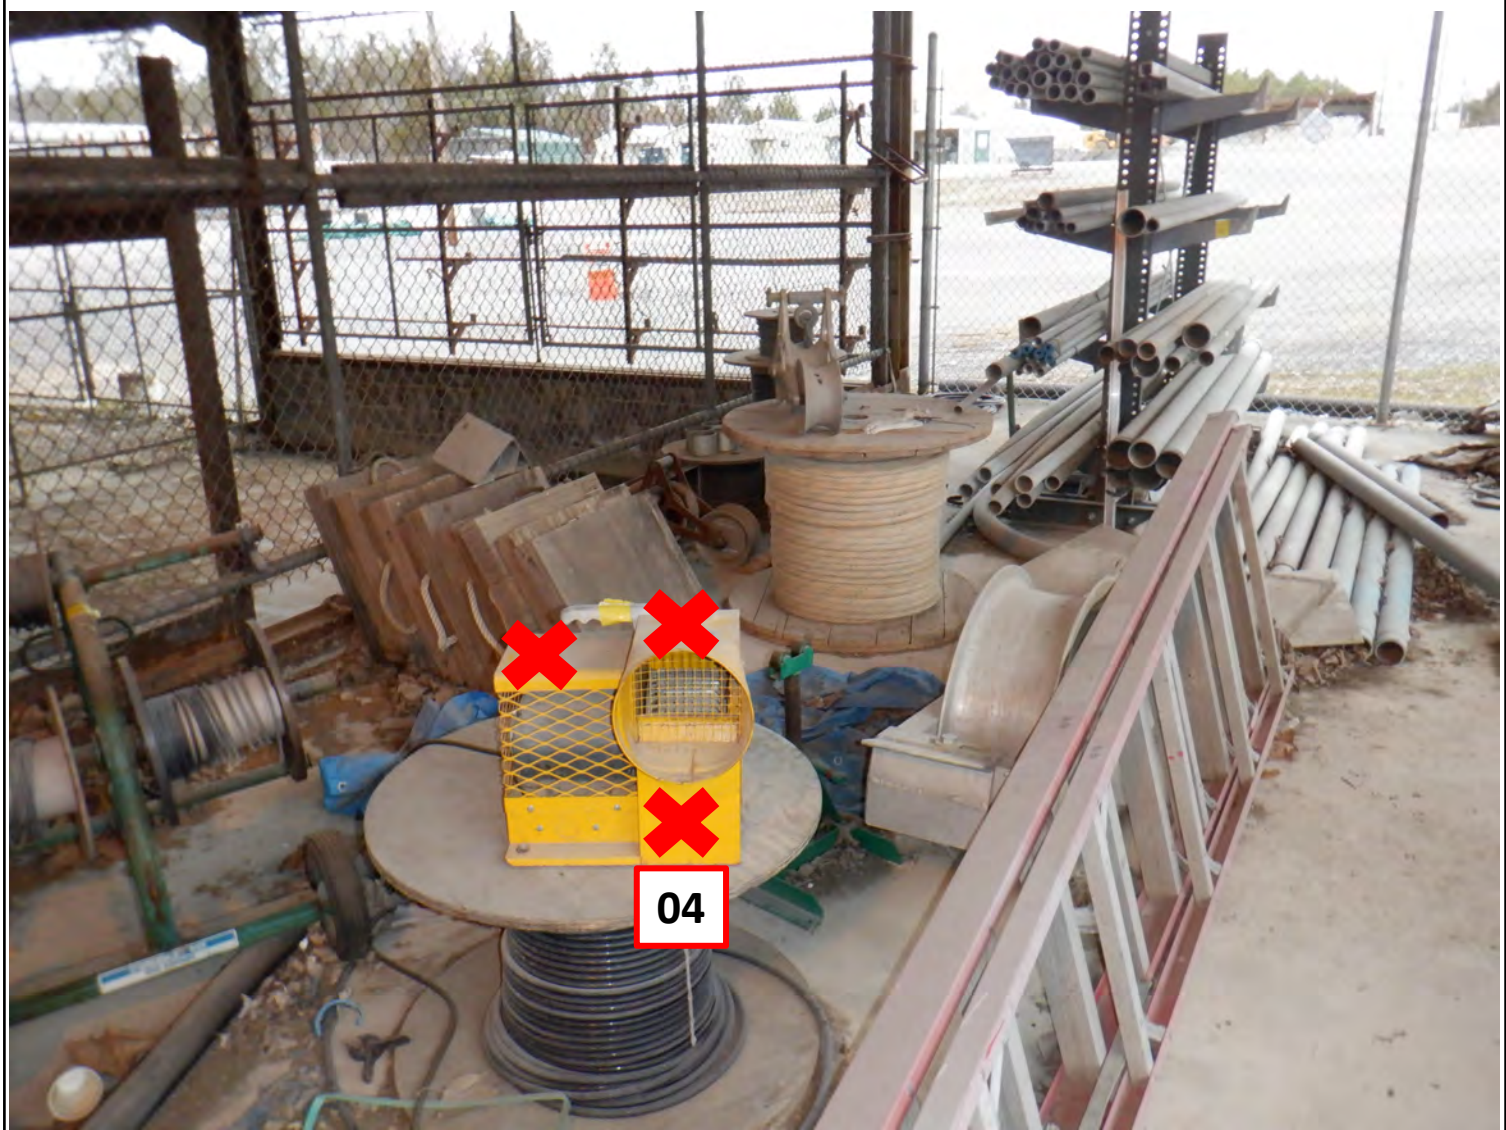
<b>Sample #</b>	<b>SID14332-04</b>
	<b>Sample Location / Orientation</b>	Equipment (Yellow Fan)
