**Scope of Work and Specifications**

**CRSF Building Demolition**

**OAK RIDGE NATIONAL LABORATORY**

**March 2021**

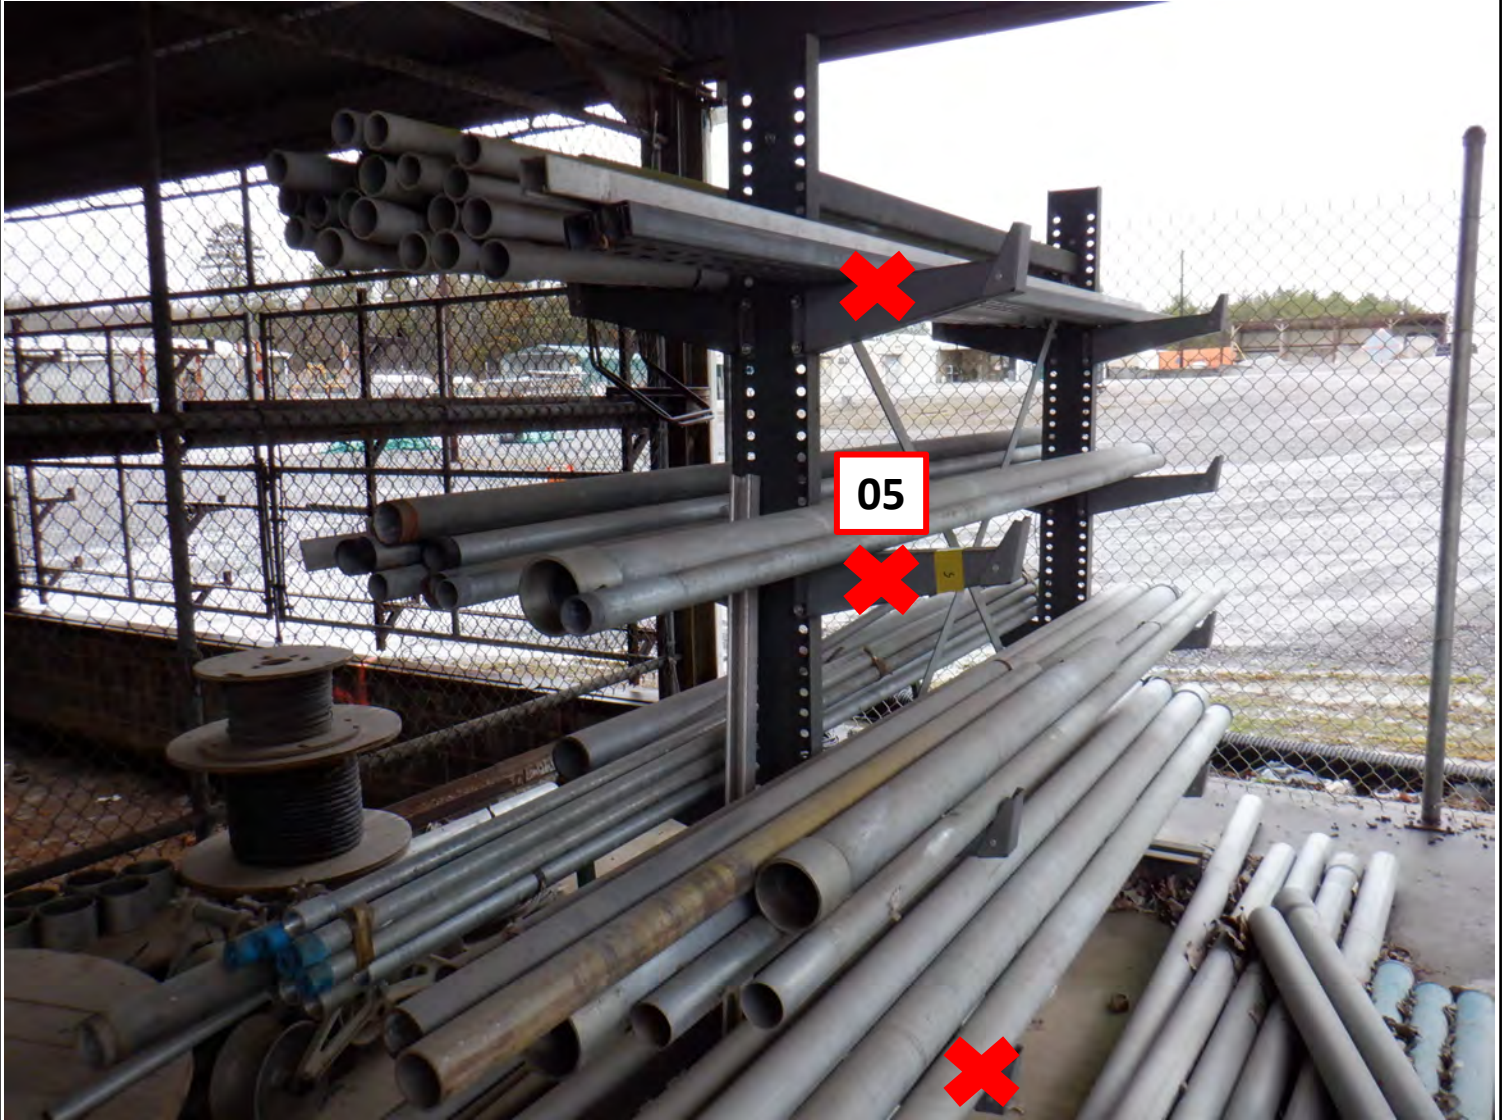
<b>Sample #</b>	<b>SID14332-05</b>
	<b>Sample Location / Orientation</b>	Storage Rack

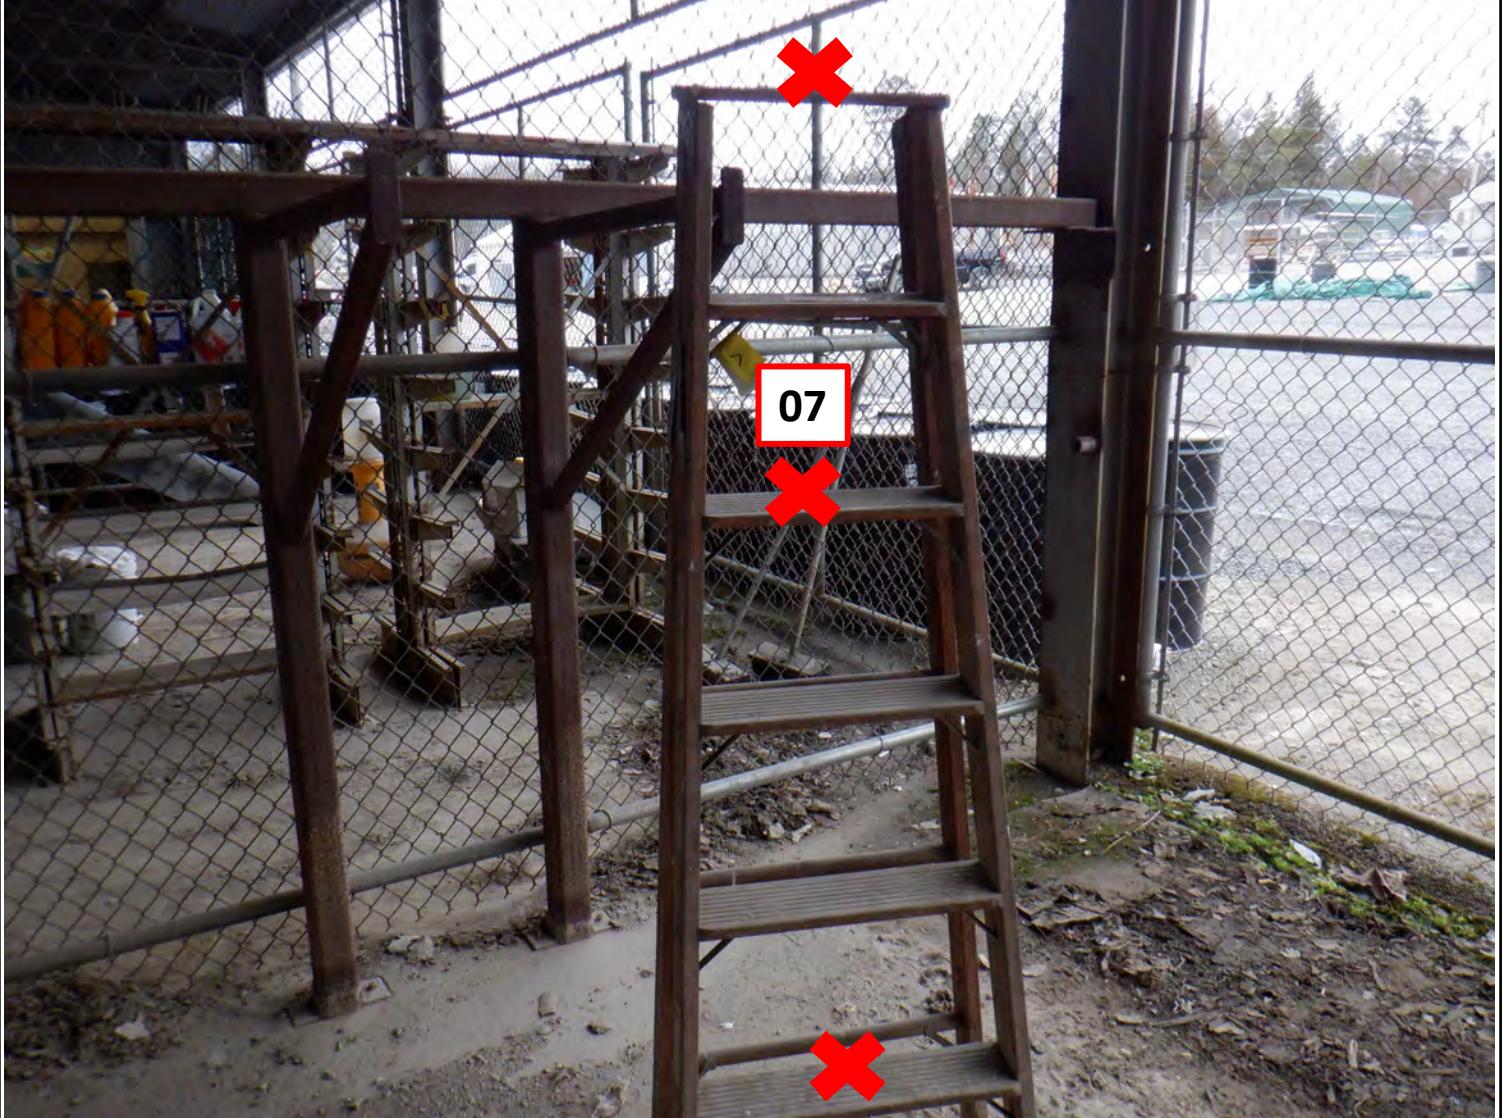
<b>Sample #</b>	<b>SID14332-07</b>
	<b>Sample Location / Orientation</b>	Wooden Ladder

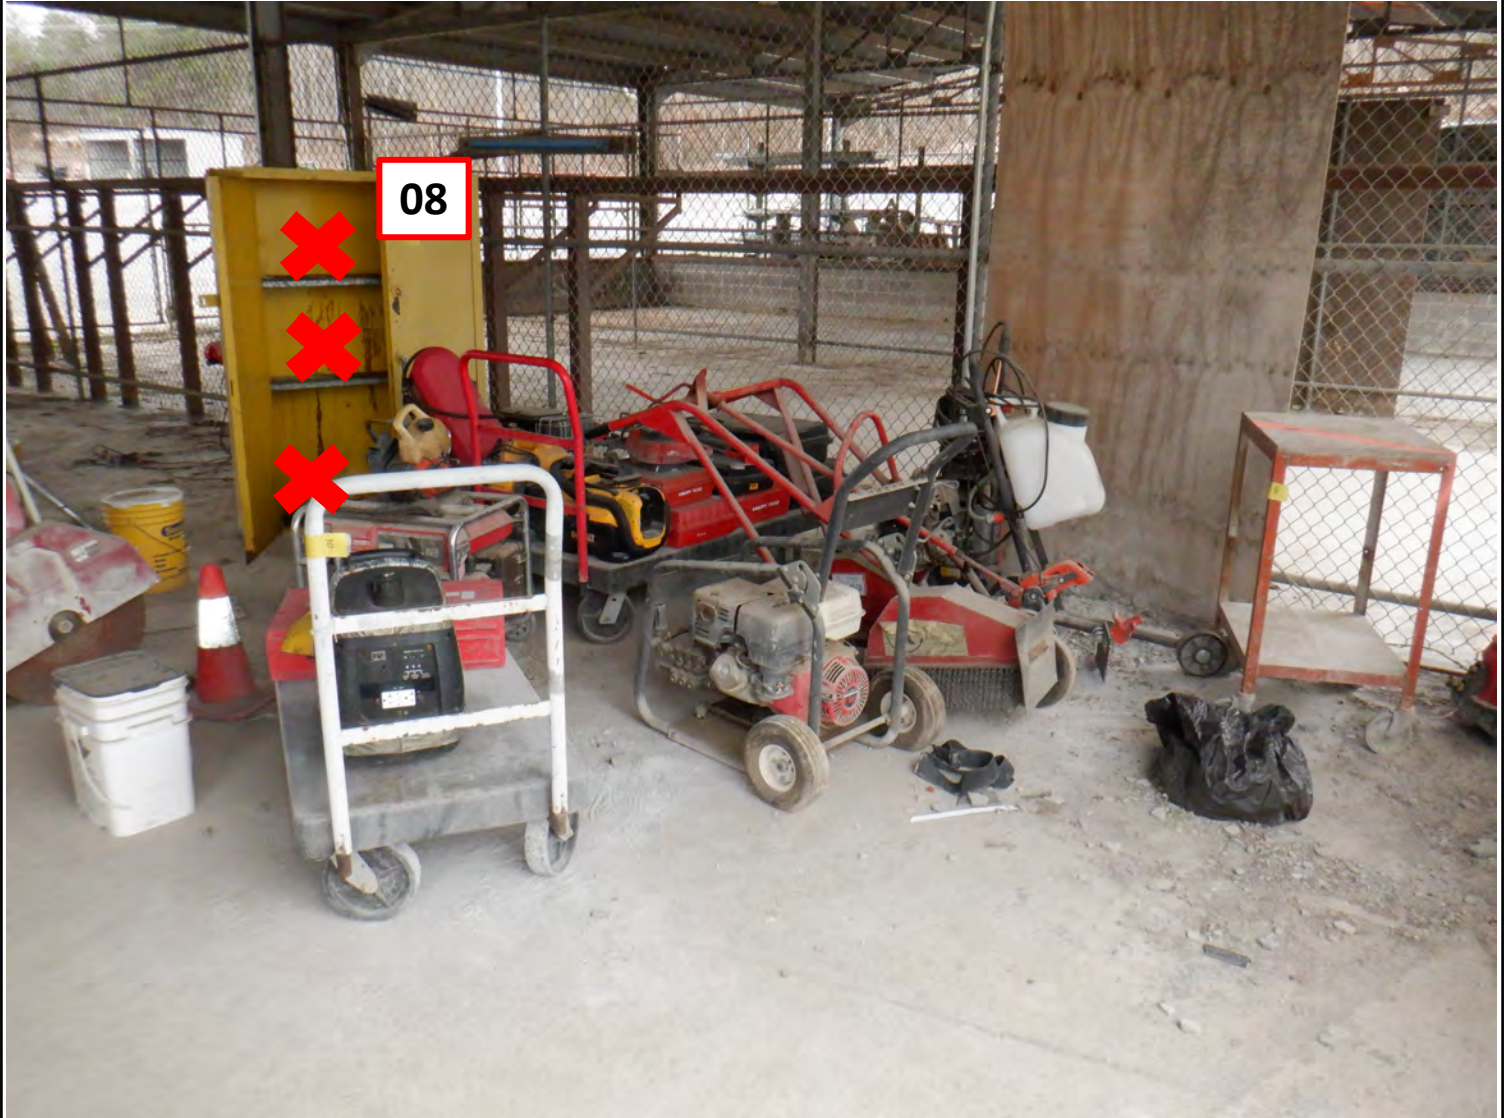
<b>Sample #</b>	<b>SID14332-08</b>
	<b>Sample Location / Orientation</b>	Flammable Storage Cabinet, Interior Shelves

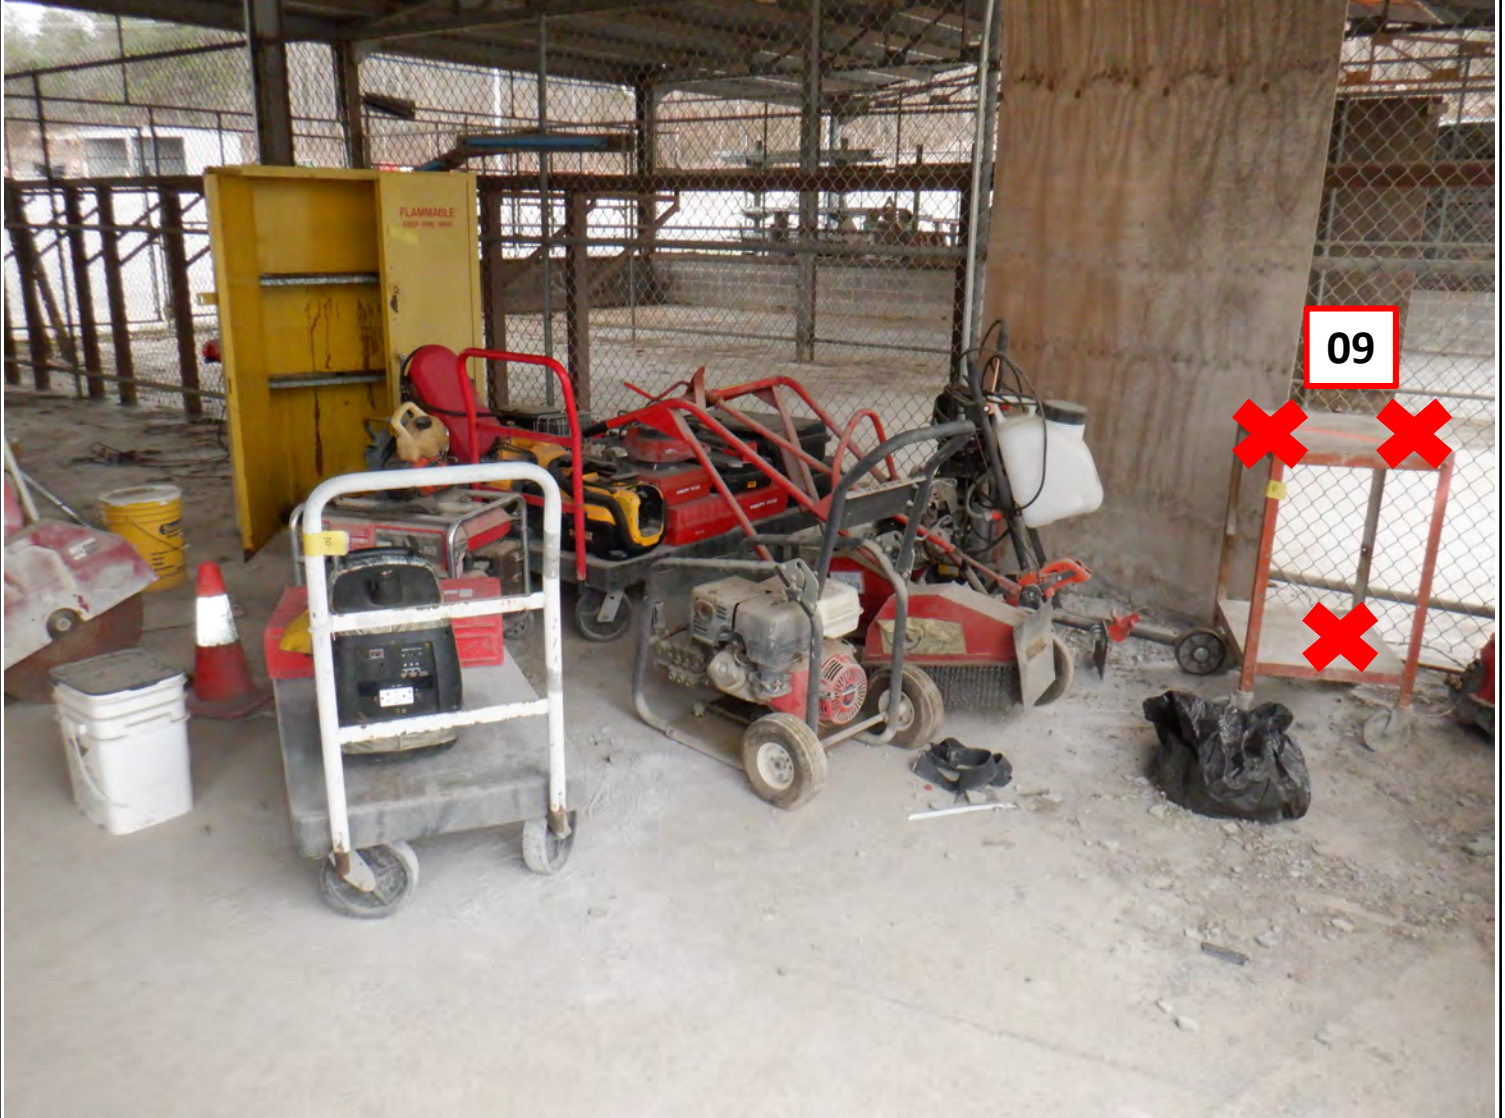
<b>Sample #</b>	<b>SID14332-09</b>
	<b>Sample Location / Orientation</b>	Mobile Metal Cart, Top and Bottom

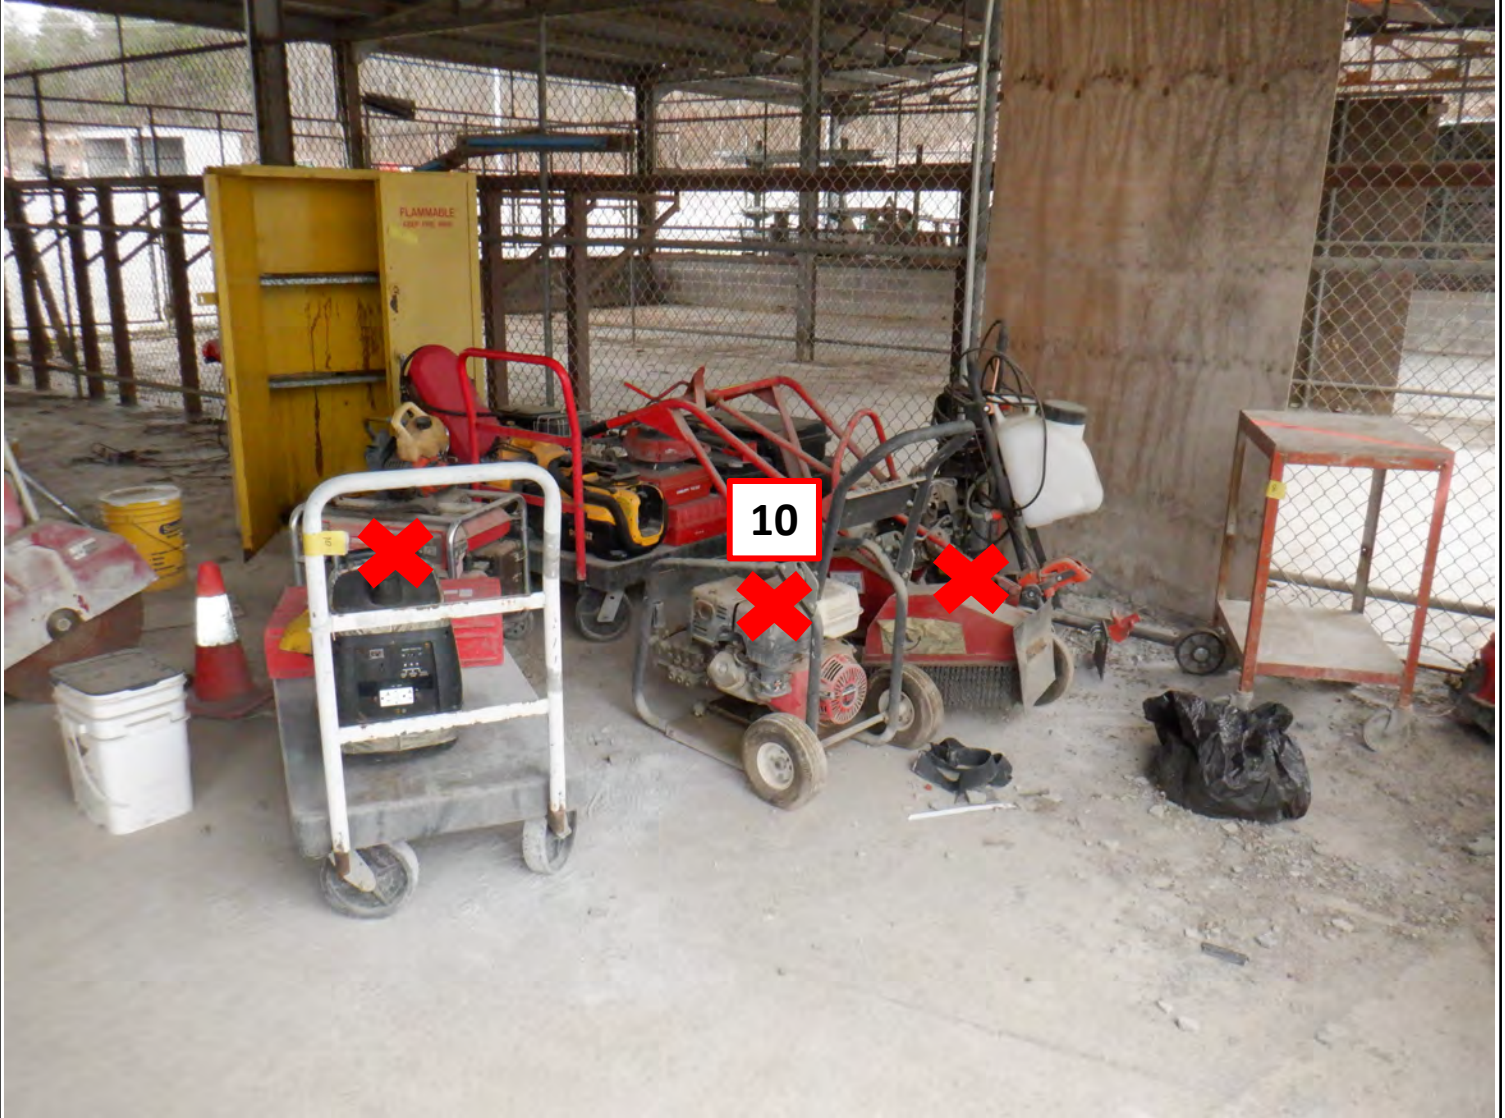
<b>Sample #</b>	<b>SID14332-10</b>
	<b>Sample Location / Orientation</b>	Power Equipment

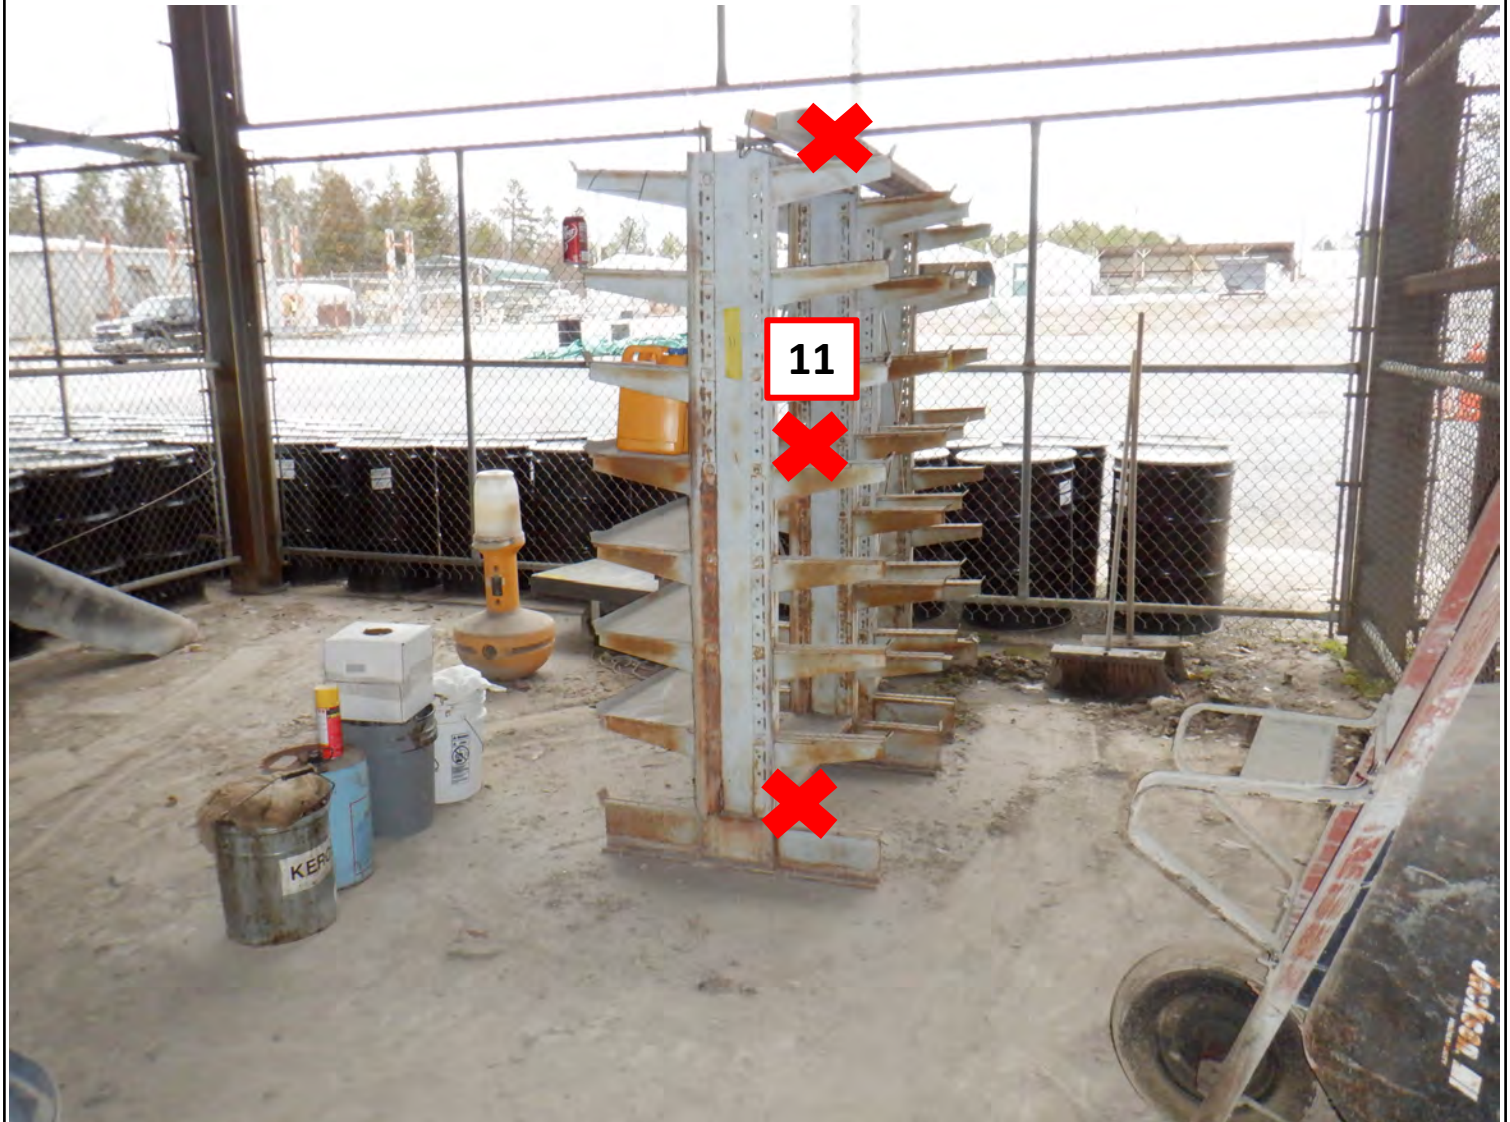
<b>Sample #</b>	SID14332-11
	<b>Sample Location / Orientation</b>	Storage Rack, West

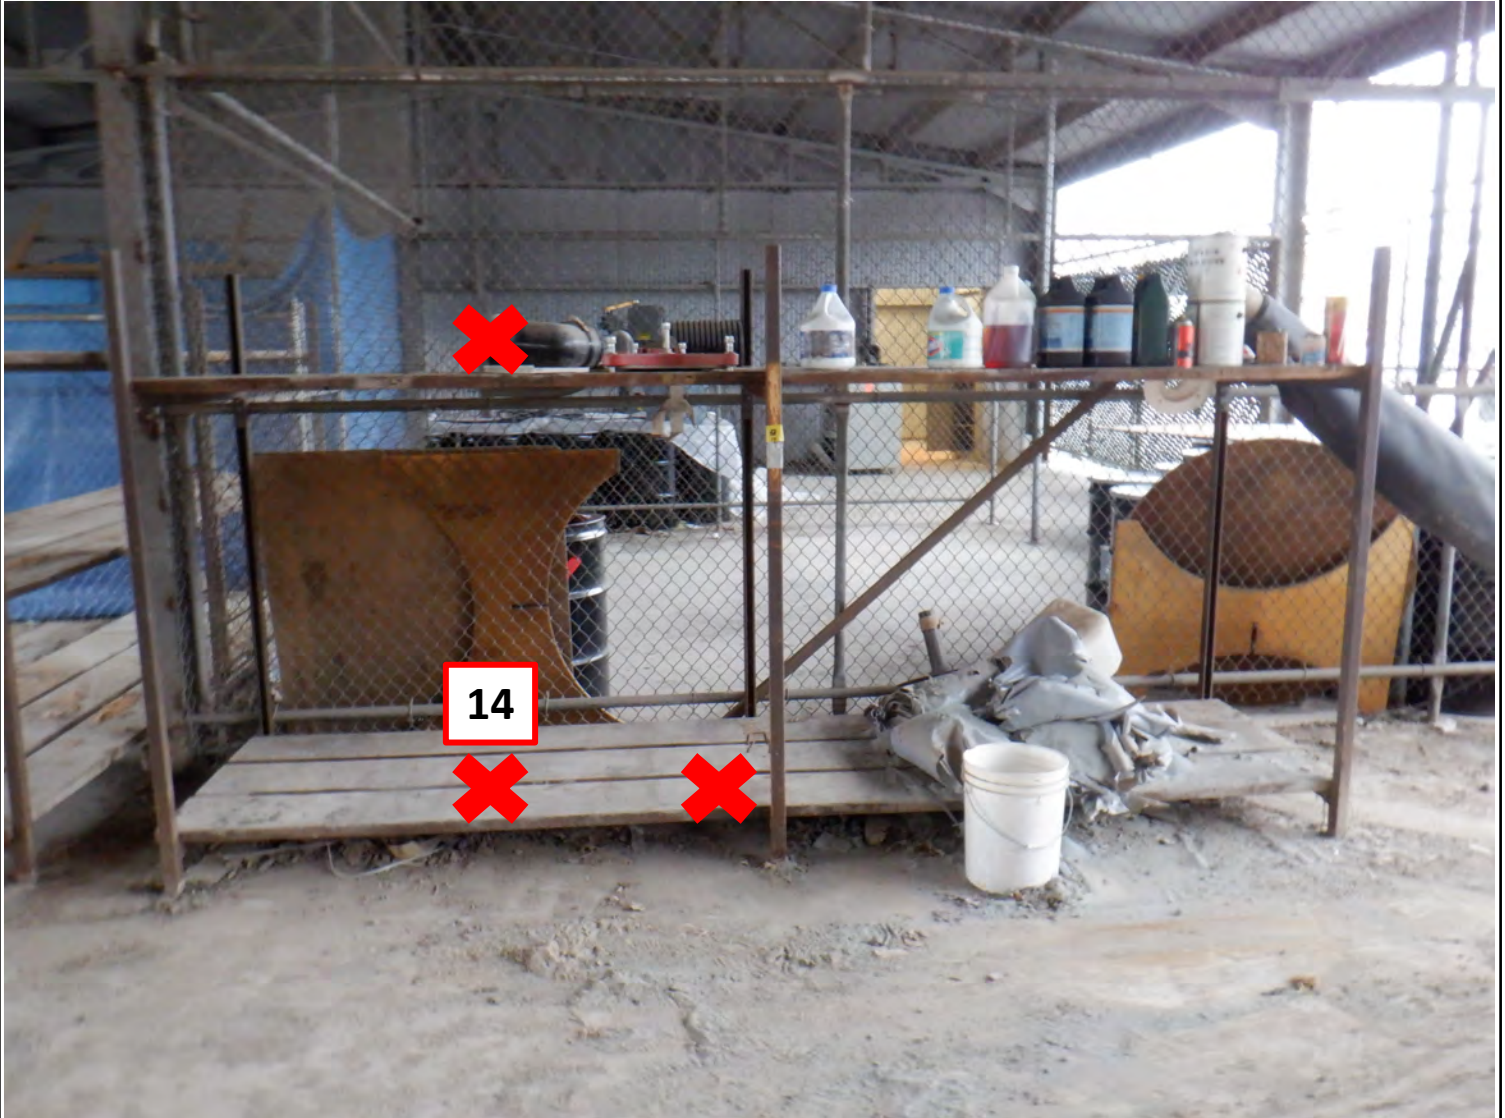
**14**

<b>Sample #</b>	<b>SID14332-14</b>
	<b>Sample Location / Orientation</b>	Shelving Unit/Storage Rack, Shelves

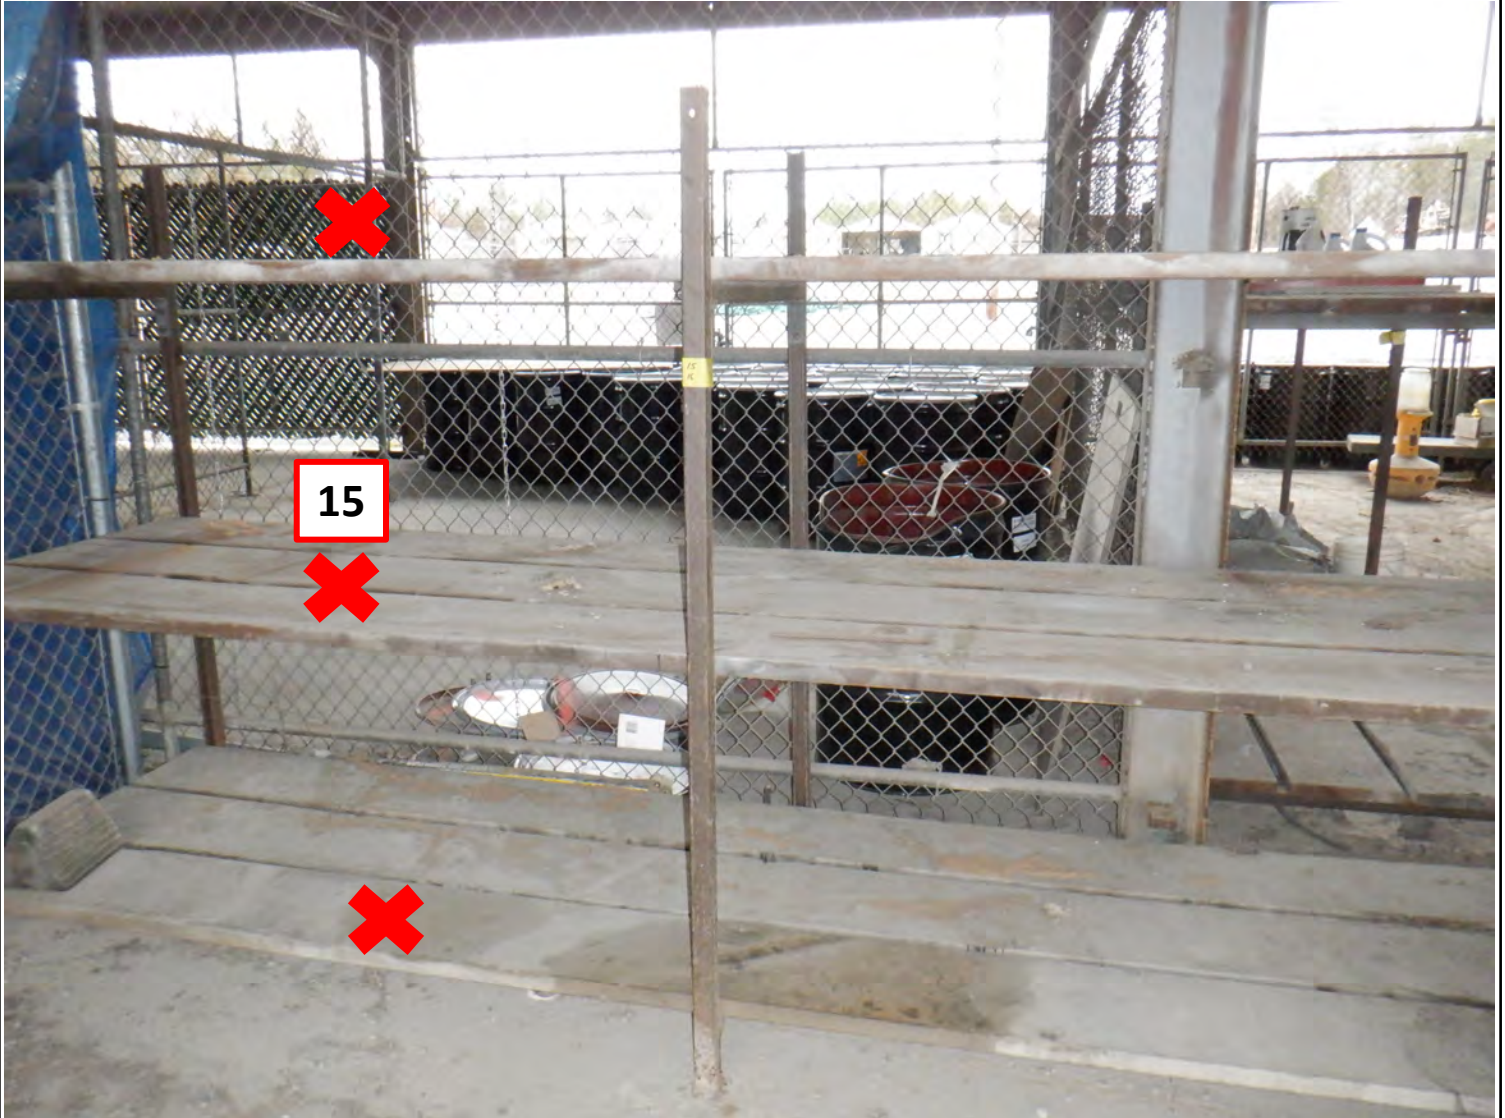
<b>Sample #</b>	<b>SID14332-15</b>
	<b>Sample Location / Orientation</b>	Shelving Unit/Storage Rack, Shelves (Left)

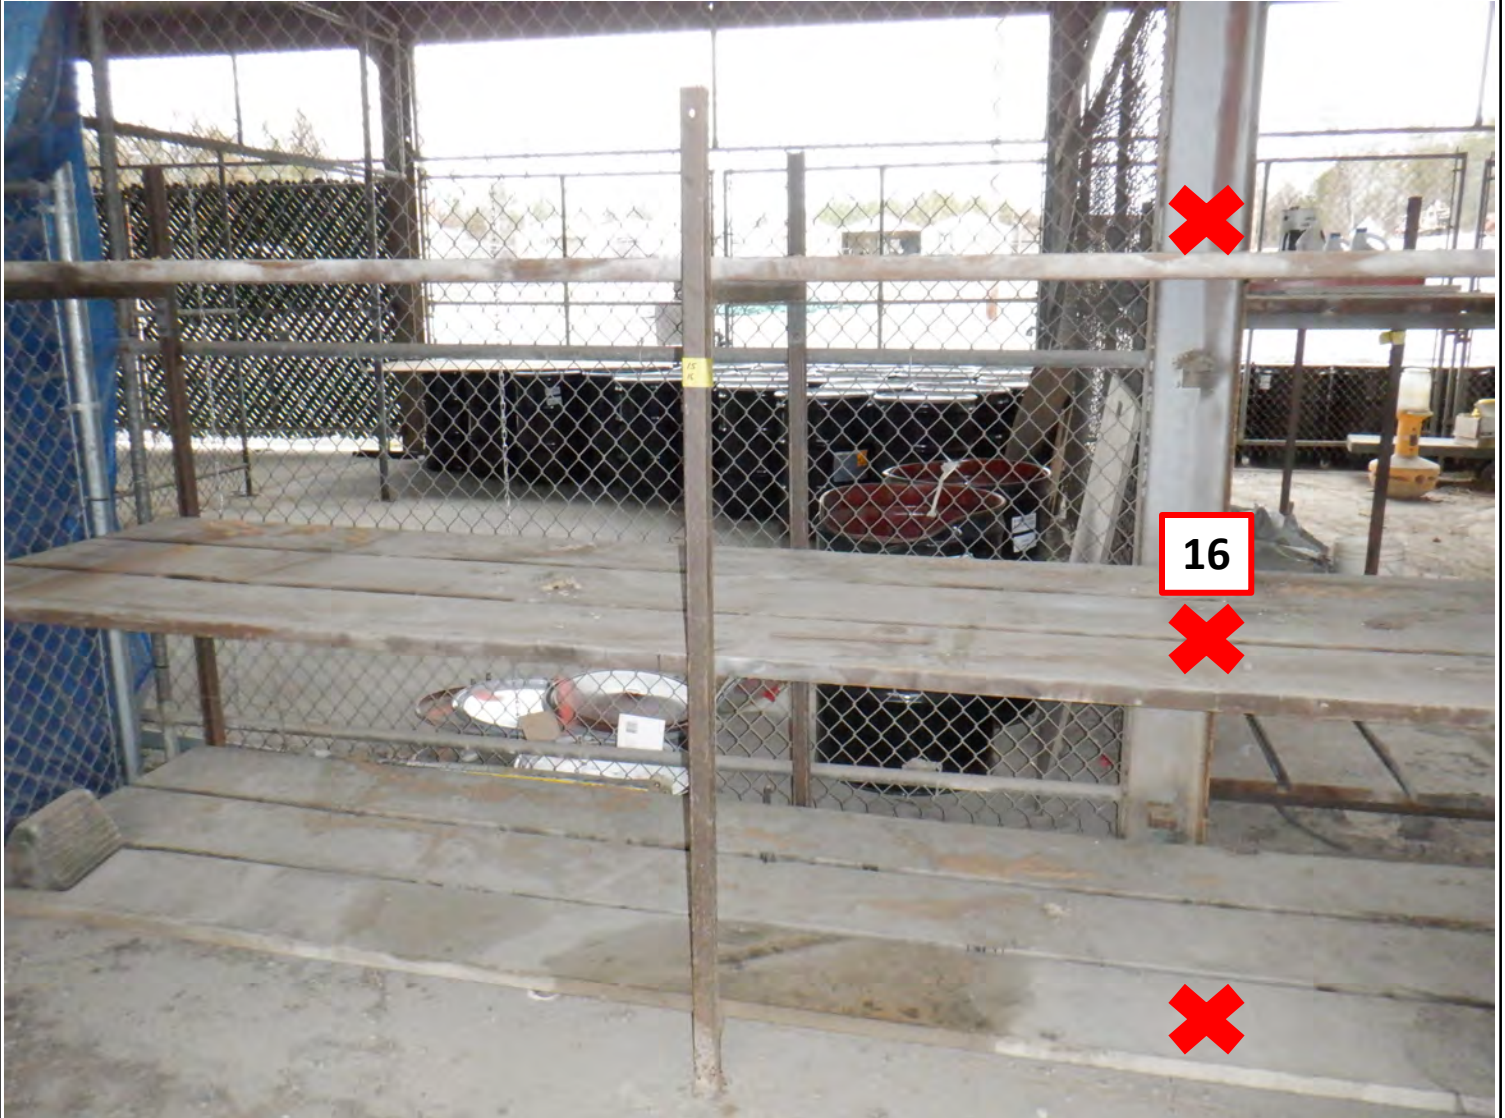
<b>Sample #</b>	<b>SID14332-16</b>
	<b>Sample Location / Orientation</b>	Shelving Unit/Storage Rack, Shelves (Right)

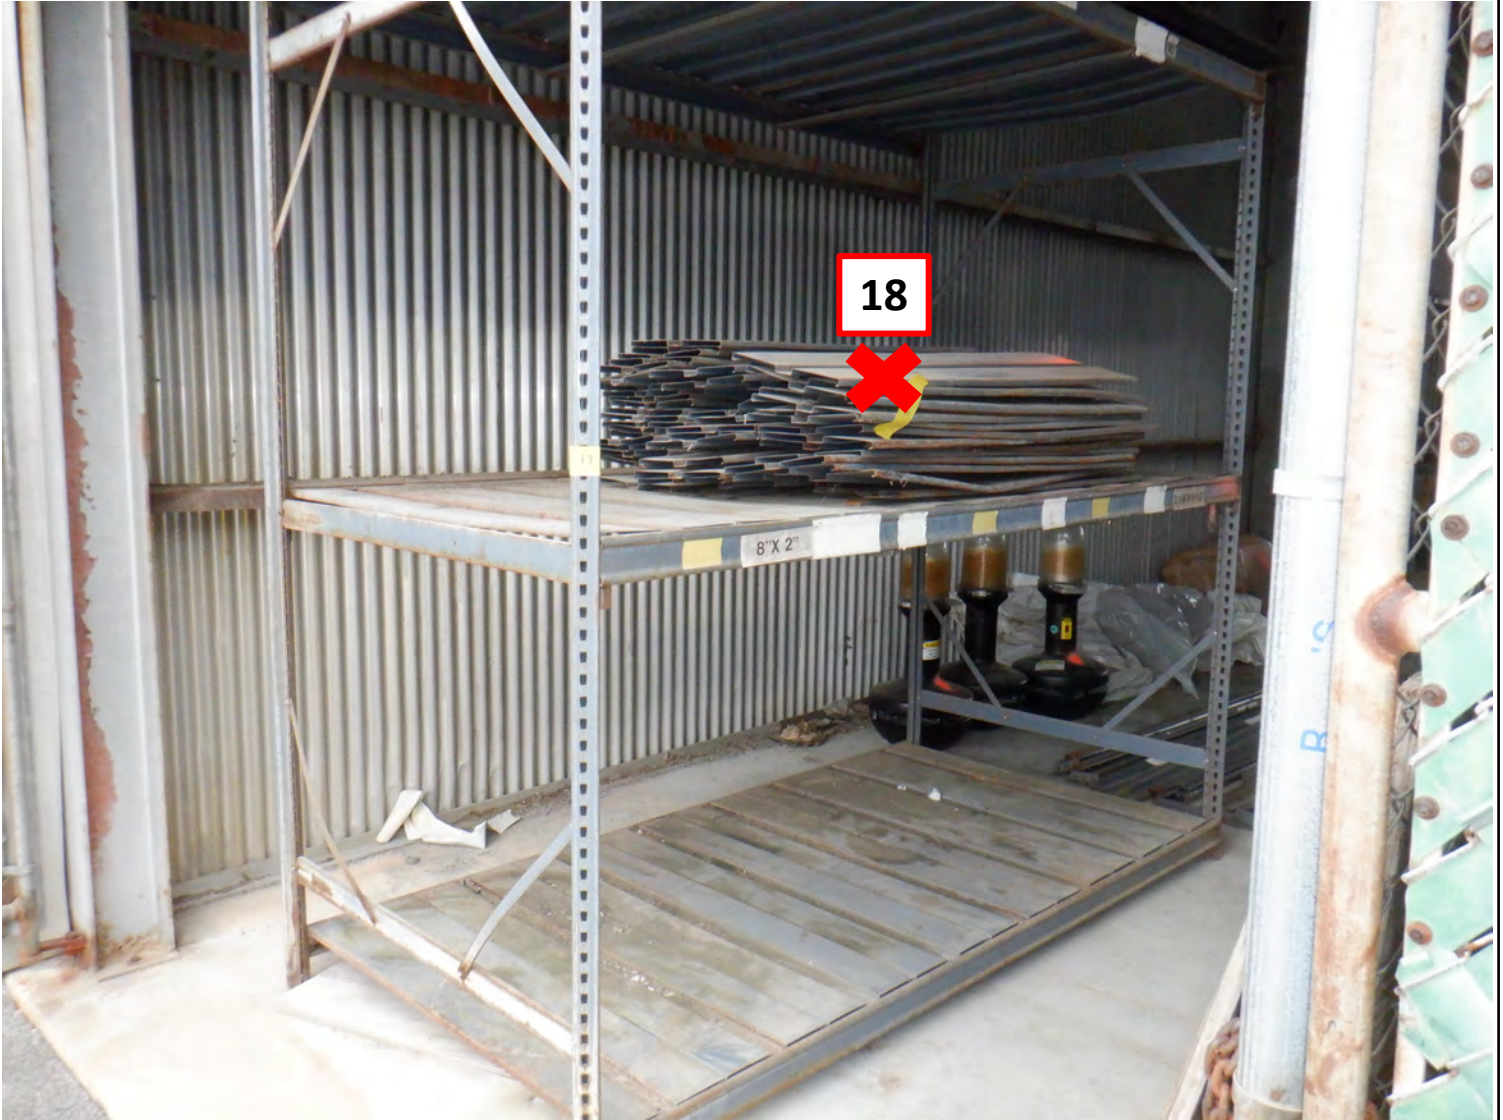
<b>Sample #</b>	<b>SID14332-18</b>
	<b>Sample Location / Orientation</b>	Metal Panels on Shelving Unit/Storage Rack on Middle Shelf (Three Locations)

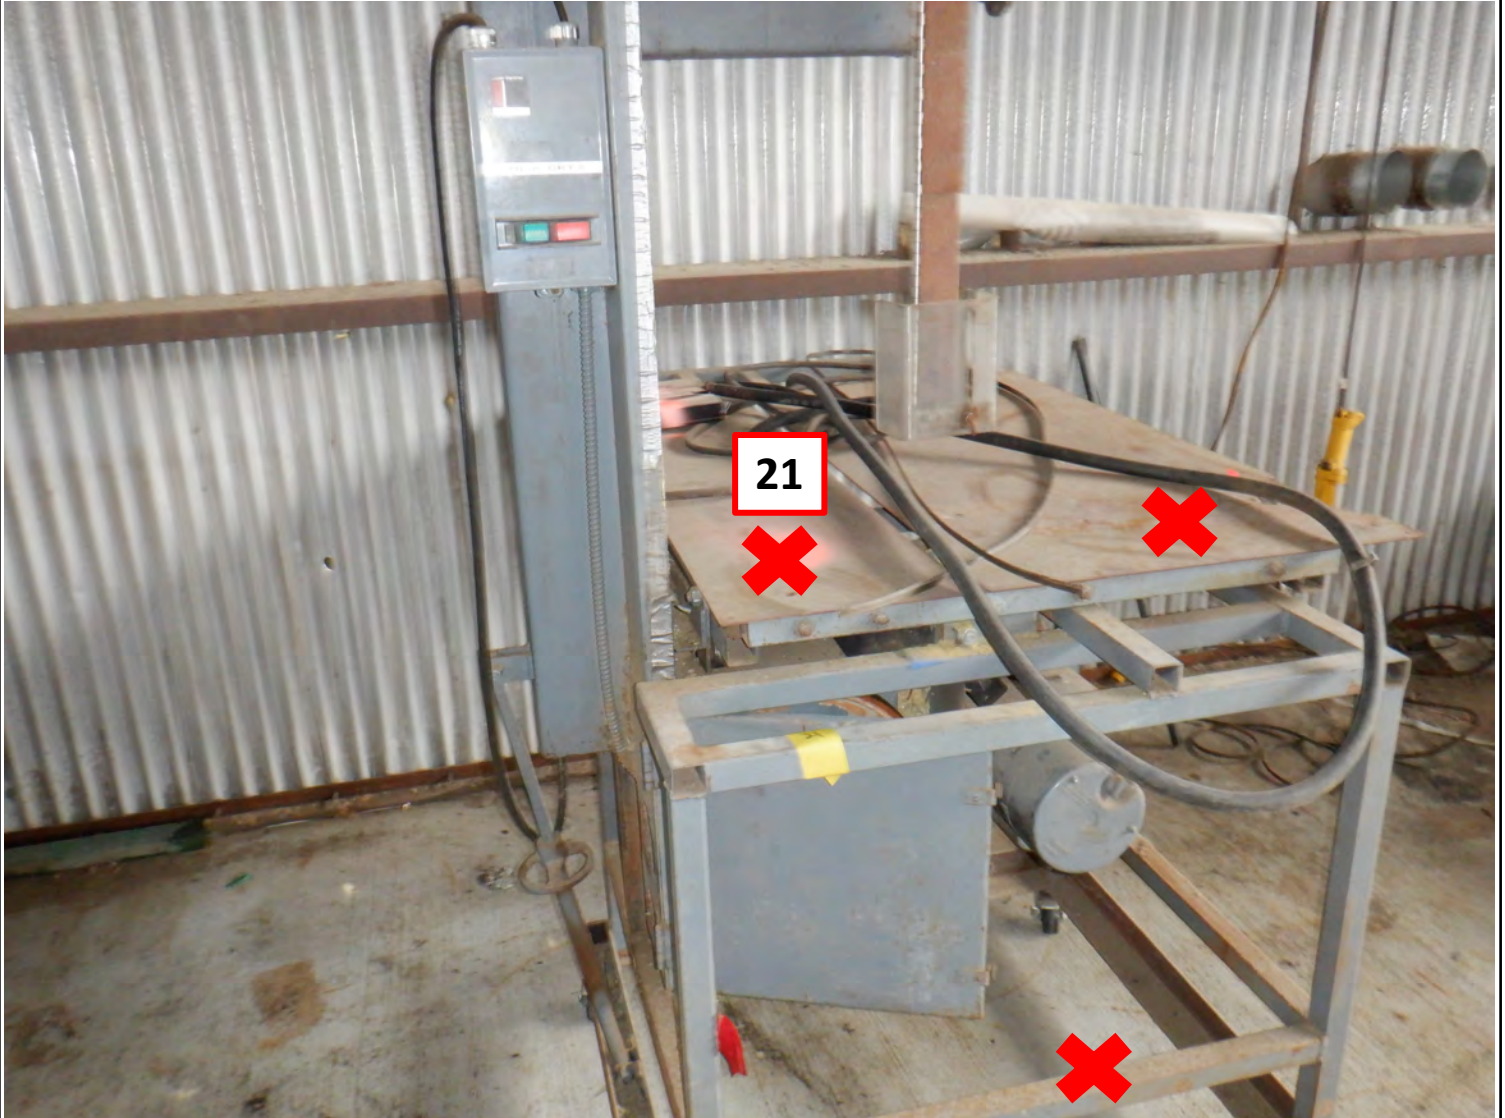
<b>Sample #</b>	<b>SID14332-21</b>
	<b>Sample Location / Orientation</b>	Table Saw

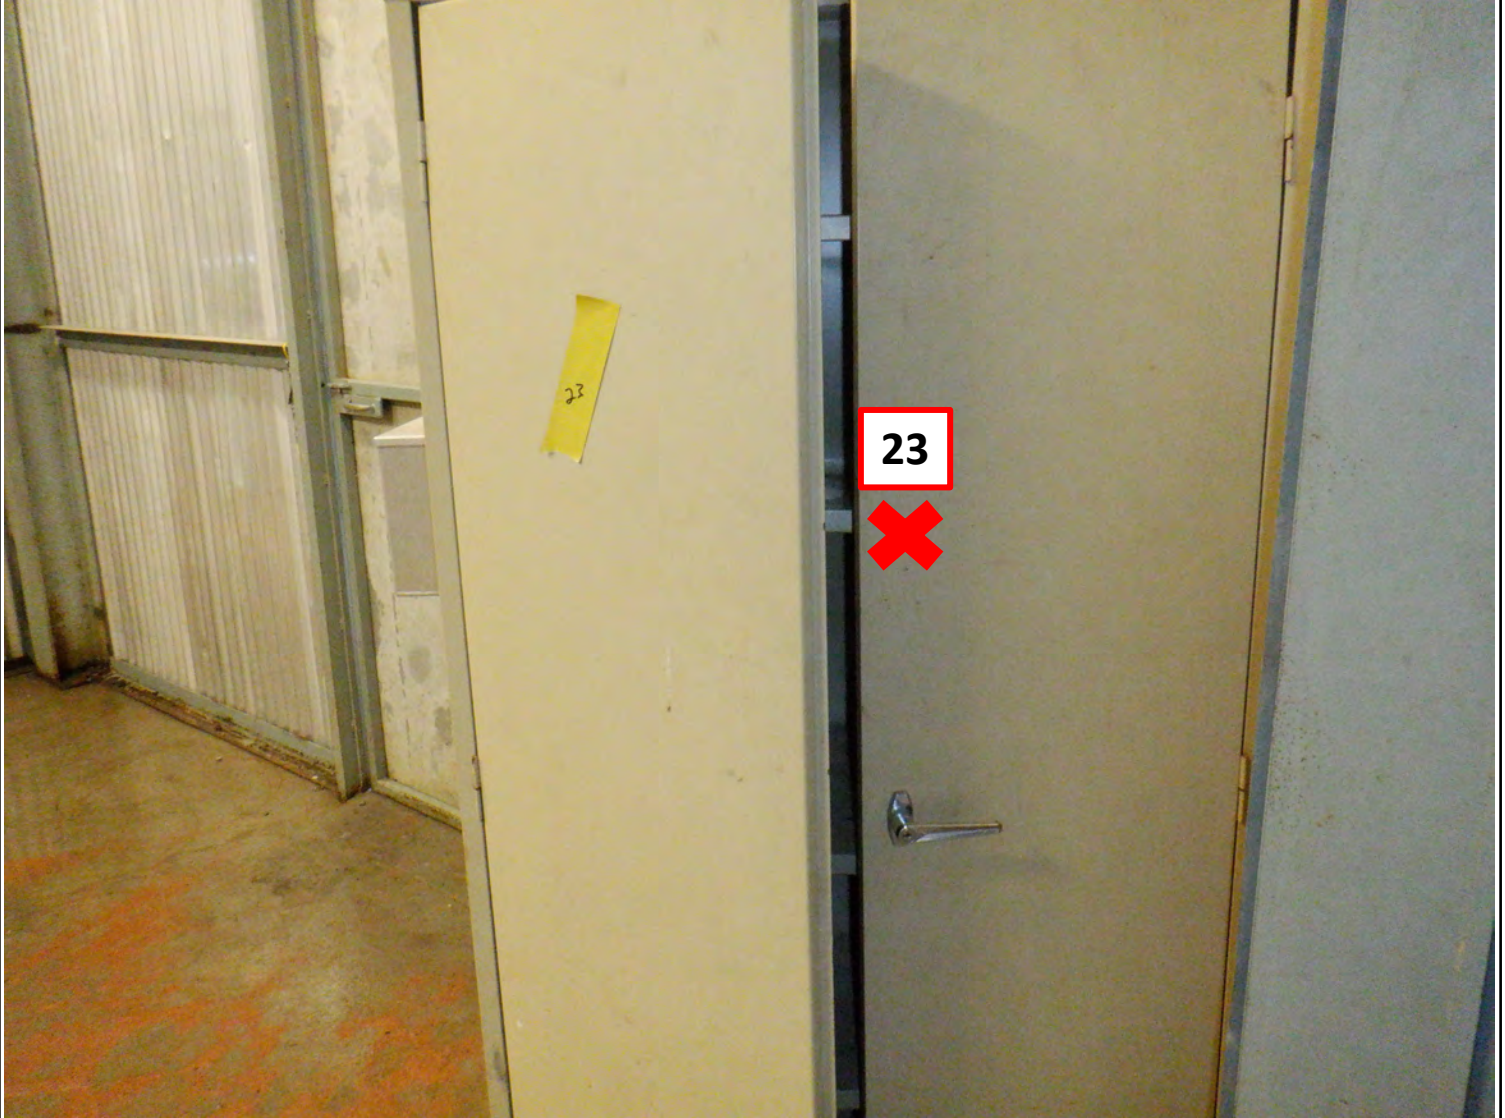
<b>Sample #</b>	<b>SID14332-23</b>
	<b>Sample Location / Orientation</b>	Metal Cabinet, Inside Shelves (Three Locations)

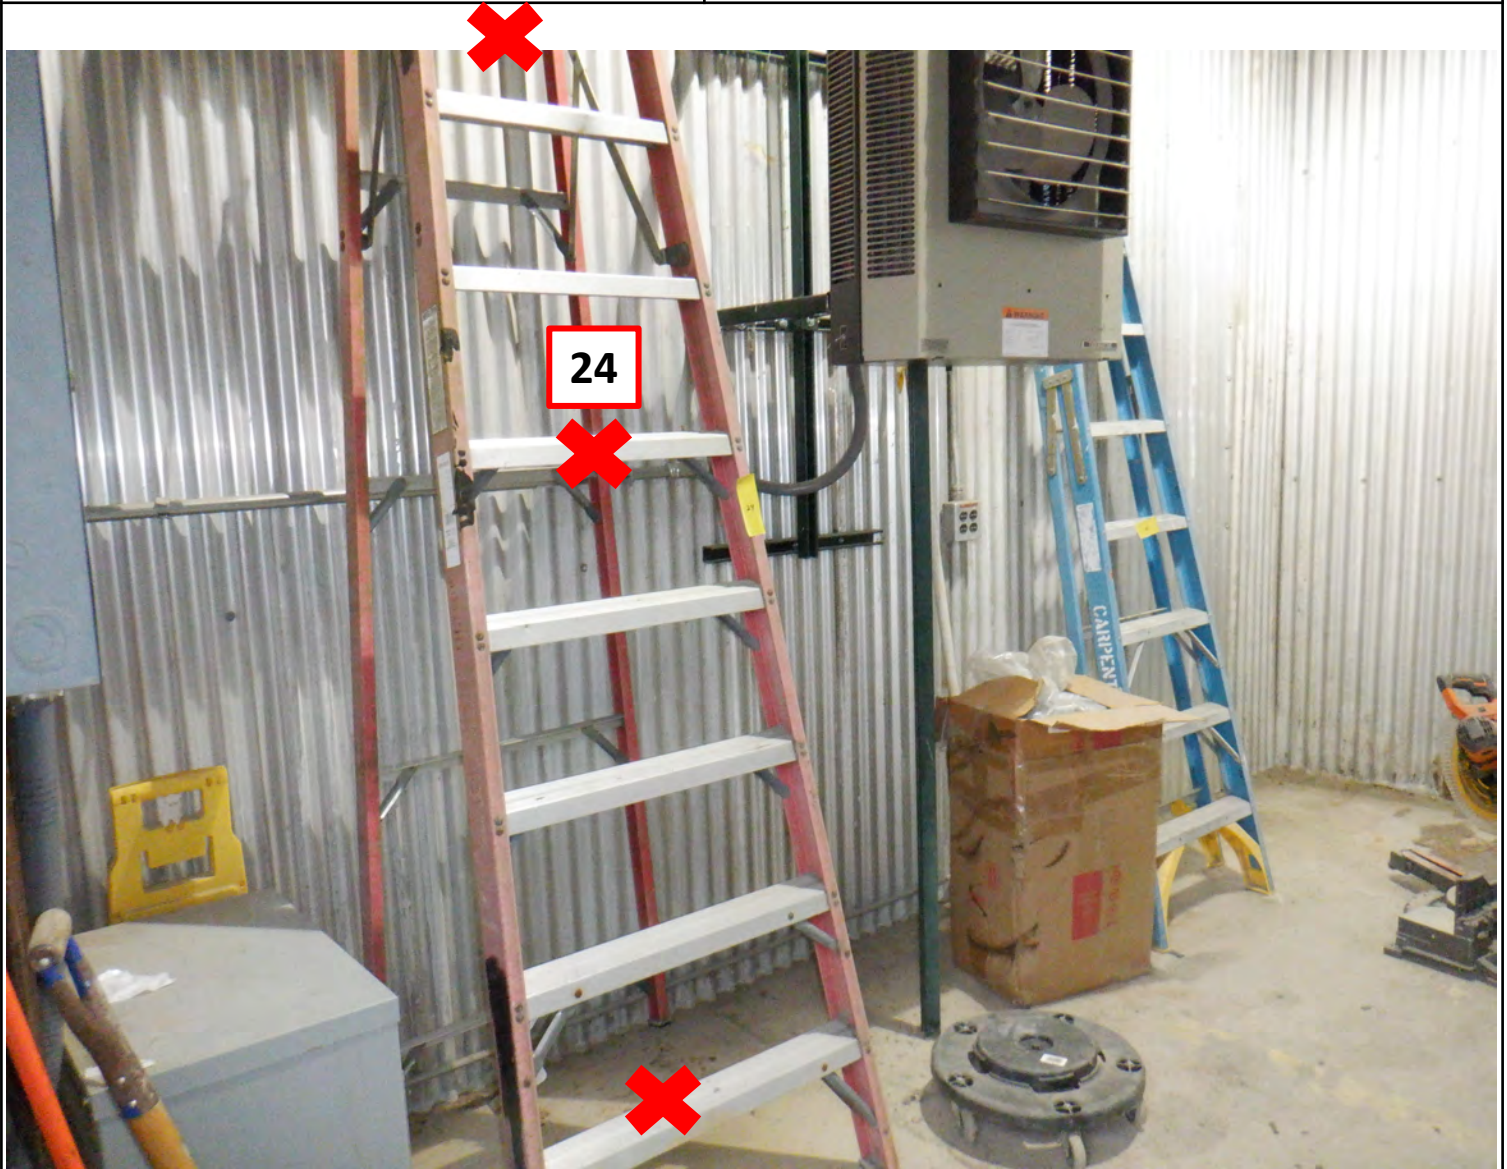
<b>Sample #</b>	<b>SID14332-24</b>
	<b>Sample Location / Orientation</b>	Ladder (Red)
