**Scope of Work and Specifications**

**CRSF Building Demolition**

**OAK RIDGE NATIONAL LABORATORY**

**March 2021**

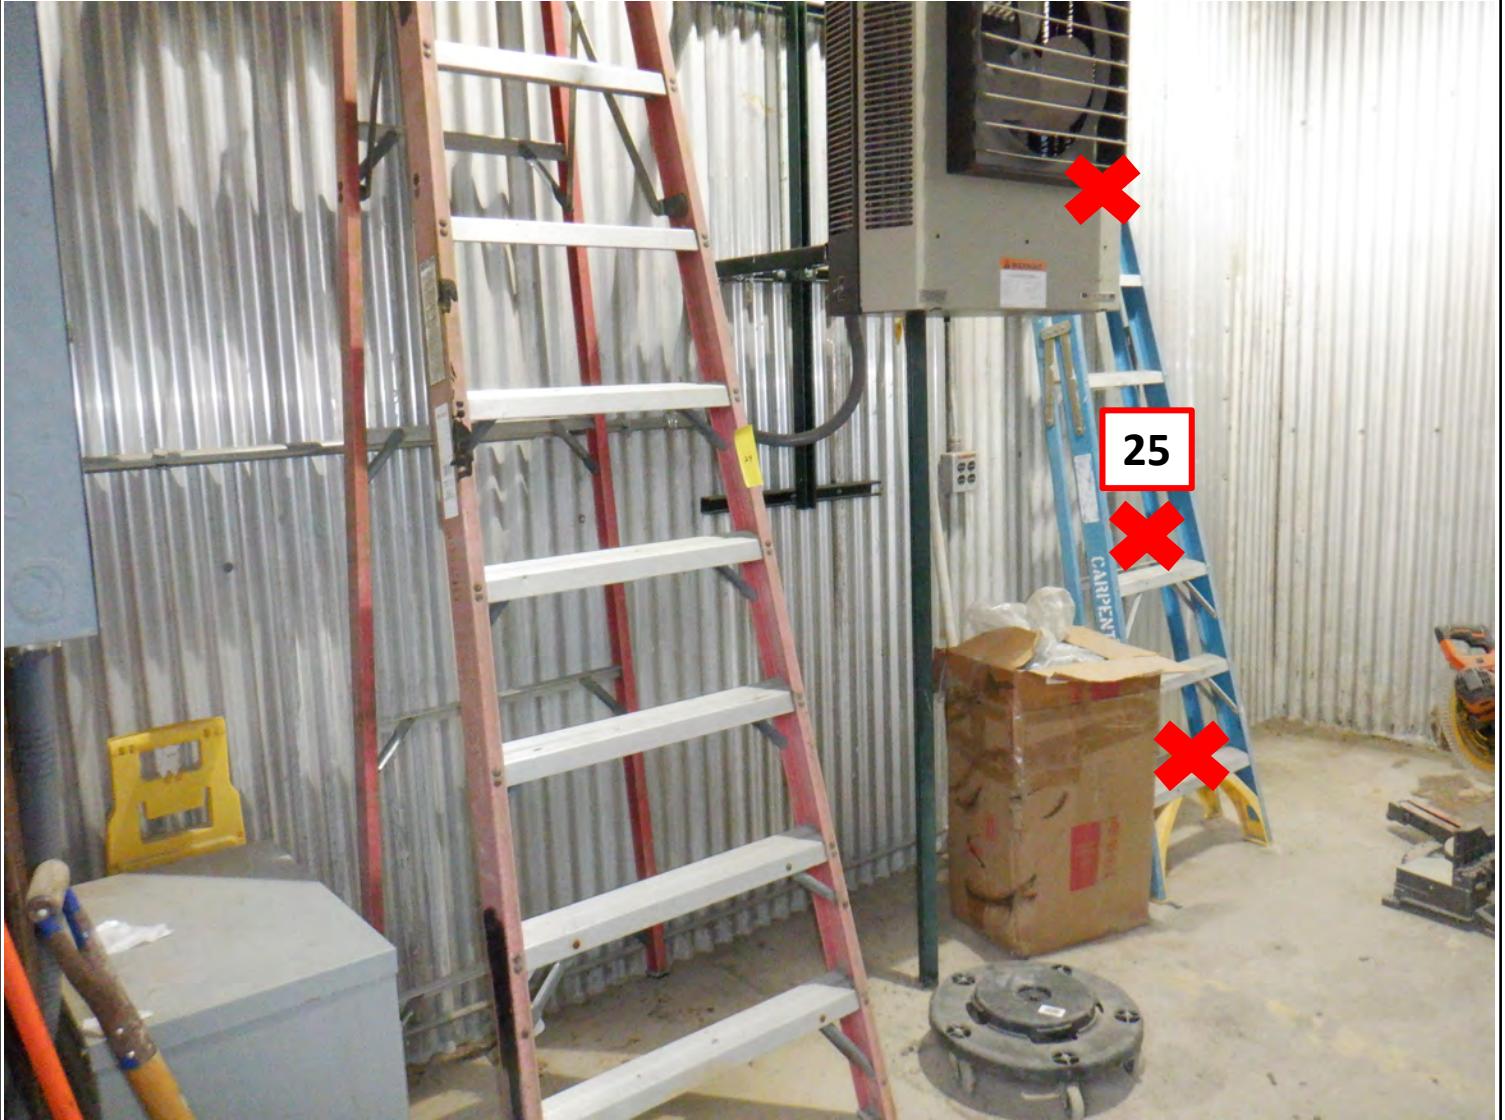
<b>Sample #</b>	<b>SID14332-25</b>
	<b>Sample Location / Orientation</b>	Ladder (Blue)

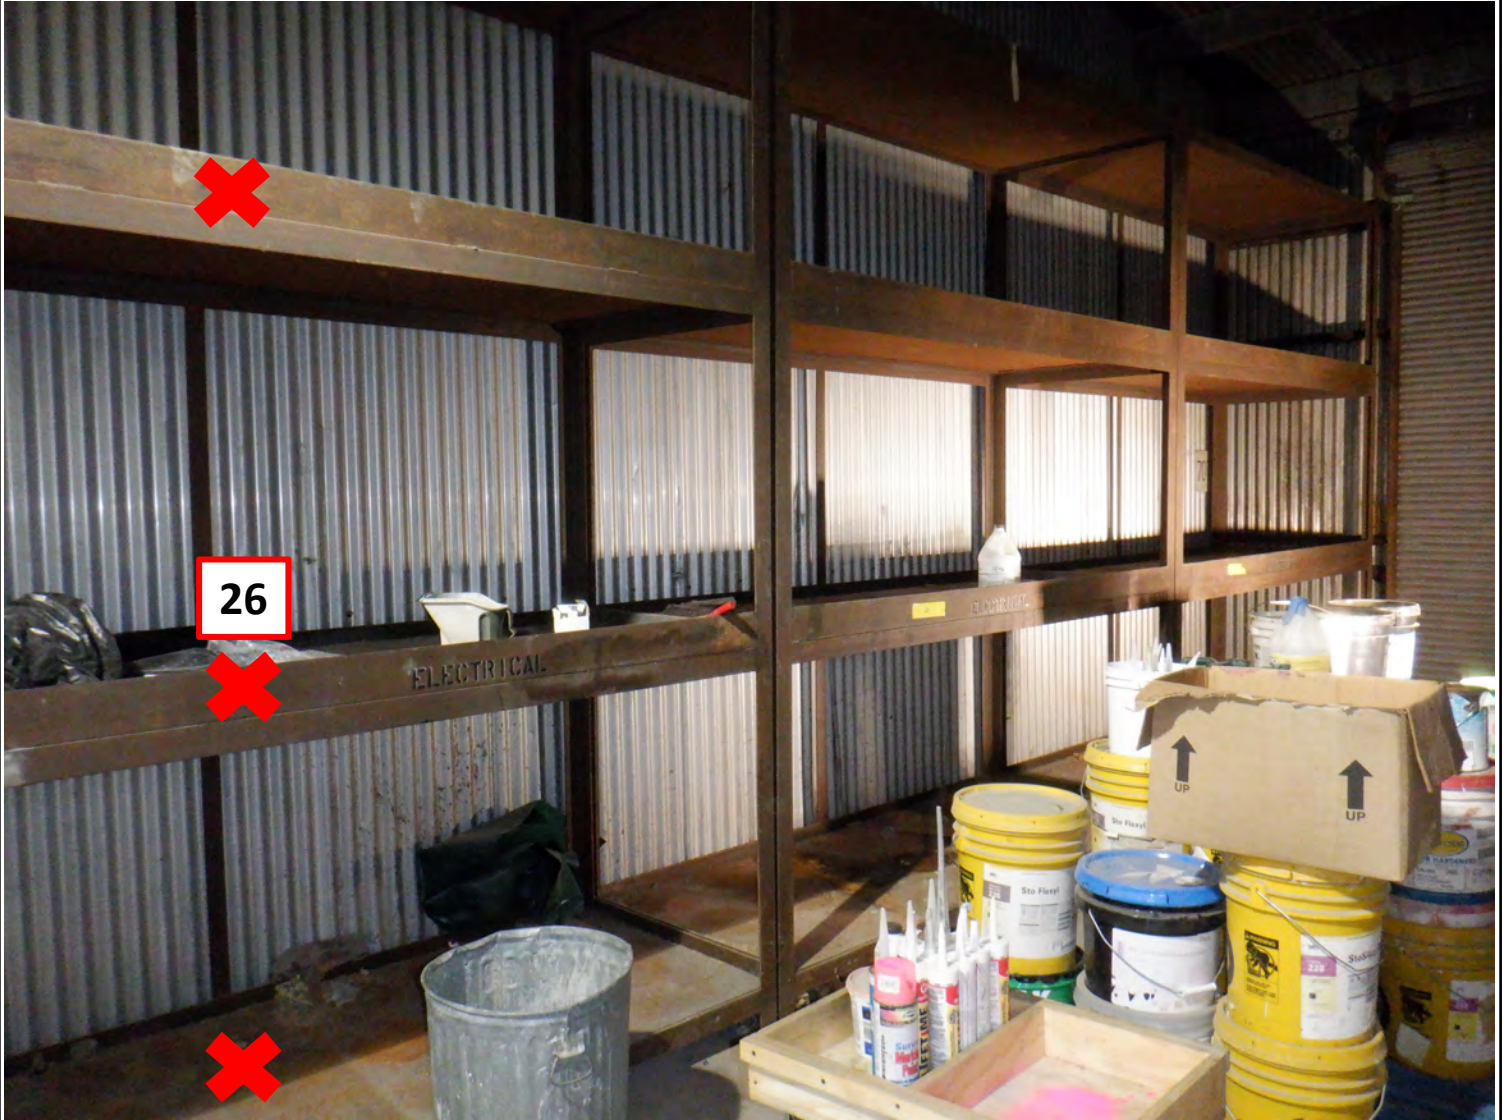
<b>Sample #</b>	<b>SID14332-26</b>
	<b>Sample Location / Orientation</b>	Shelving Unit/Storage Rack, Bottom Three Shelves

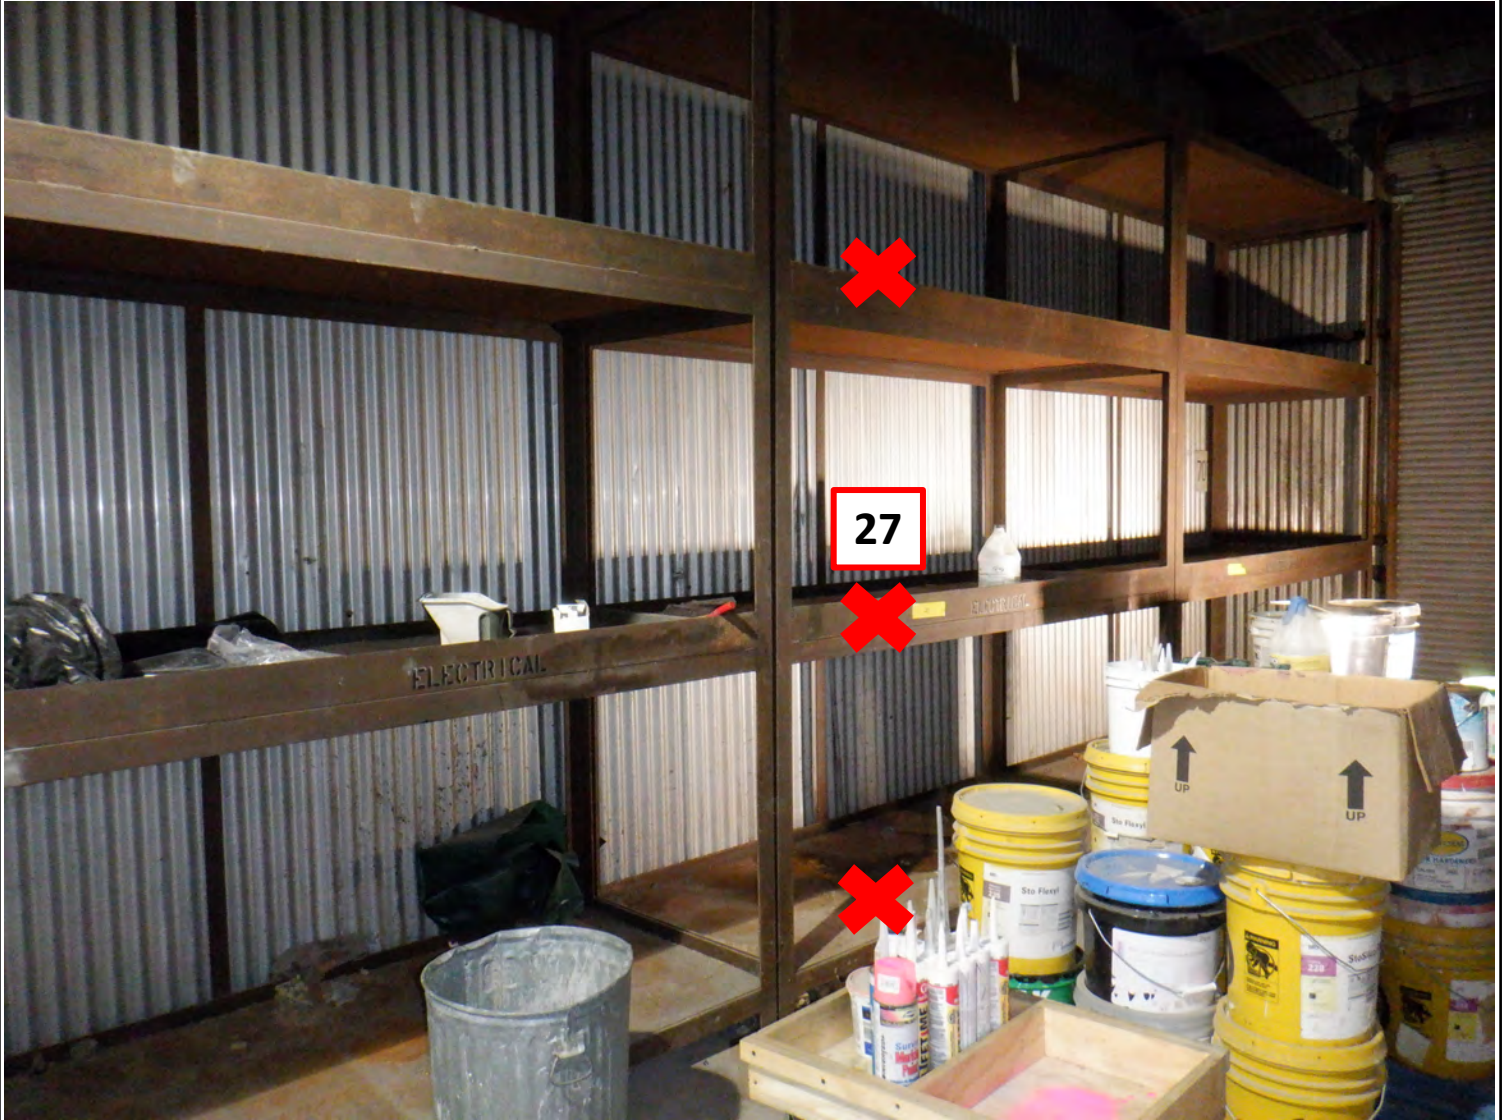
<b>Sample #</b>	SID14332-27
	<b>Sample Location / Orientation</b>	Shelving Unit/Storage Rack, Bottom Three Shelves

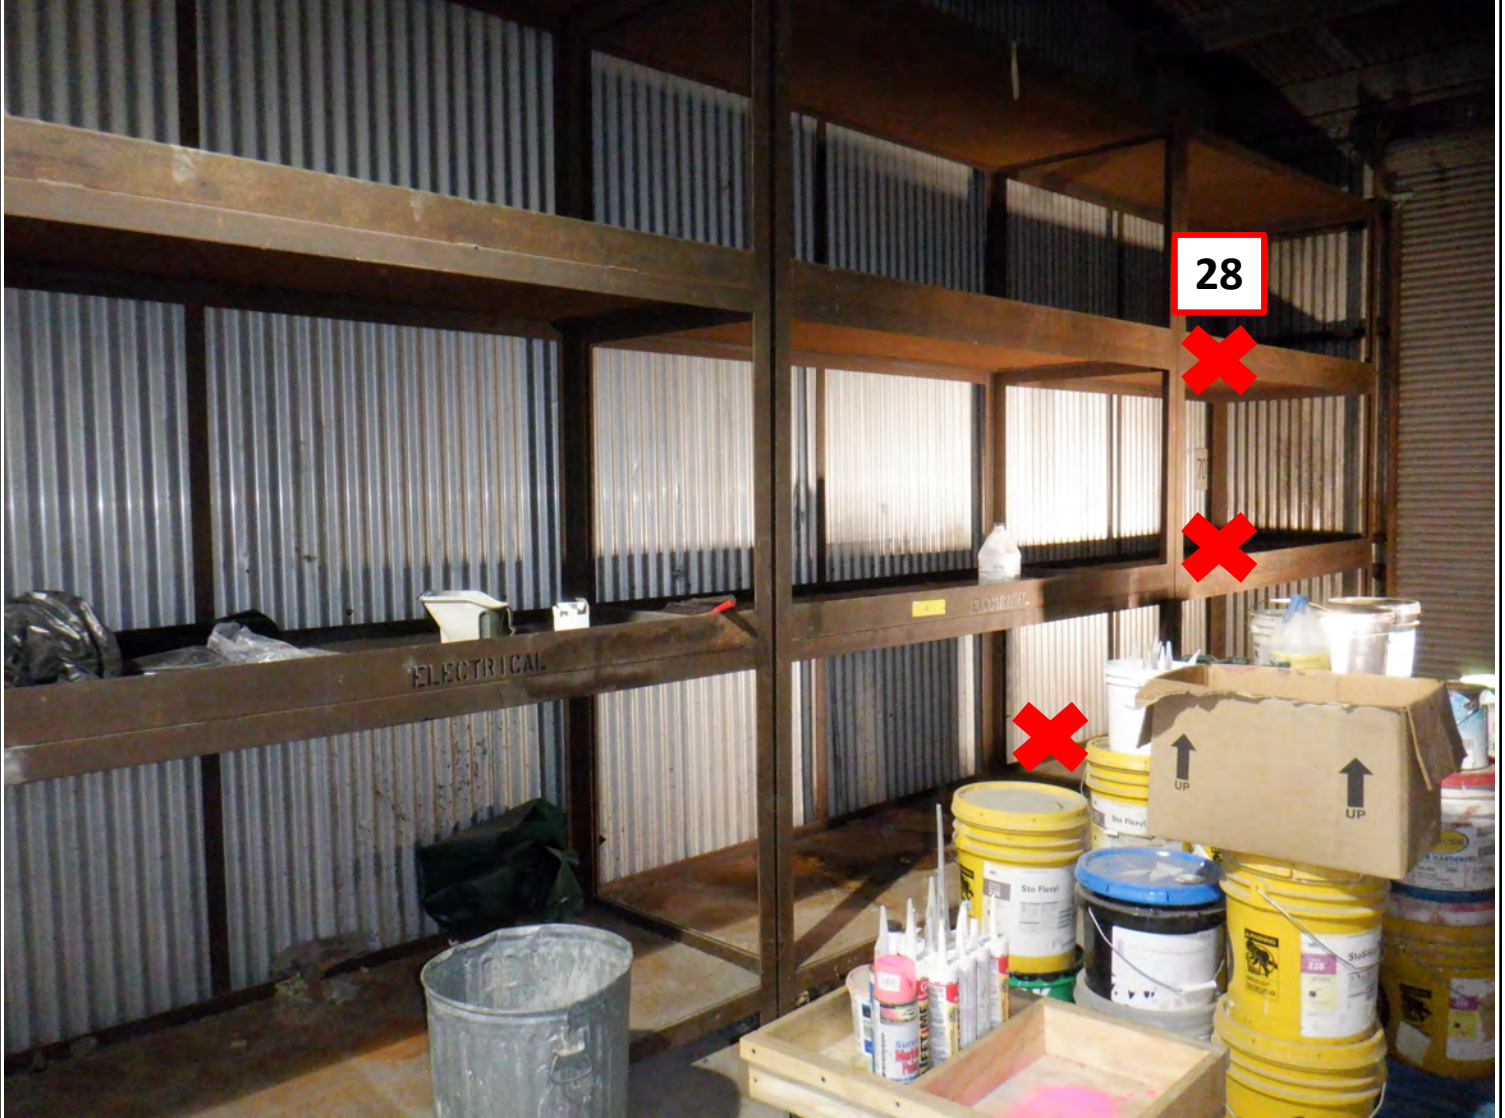
<b>Sample #</b>	<b>SID14332-28</b>
<b>Sample Location / Orientation</b>	Shelving Unit/Storage Rack, Bottom Three Shelves, Right

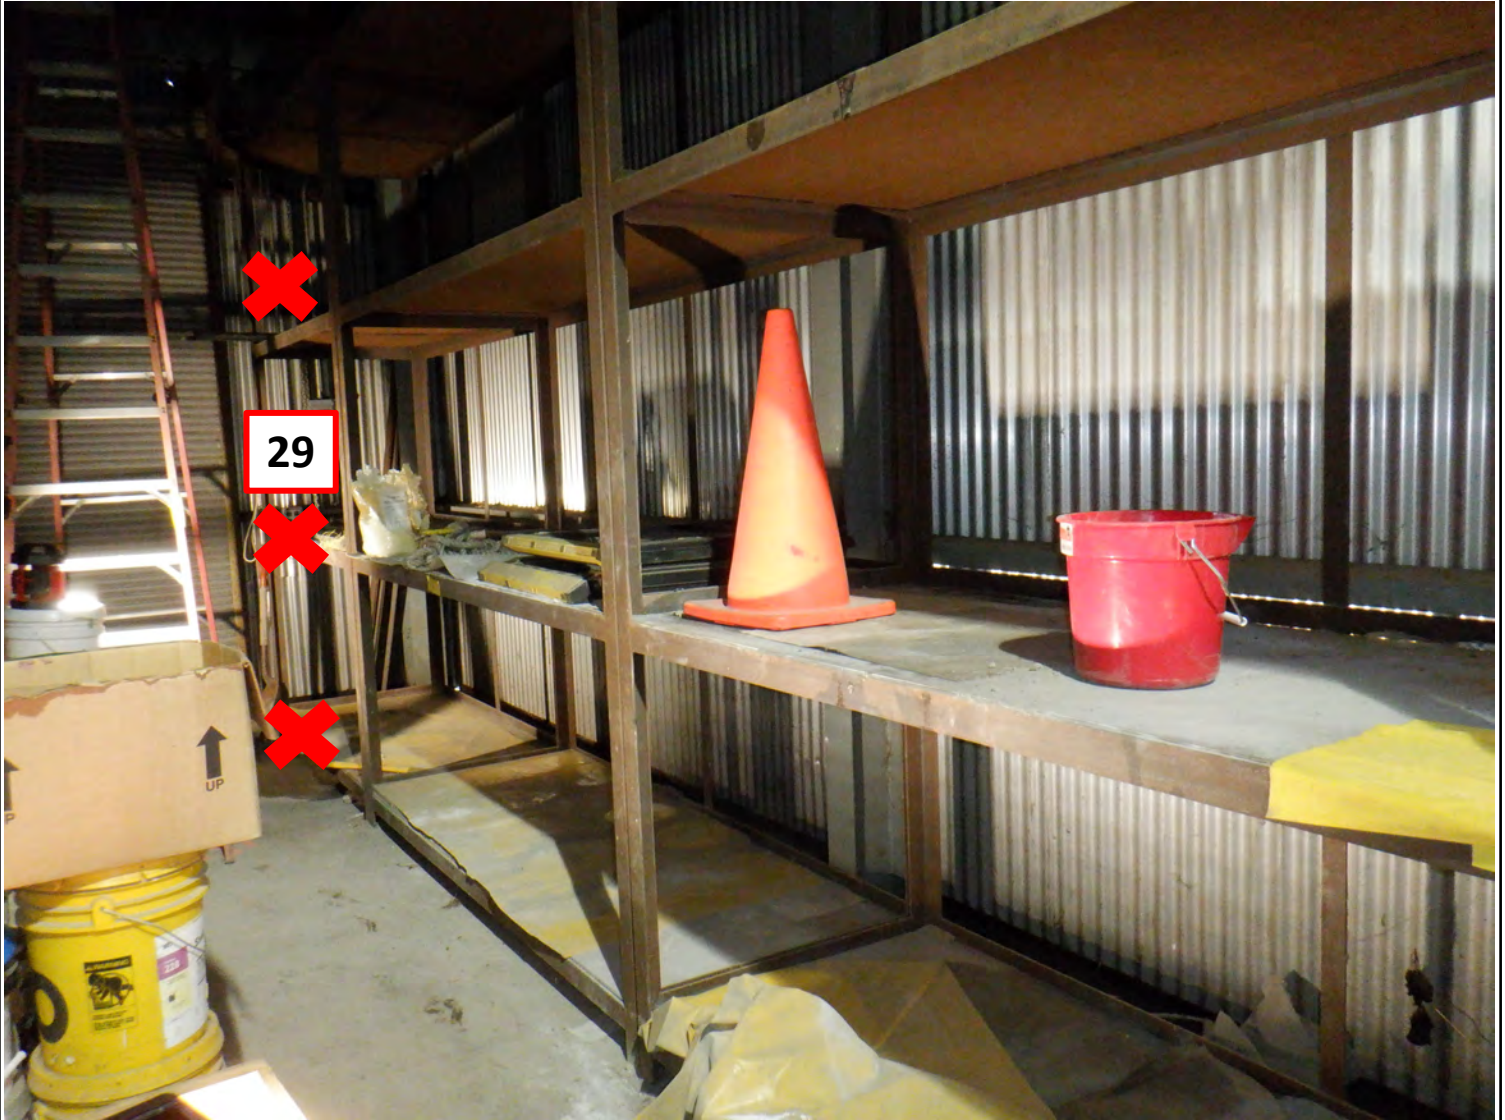
<b>Sample #</b>	<b>SID14332-29</b>
<b>Sample Location / Orientation</b>	Shelving Unit/Storage Rack, Bottom Three Shelves, Left

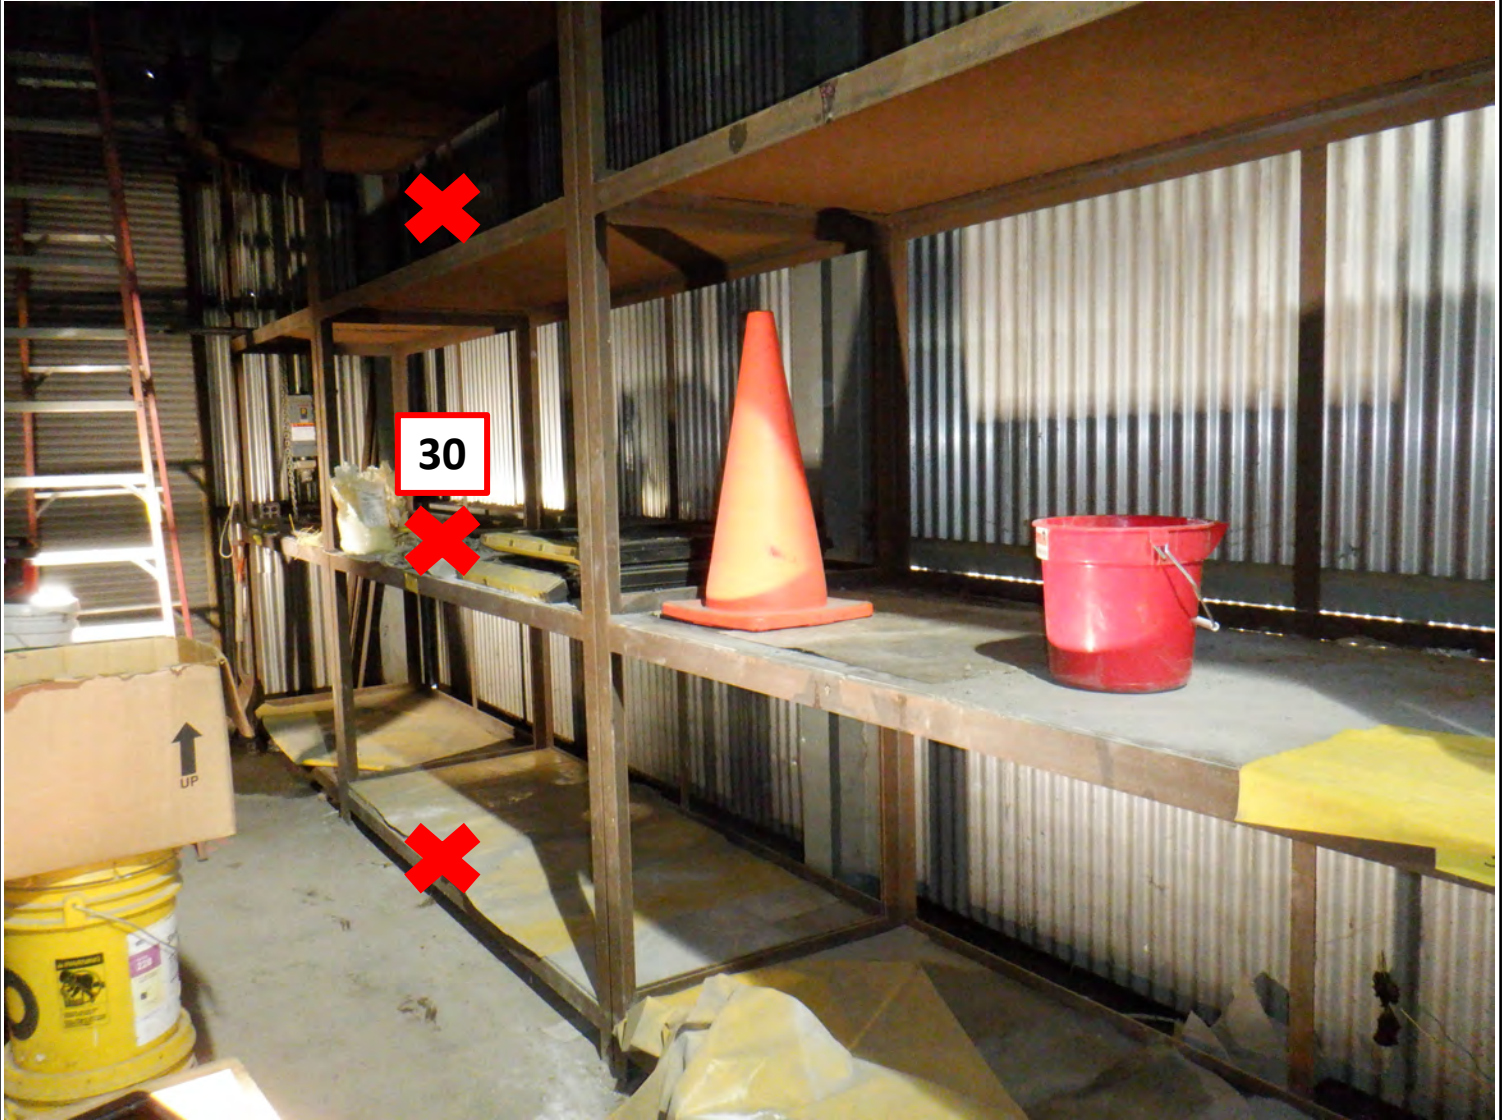
<b>Sample #</b>	<b>SID14332-30</b>
<b>Sample Location / Orientation</b>	Shelving Unit/Storage Rack, Bottom Three Shelves, Center

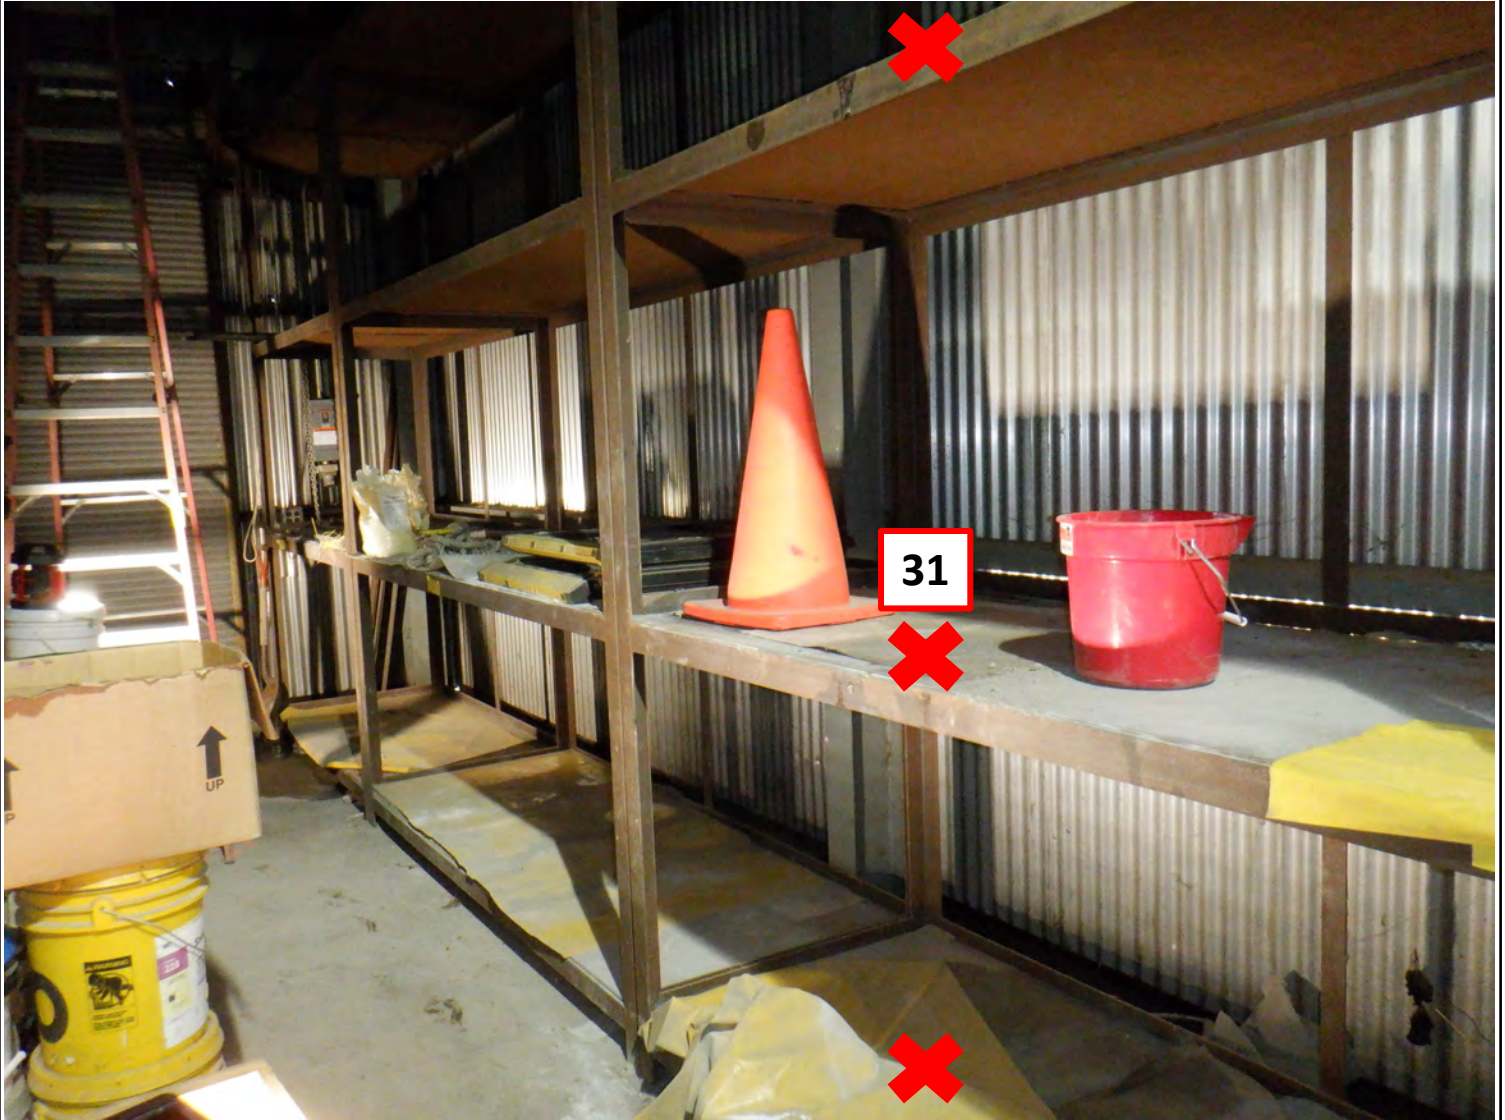
<b>Sample #</b>	<b>SID14332-31</b>
<b>Sample Location / Orientation</b>	Shelving Unit/Storage Rack, Bottom Three Shelves, Right
